## **DAMAGED VEHICLE (SLJ 1362 D) INSPECTION REPORT (WITHOUT PREJUDICE)**

| Registration No | : SLJ 1362 D | Mileage | : 160062 Km |
| Make & Model | : HONDA SHUTTLE 1.5 CVT | Chassis No. | : GP71043538 |

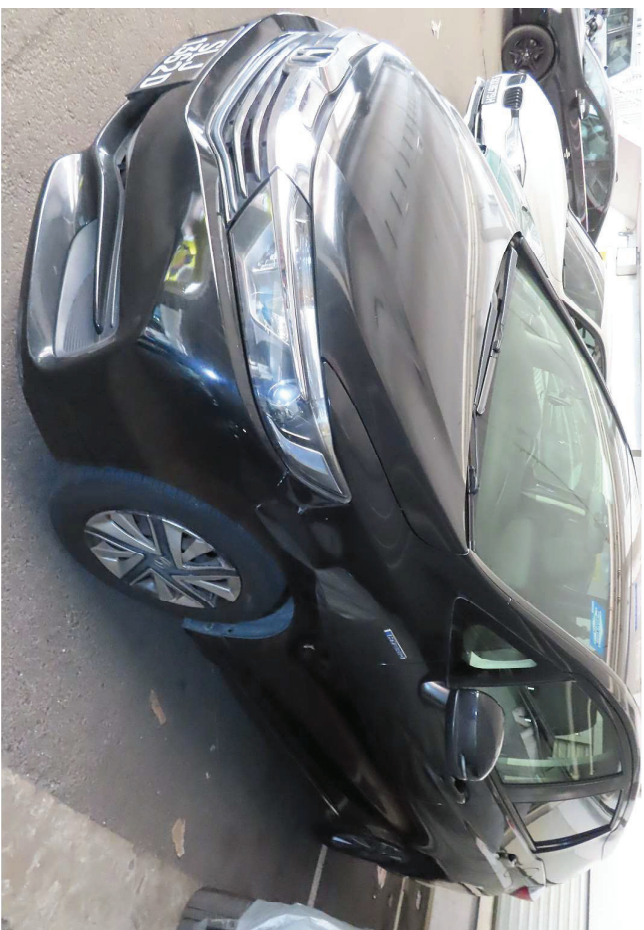
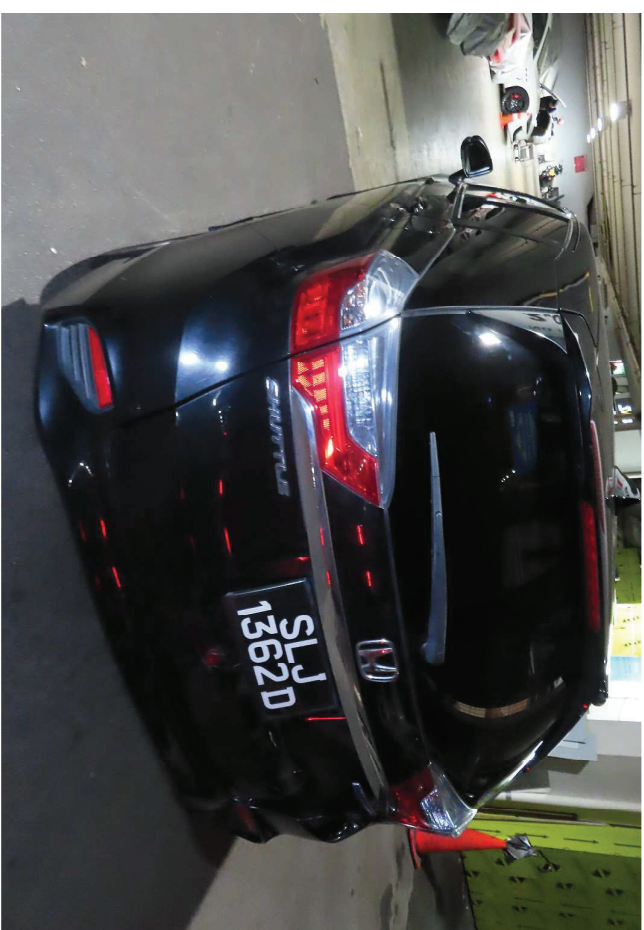
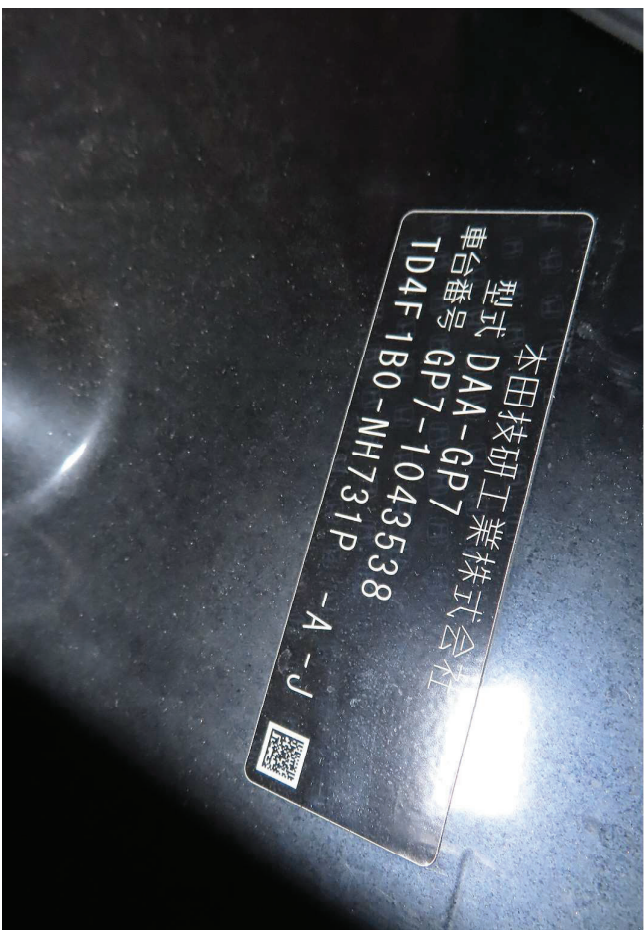
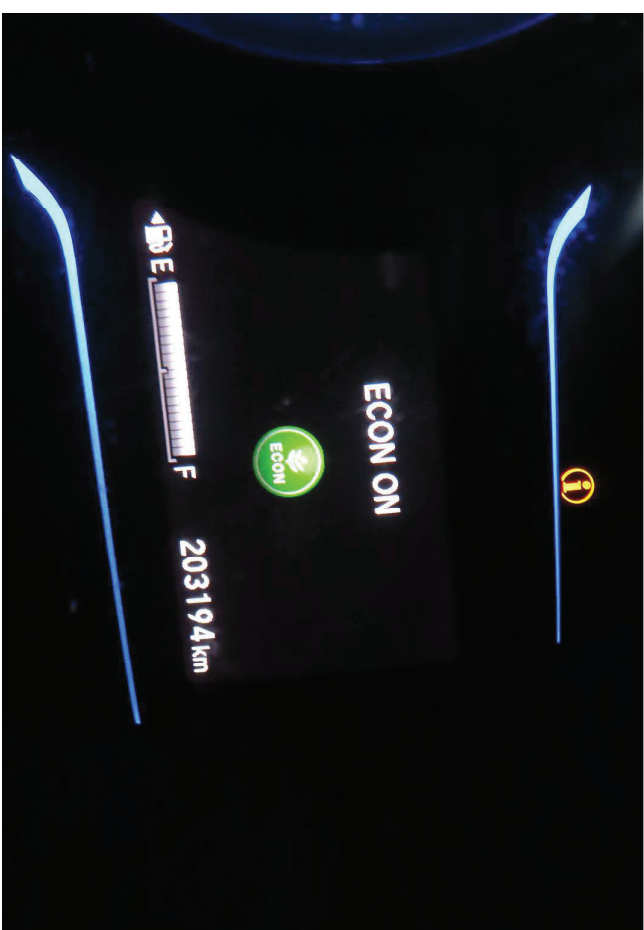
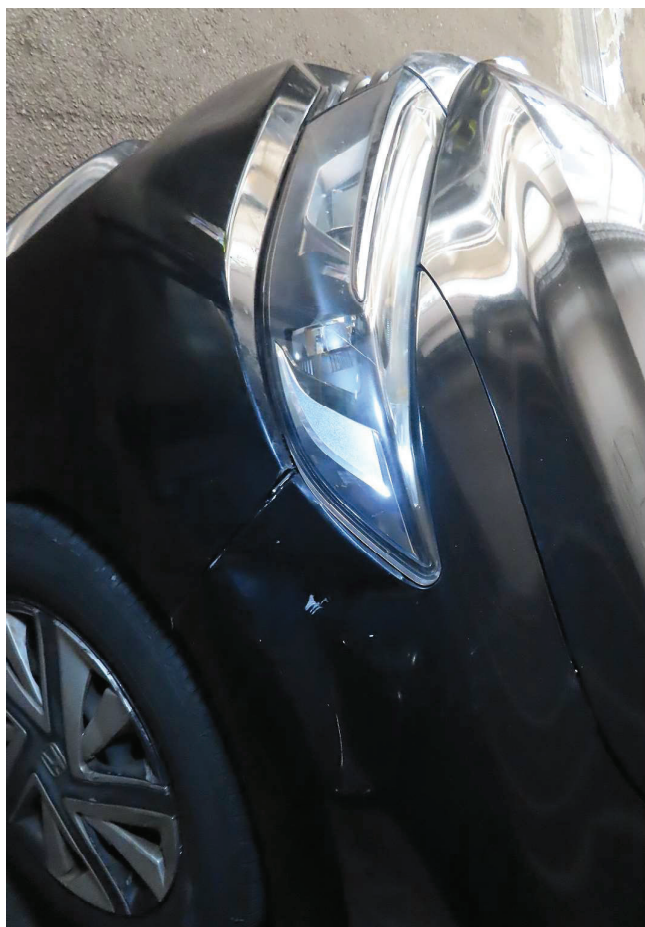
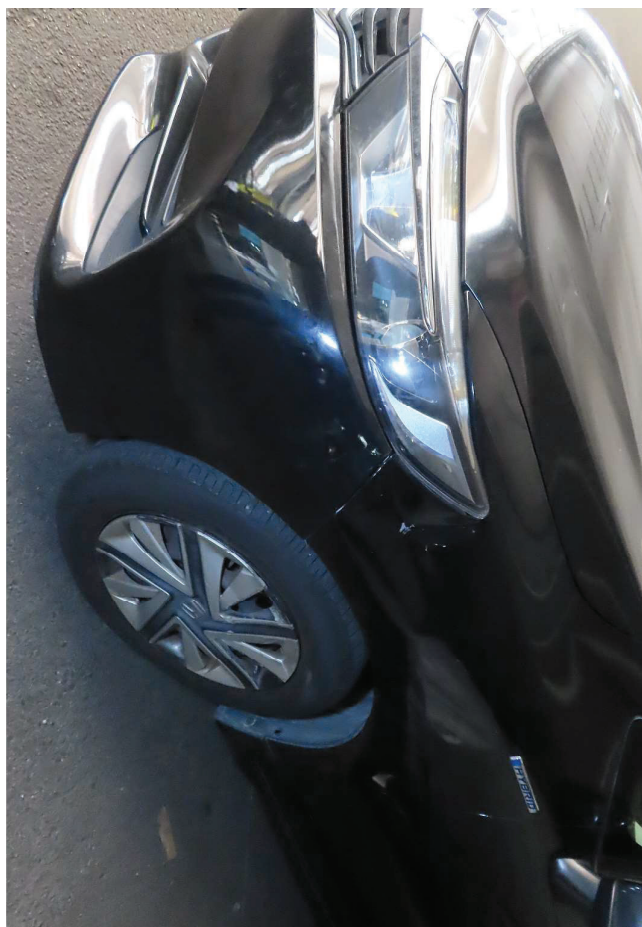
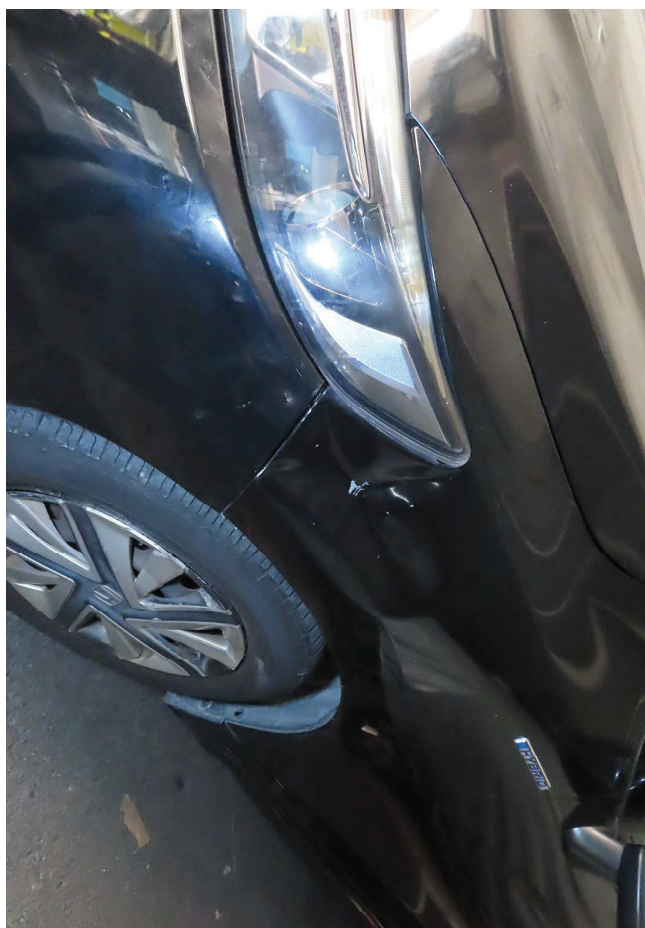
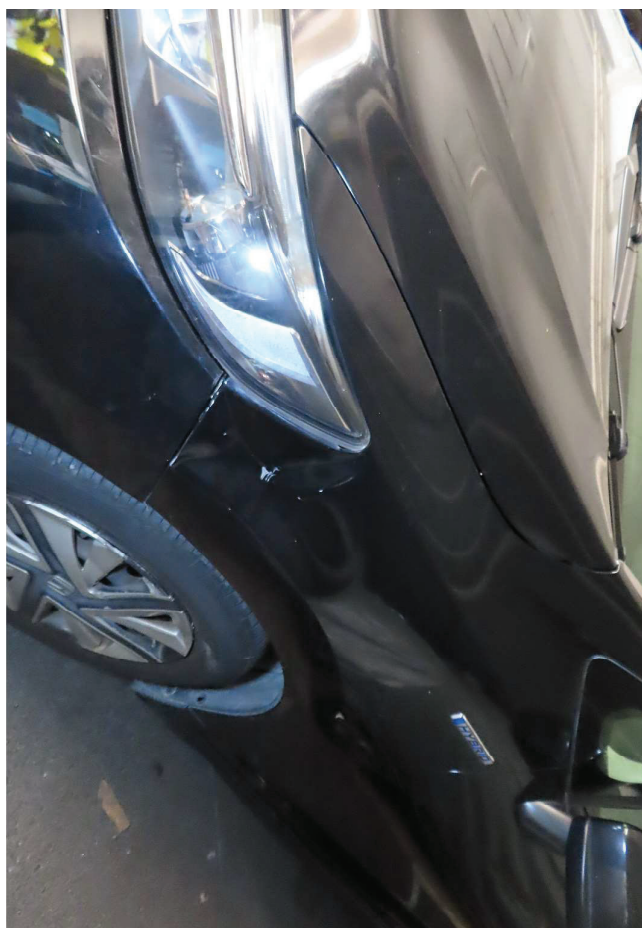
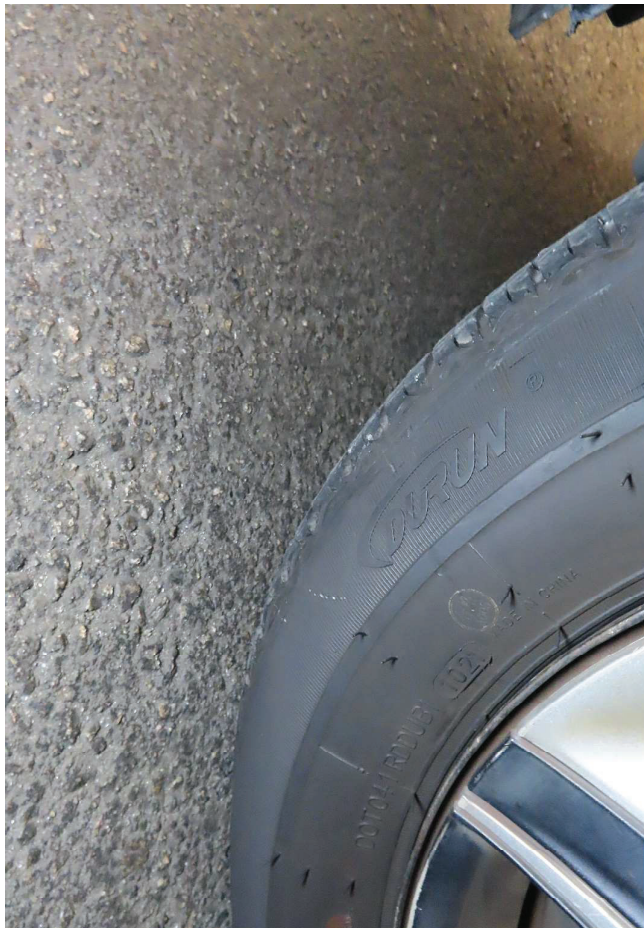
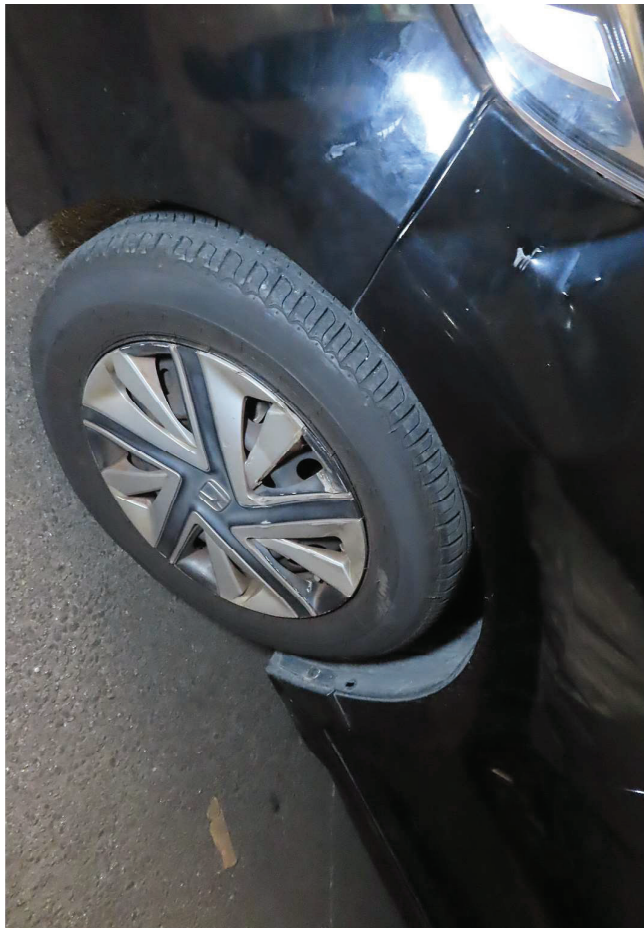
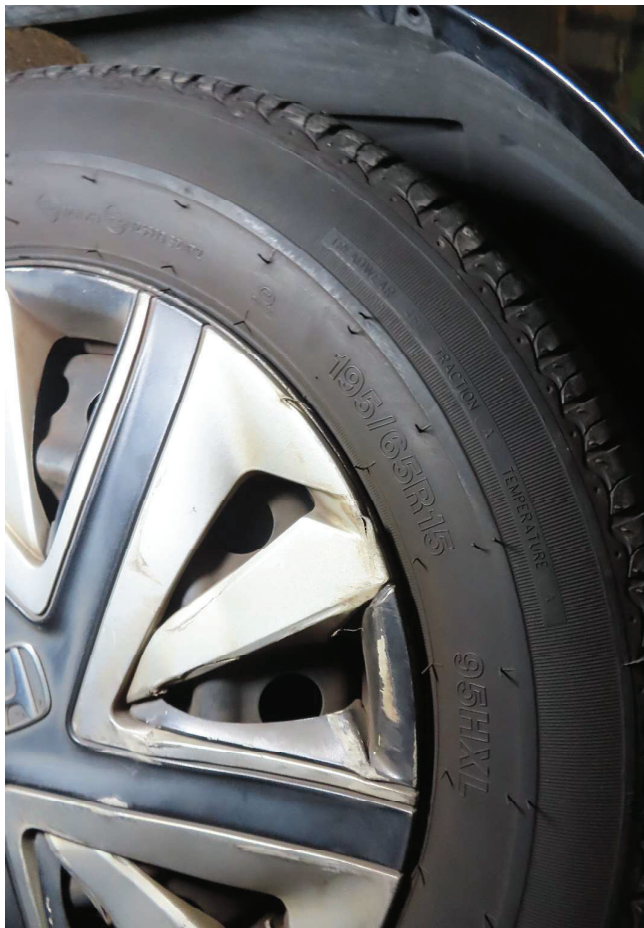
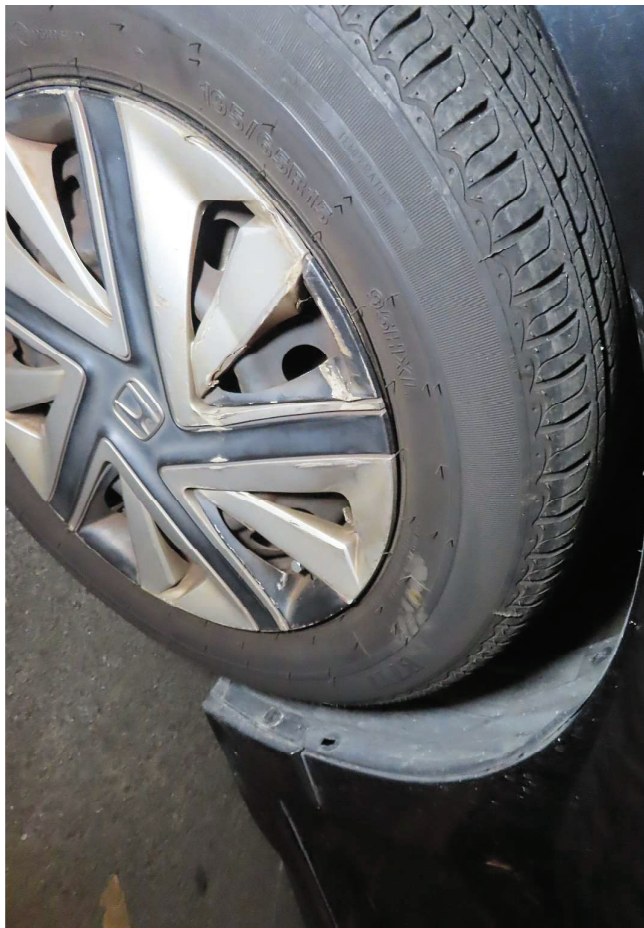
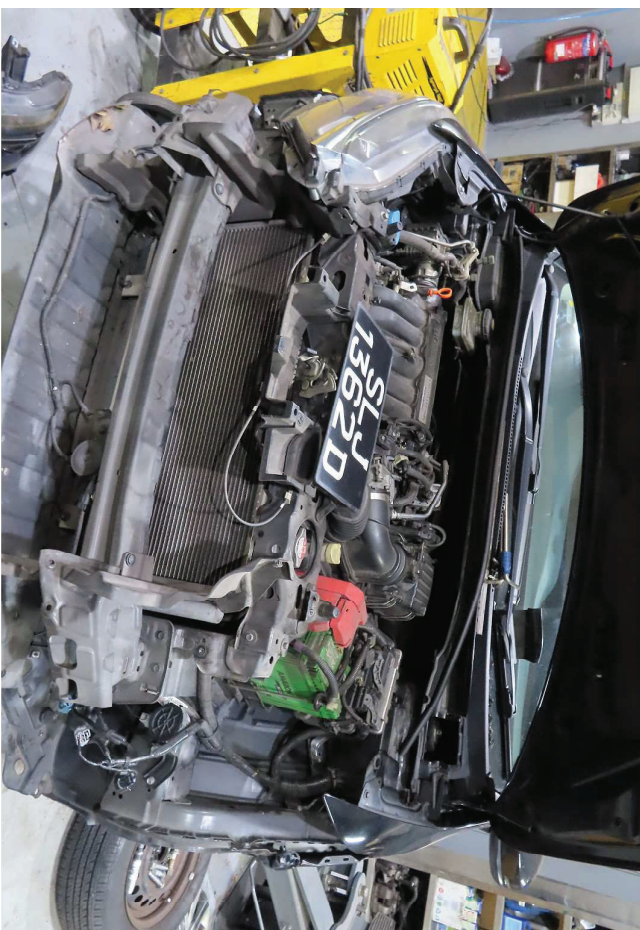
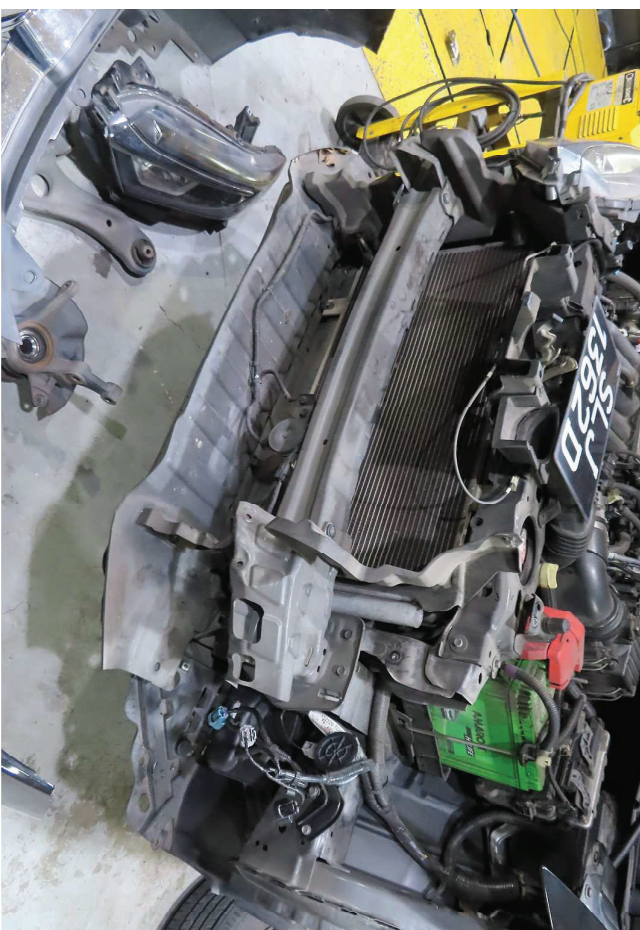
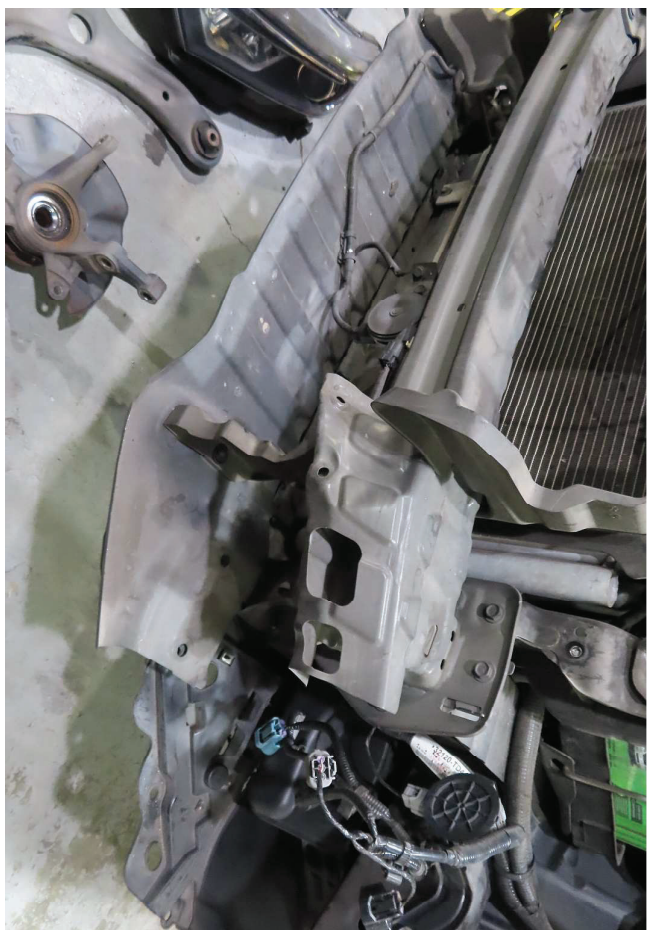
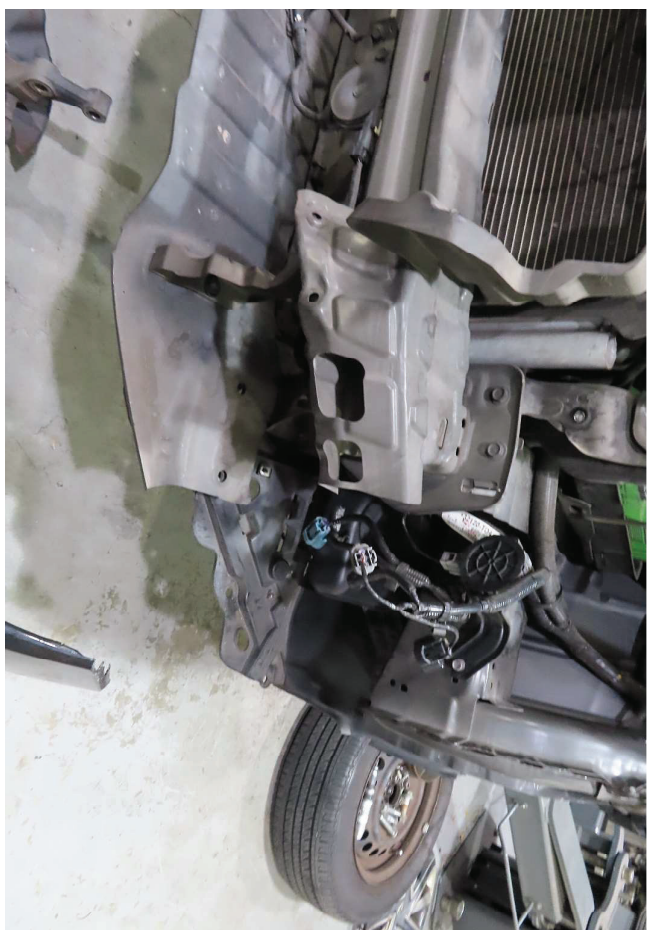
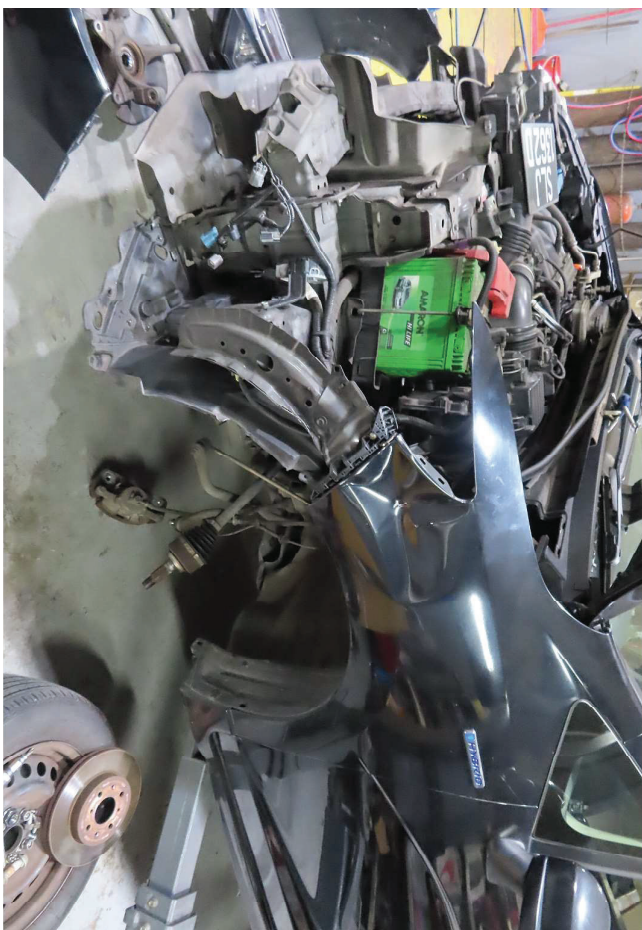
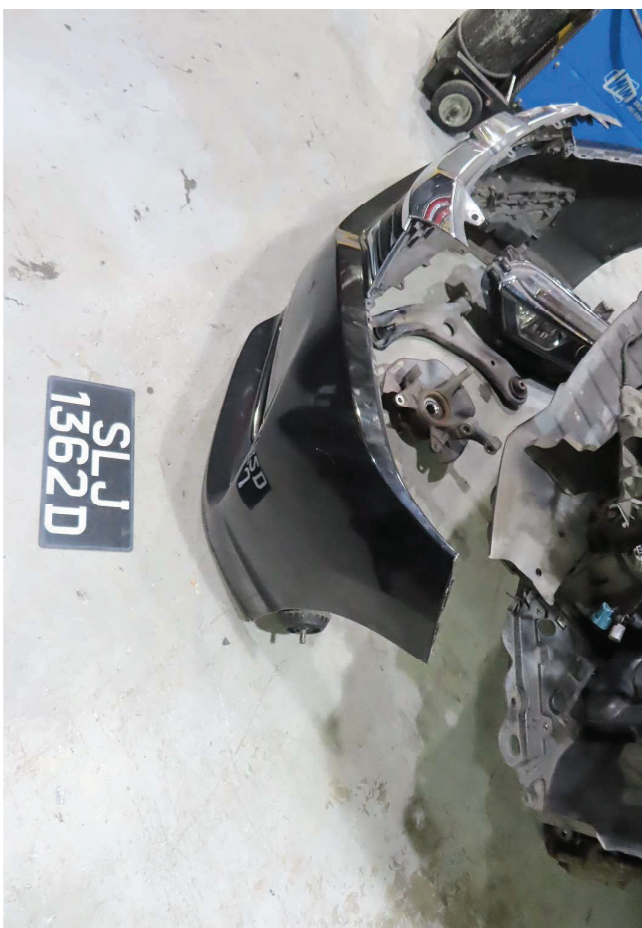
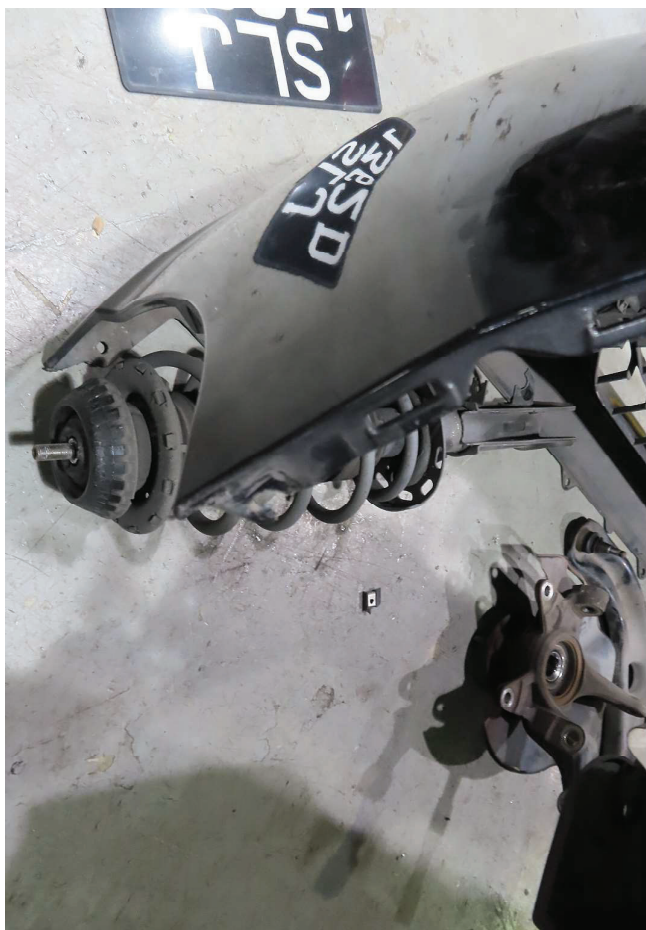
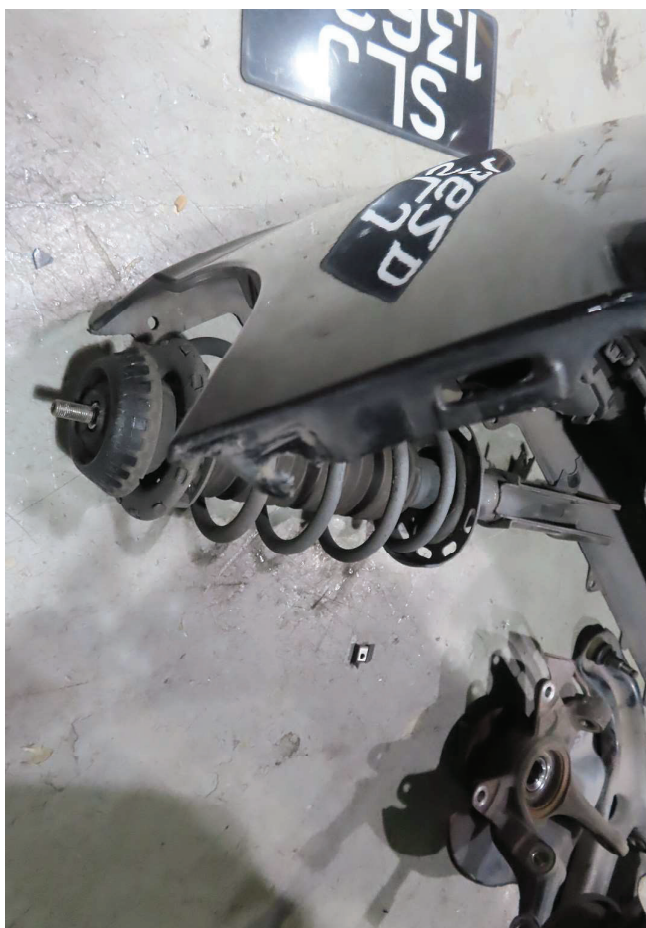
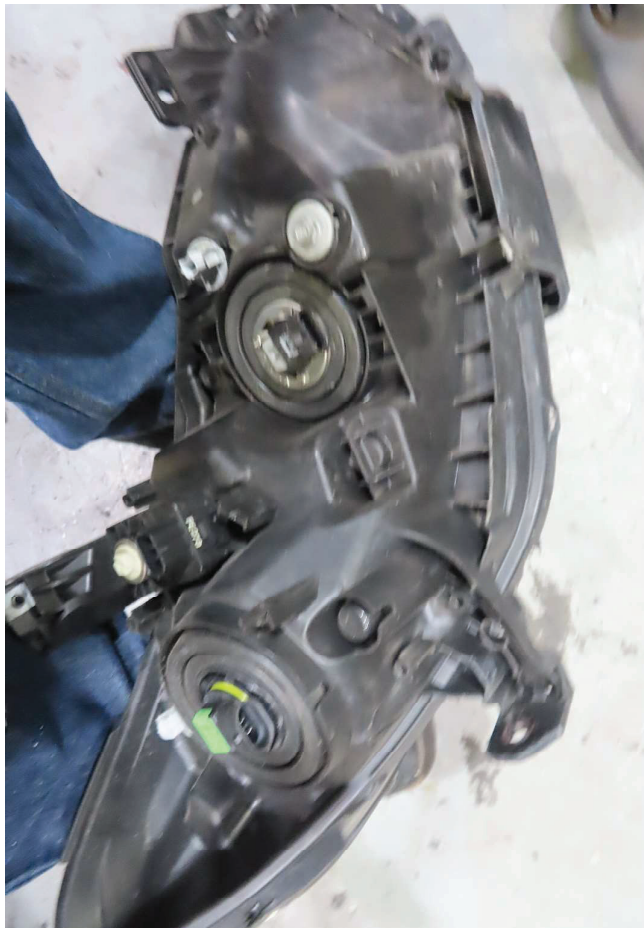
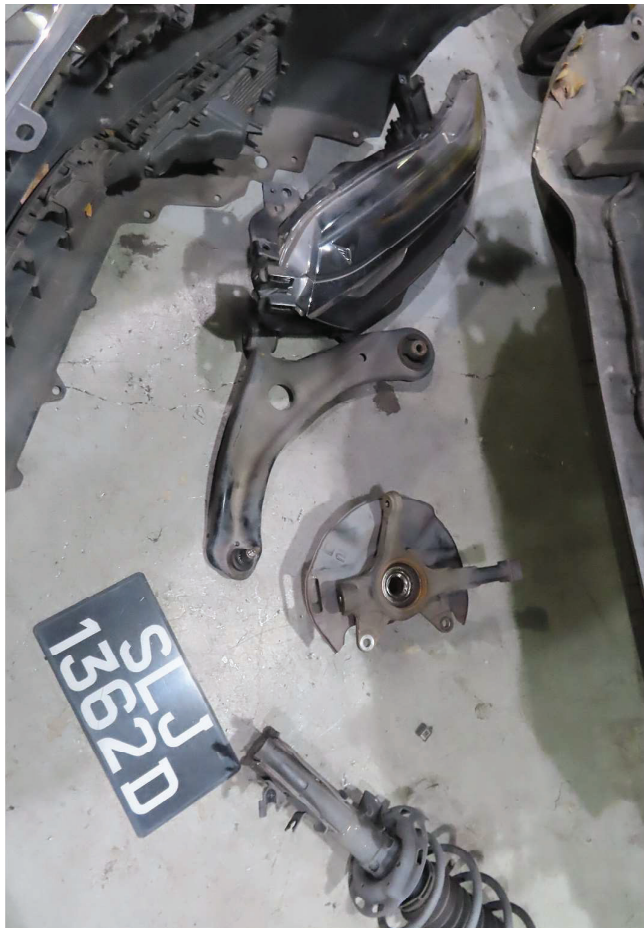
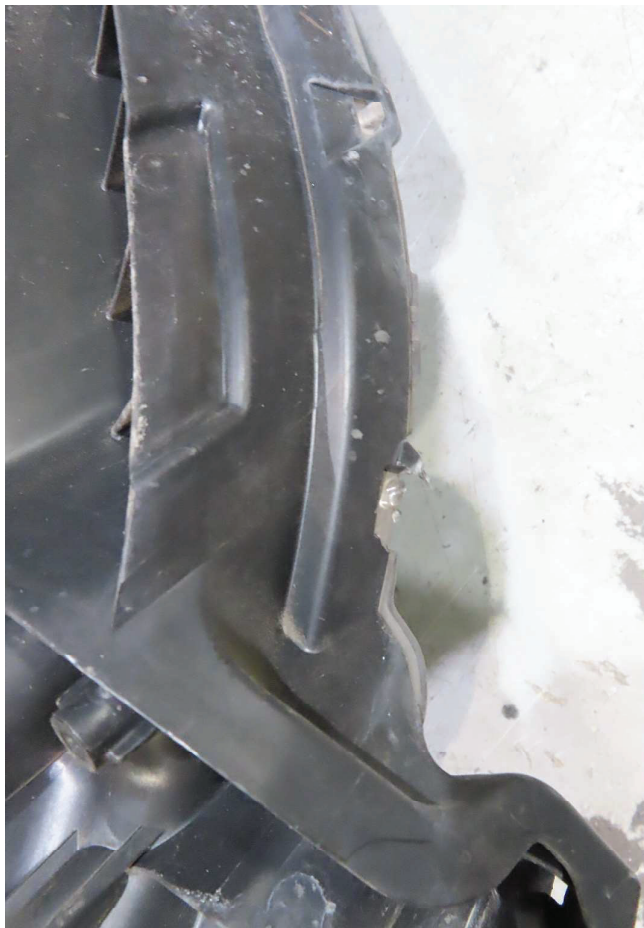
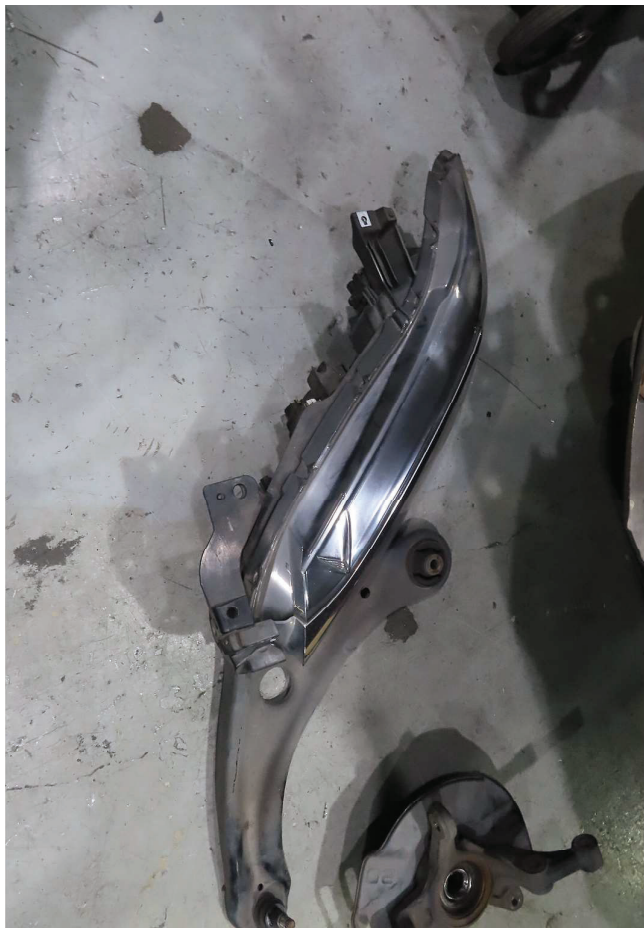
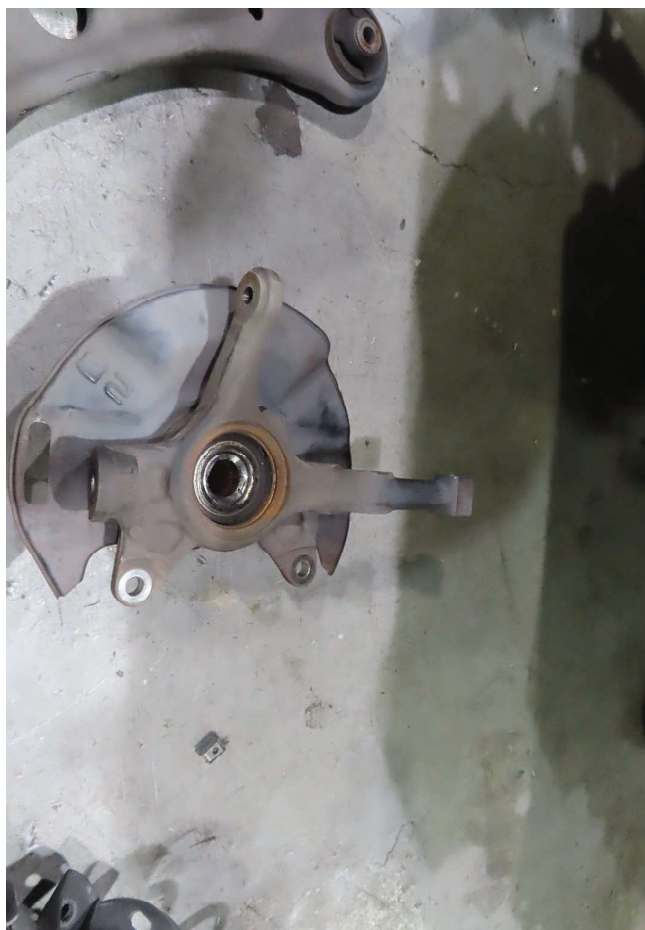
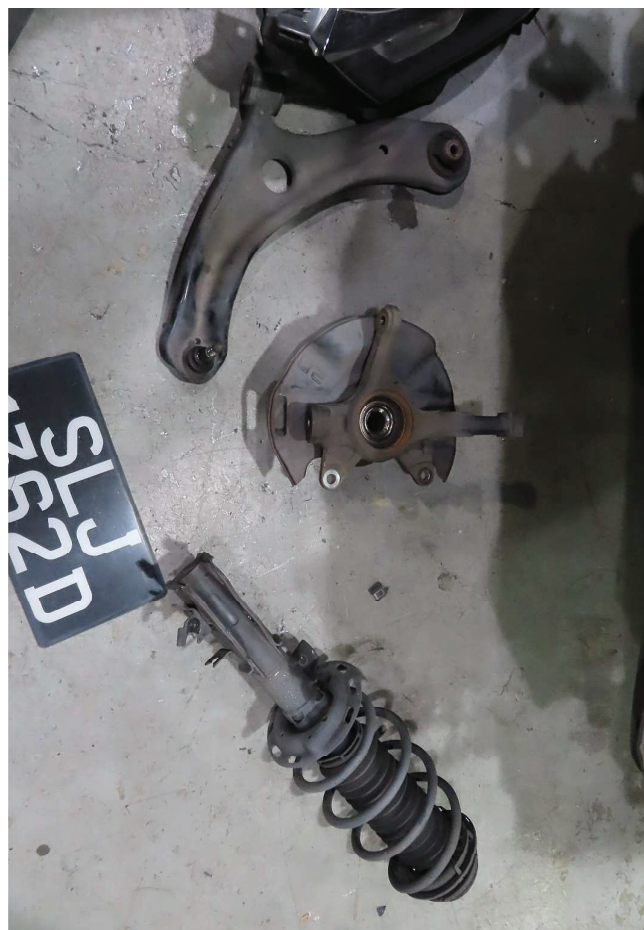
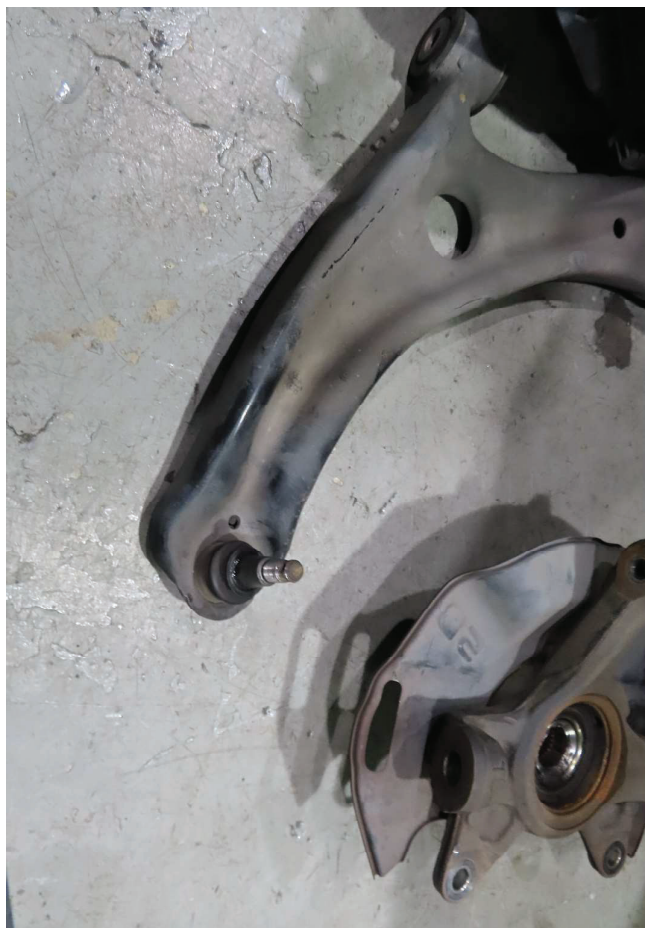
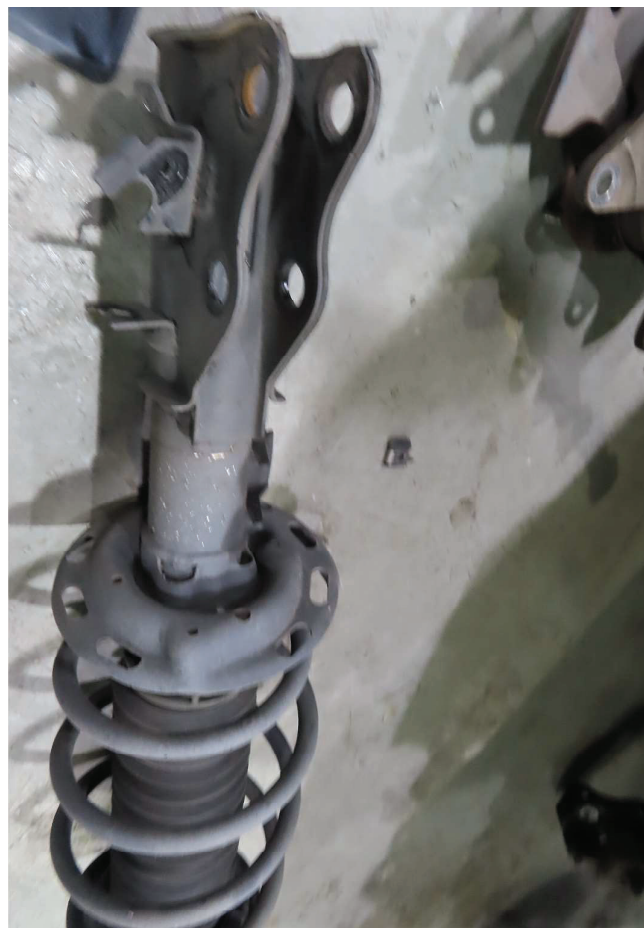
The impact of the collision has damaged/affected the front fender, front bumper, headlamp, front suspension and etc.

Please refer to the Annex for a detailed account of the damages and photographs taken.

Our adjusted cost of lump sum repair is **\$5,100.00** and an estimated **5** days is required to repair the vehicle. Please refer to the Annex for a detailed account of the cost estimates.
