## LKK Auto Consultants Pte Ltd

### Tax Invoice

## ADJUSTMENT ON REPAIR COST FOR VEHICLE NO SKQ 69H

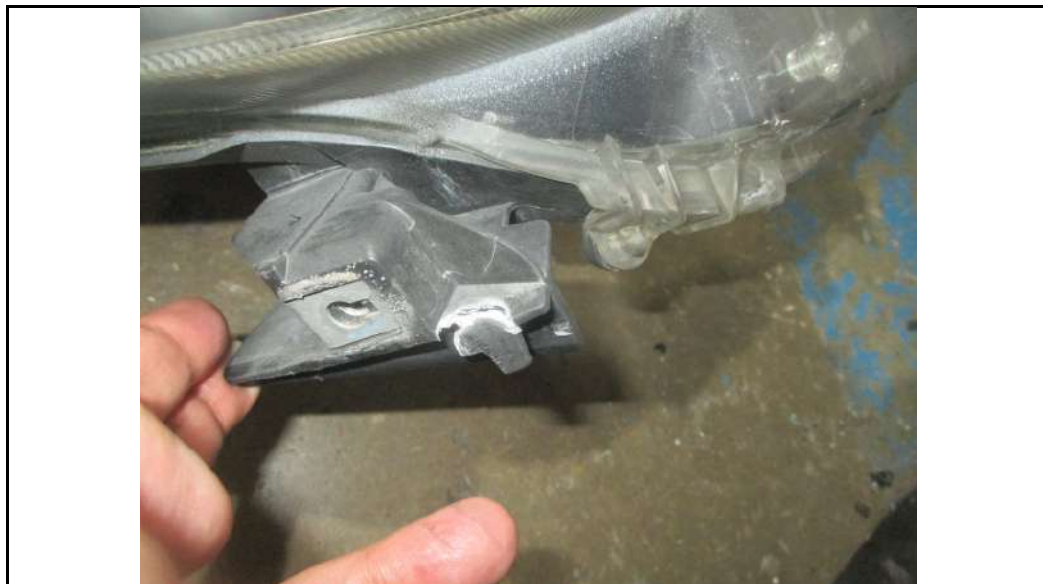
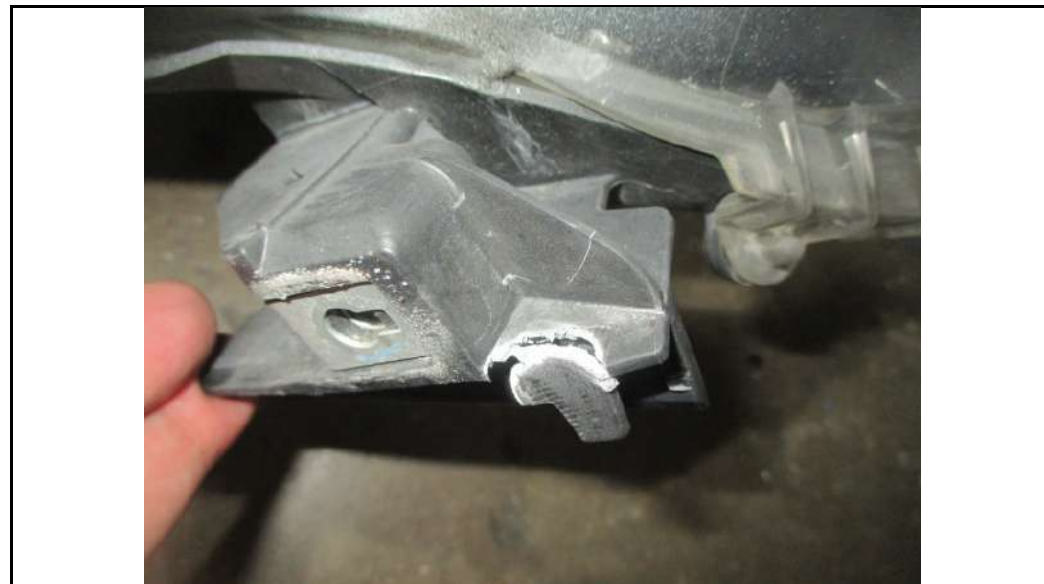
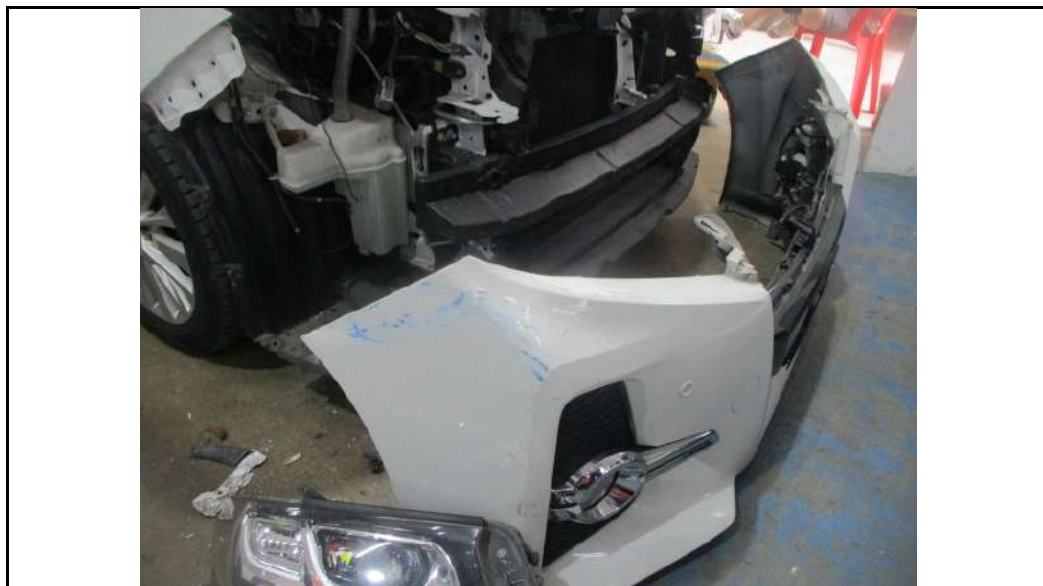
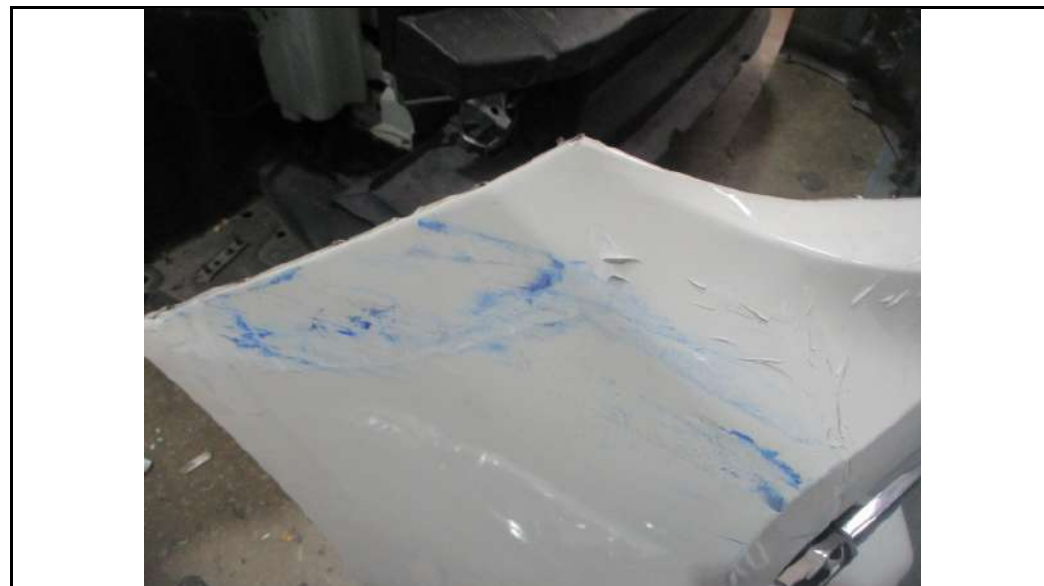
**PHOTOGRAPHS FOR VEHICLE NO. : SKQ 69H**

THE VEHICLE SUSTAINED DAMAGES AT THE O/S FRONT PORTION.
