**LKK Auto Consultants Pte Ltd**

## ADJUSTMENT ON REPAIR COST FOR VEHICLE NO GBJ 4342K

## PHOTOGRAPHS FOR VEHICLE NO. : GBJ 4342K

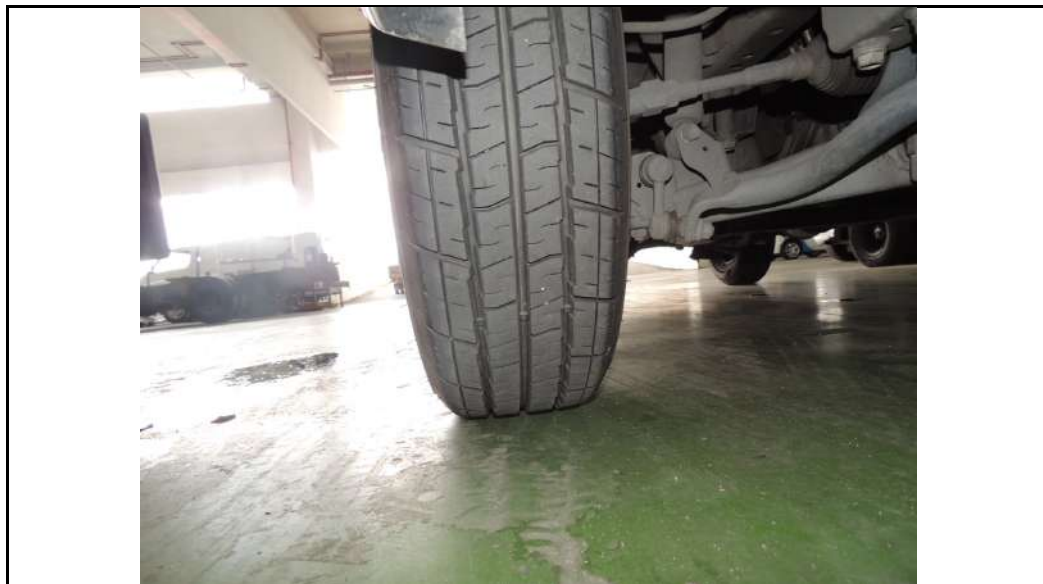
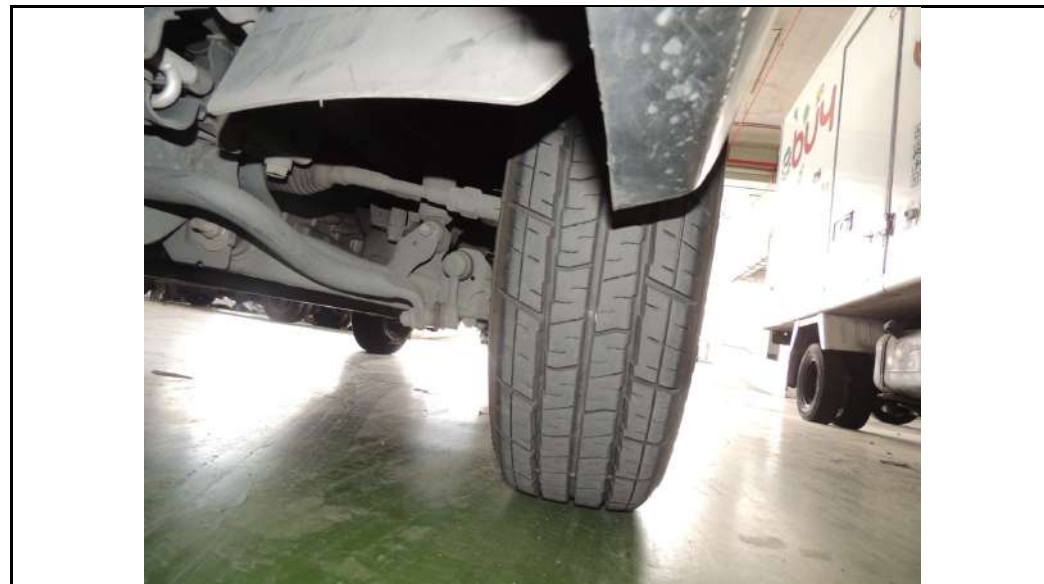
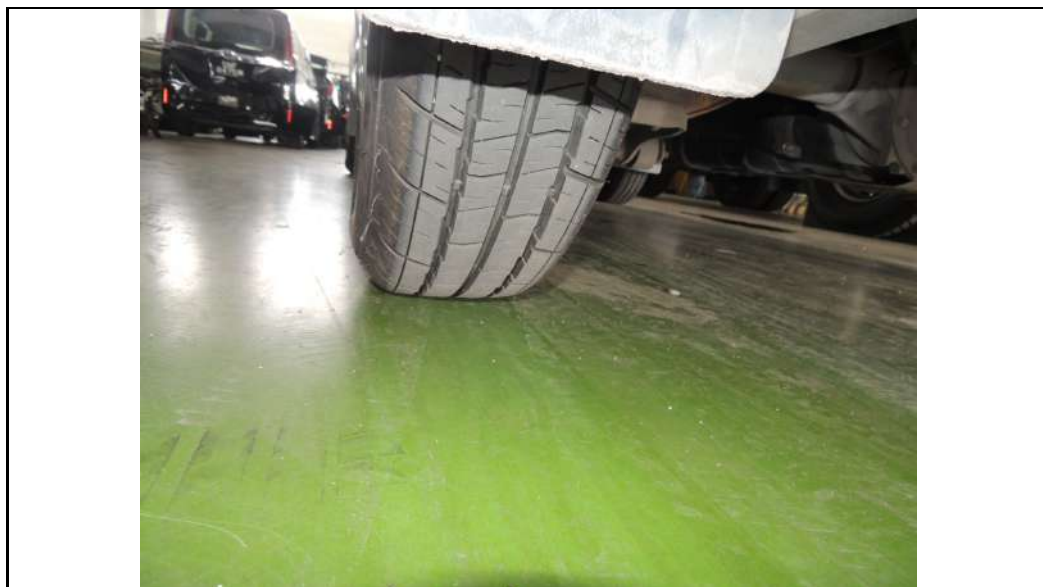
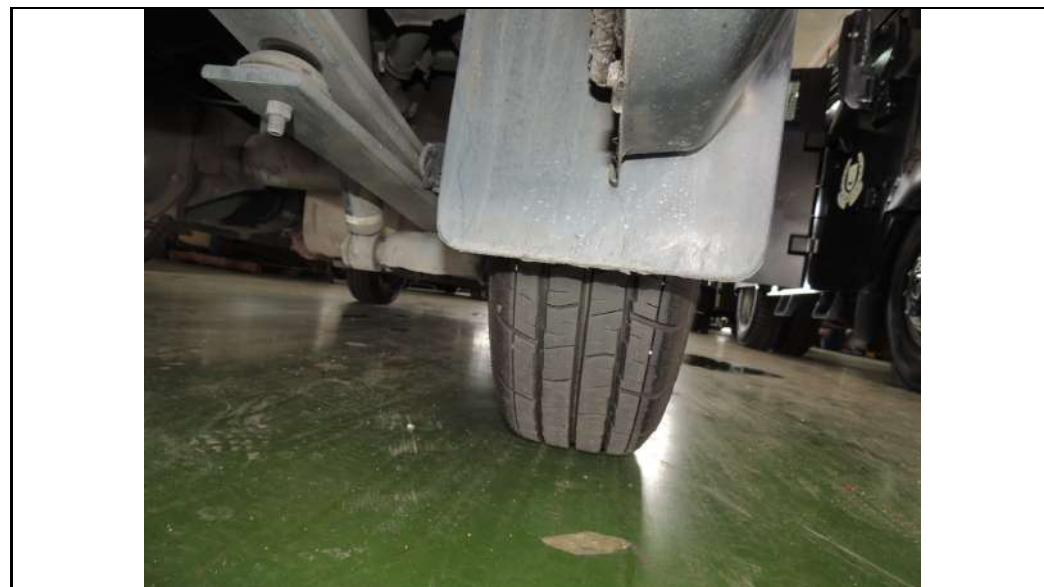
**PHOTOGRAPHS FOR VEHICLE NO. : GBJ 4342K**

THE VEHICLE SUSTAINED DAMAGES AT THE FRONT PORTION.
