## LKK Auto Consultants Pte Ltd

### PROFESSIONAL SERVICE FEE

Vehicle No. GBM 444K  
Insured Veh. XE 5224C  
Claim No. 24/24/24/VC05/029925  
Policy No. Z24VC05026670  
Accident Date 26/09/2024  
Inspection Date 27/09/2024

## ADJUSTMENT ON REPAIR COST FOR VEHICLE NO. GBM 444K

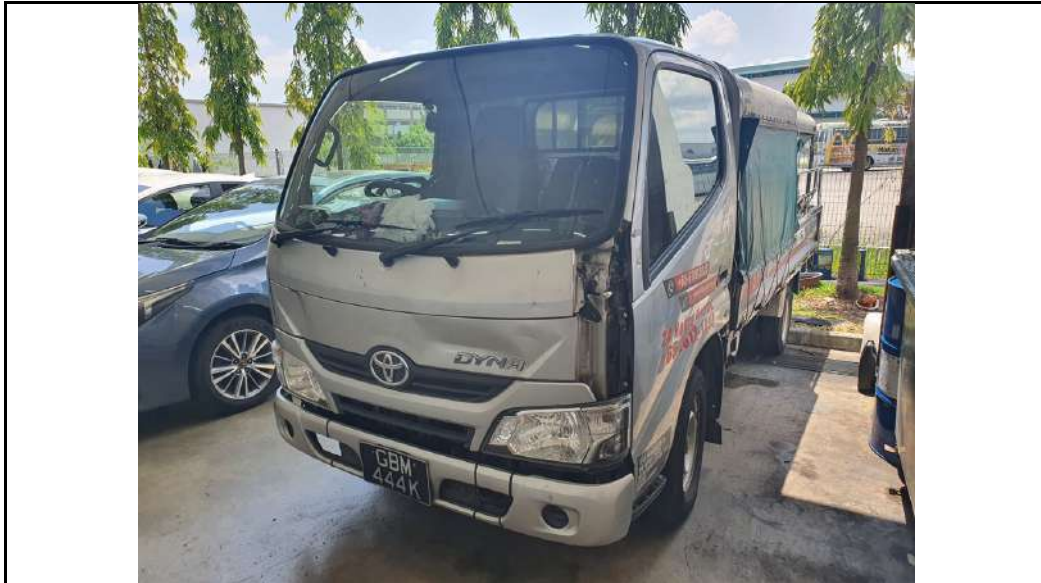
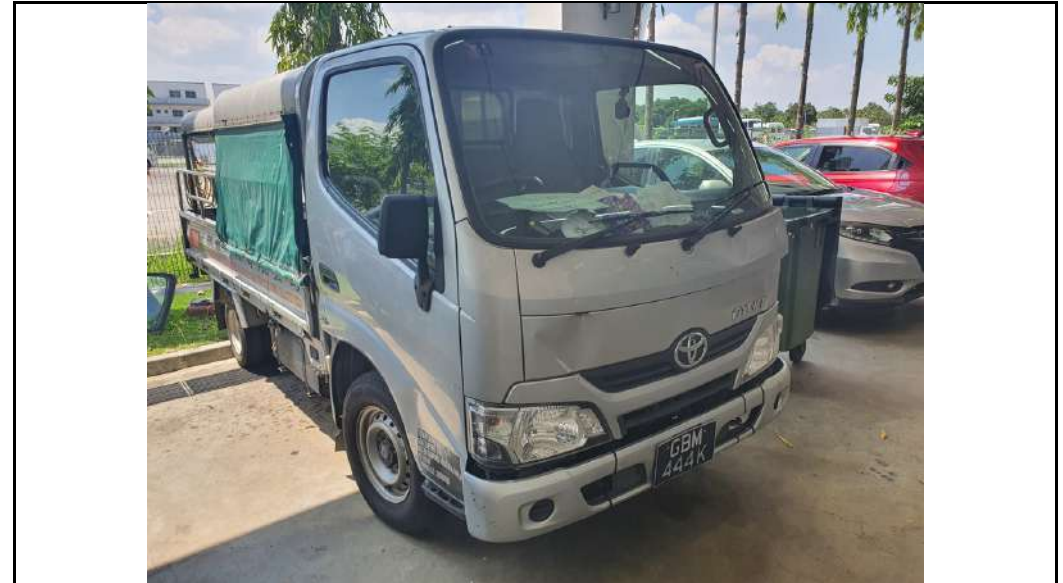
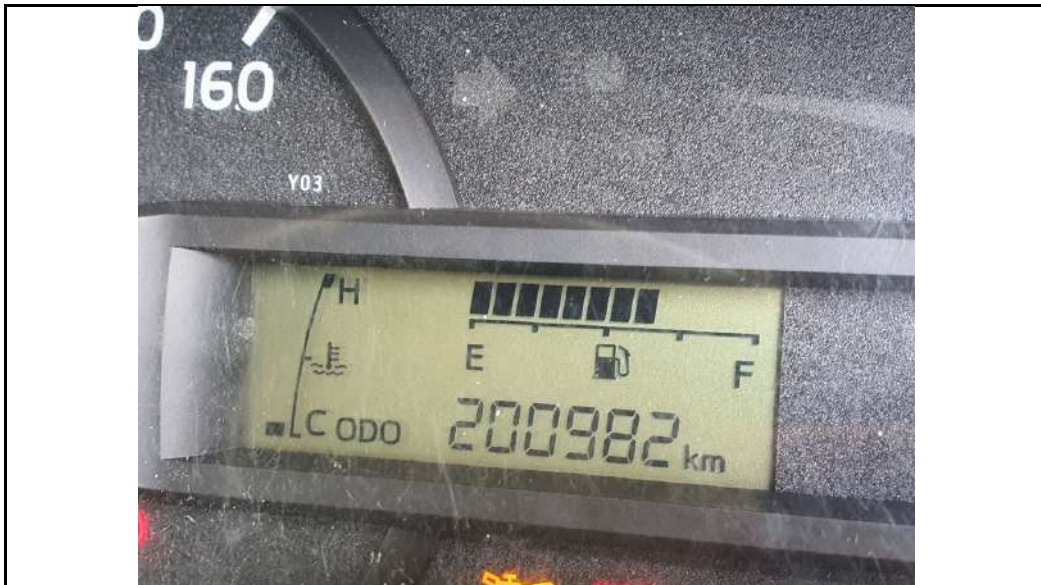
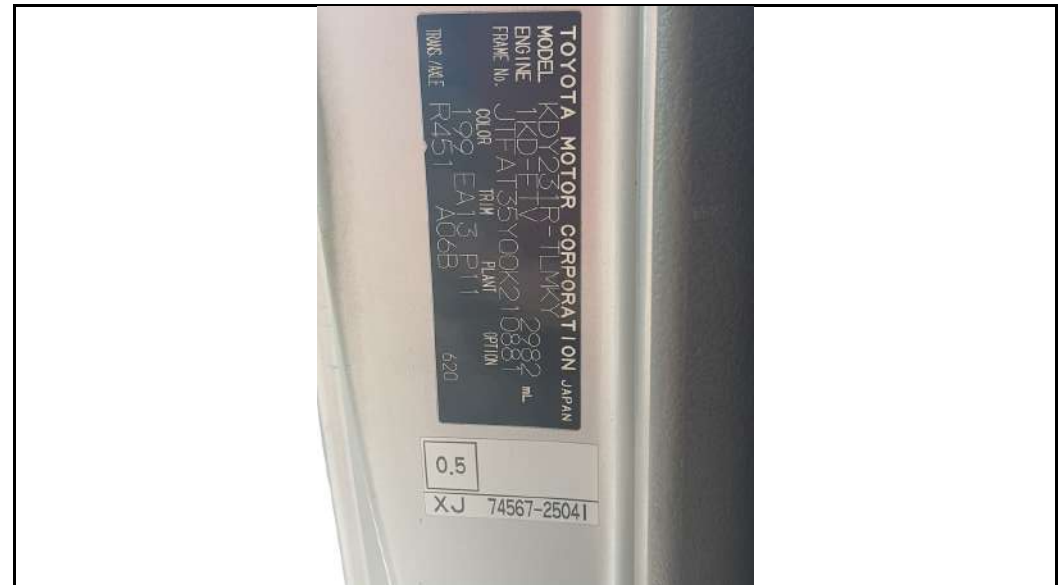
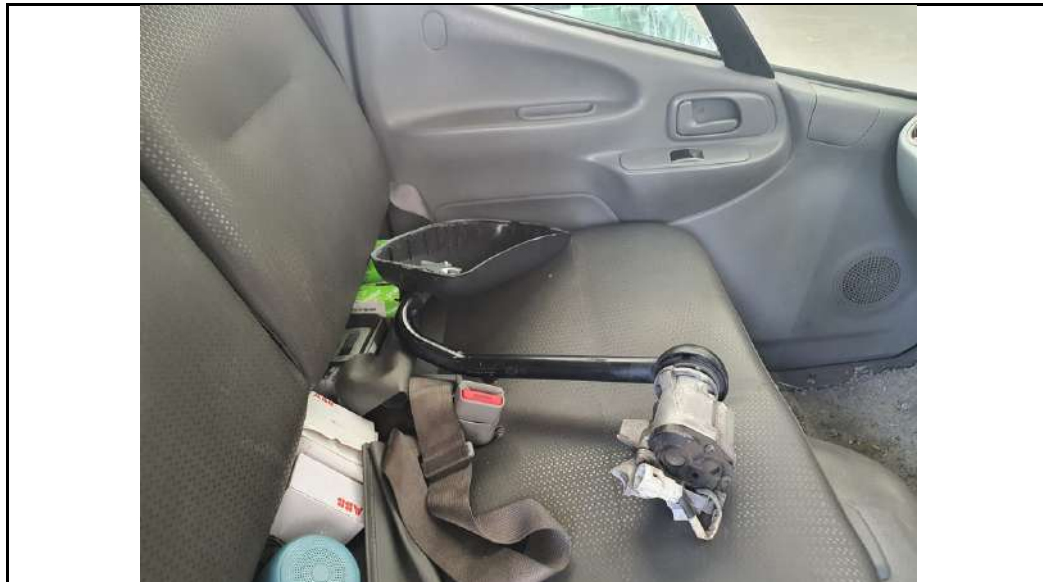
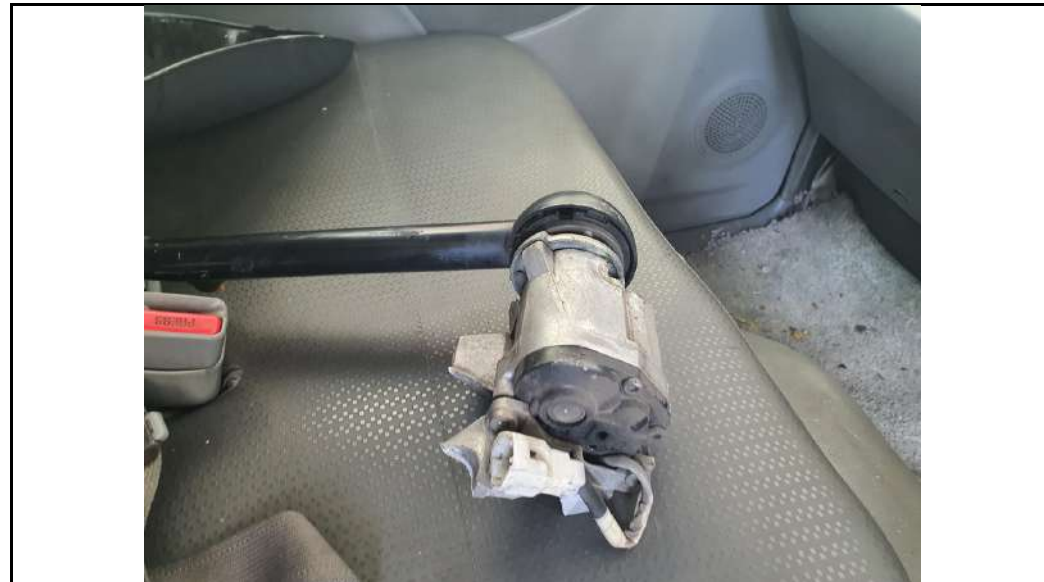
**PHOTOGRAPHS FOR VEHICLE NO. : GBM 444K**

| Affiliated to Federation Internationale Des Experts En Automobile | | | | |
|---|---|---|---|---|
| | THE VEHICLE SUSTAINED DAMAGES AT THE FRONT N/S AND FRONT O/S PORTION.<br>DAMAGES SEE DETAILS. | | | |
