VEHICLE INSPECTION REPORT

Registration No : SFD 555 Z
Make / Model : BMW 116D
Chassis No : WBA1V720305G86422
Engine No : 37539812B37D15A

GENERAL DESCRIPTION OF DAMAGE VEHICLE

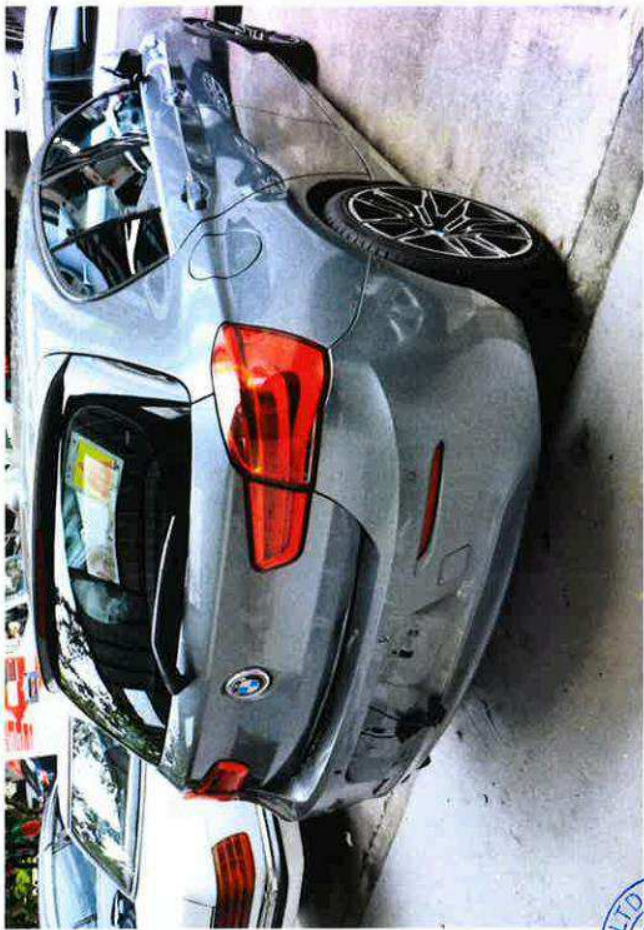
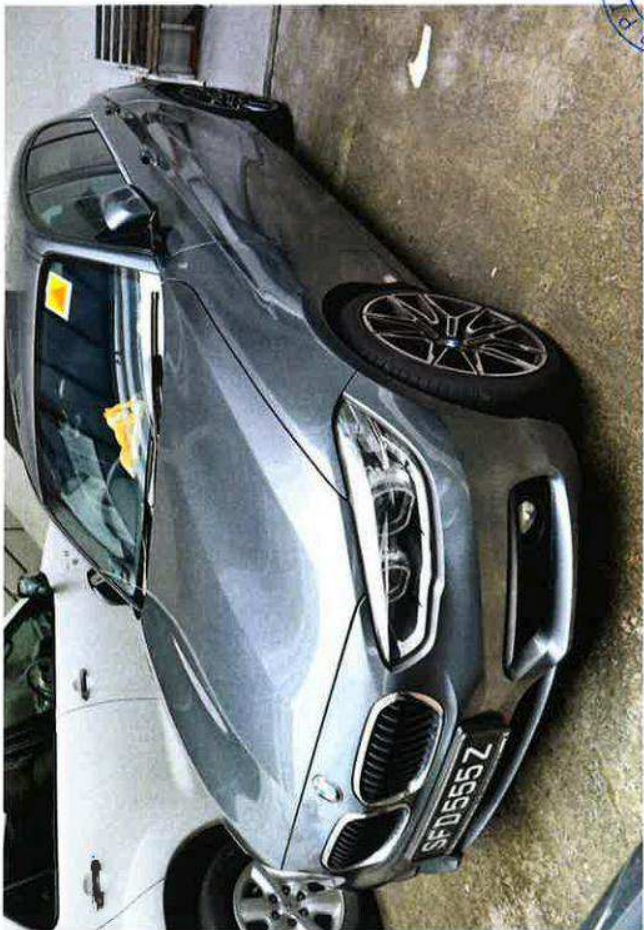
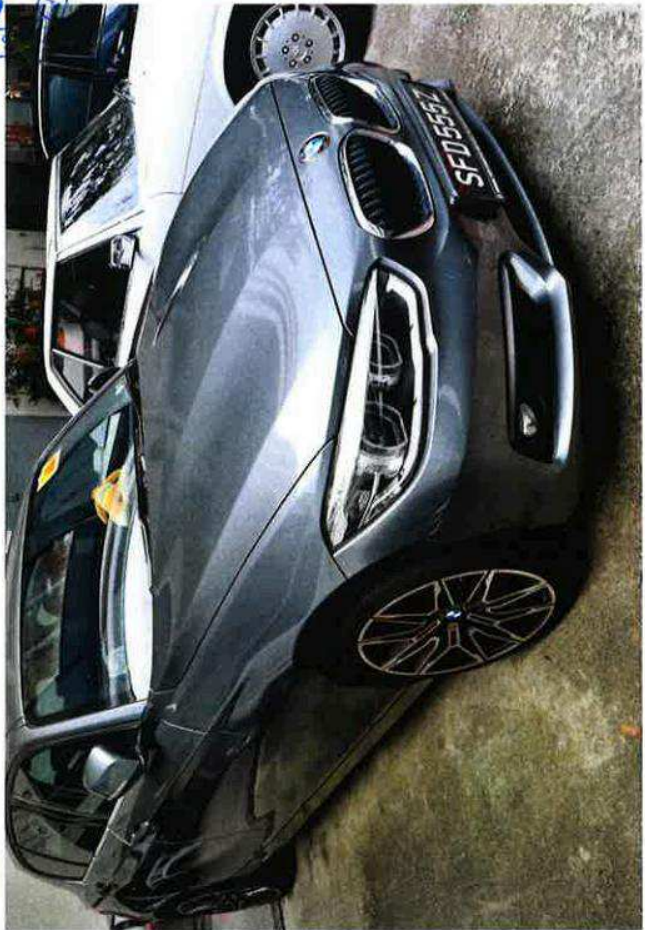
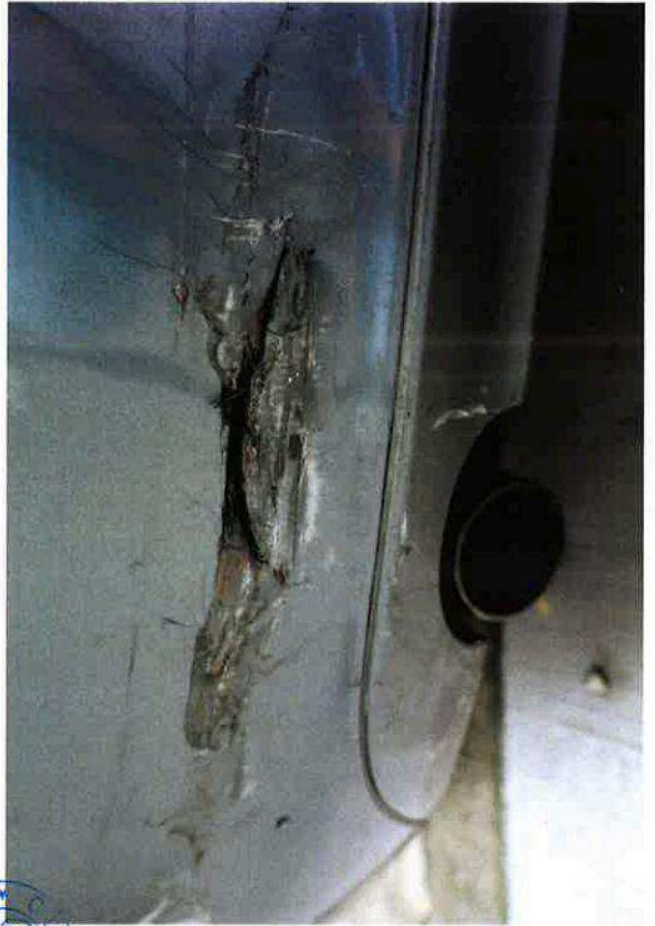
The impact damages sustained on the vehicle at the time of inspection is on the rear portion.
(Details refer to the photographs attached)
