LKK Auto Consultants Pte Ltd

TAX INVOICE

PROFESSIONAL SERVICE FEE

Vehicle No. SGW 60Y
Insured Veh. GBK 5742C
Claim No. 24/24/24/VC05/030071
Policy No. Z24VC05000126
Accident Date 21/10/2024
Inspection Date 04/11/2024

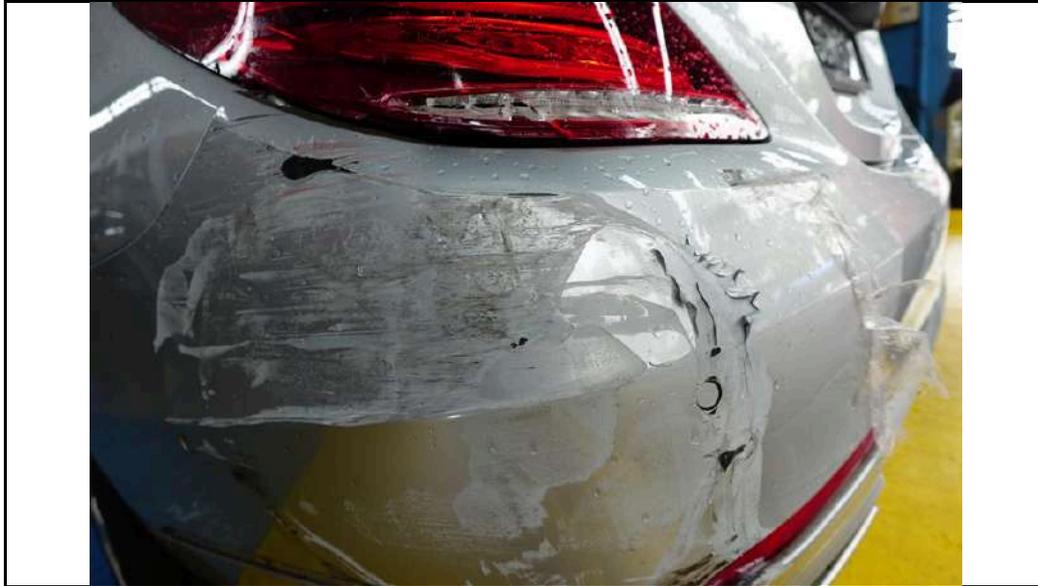
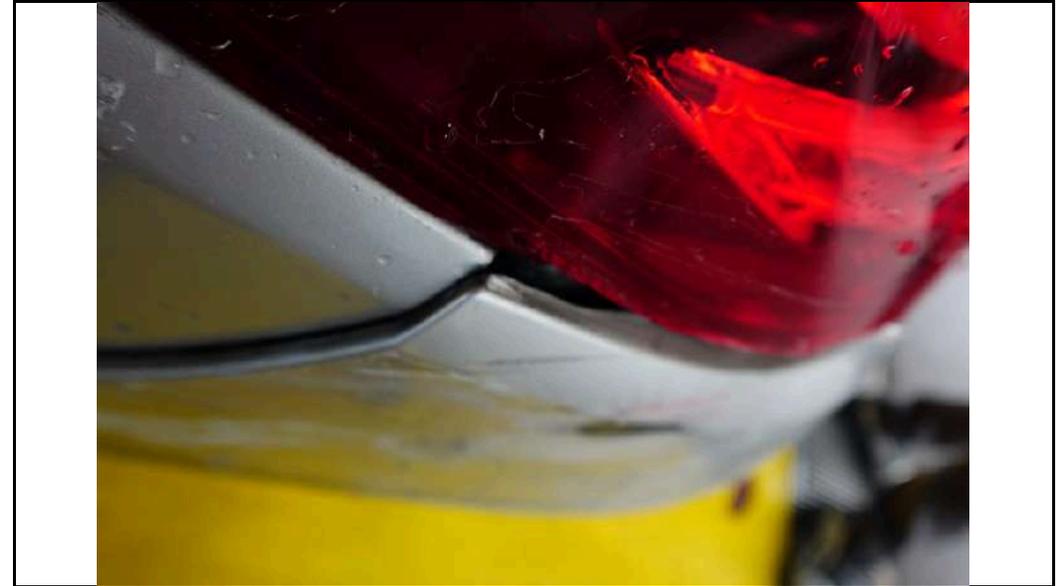
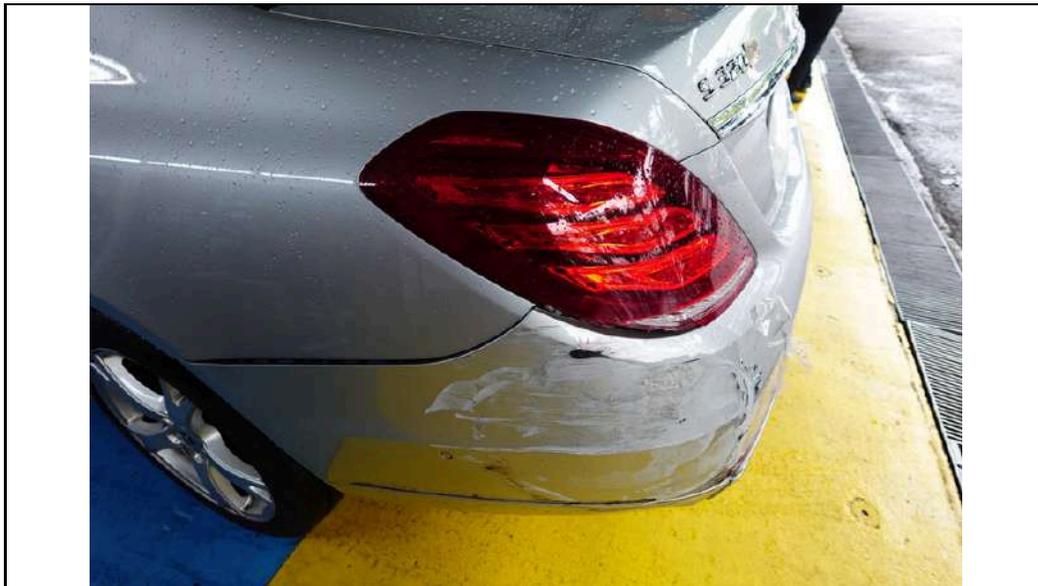
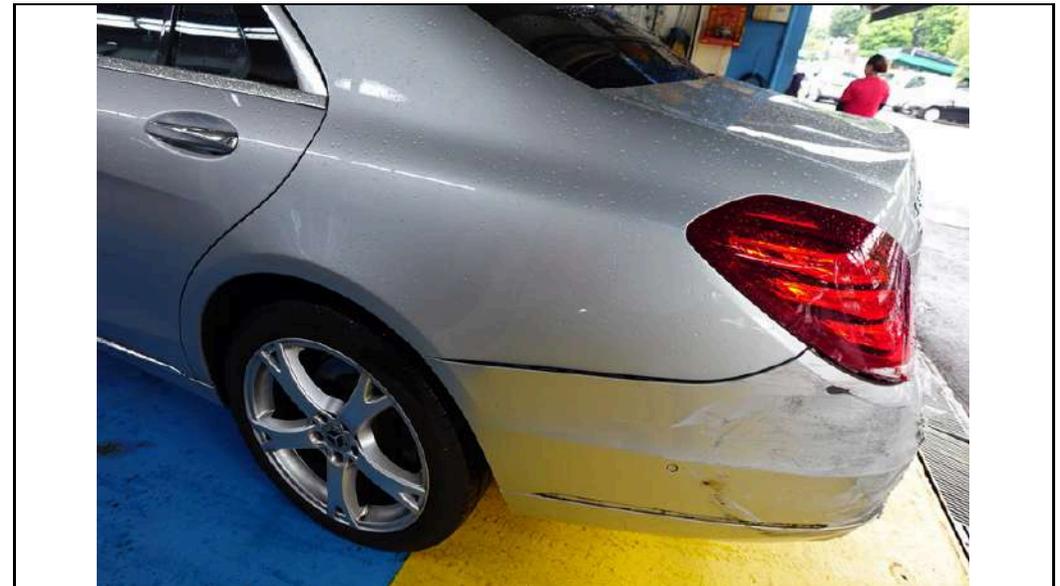
PHOTOGRAPHS FOR VEHICLE NO. : SGW 60Y

THE VEHICLE SUSTAINED DAMAGES AT THE N/S REAR PORTION.
DAMAGES SEE DETAILS.
