## LKK Auto Consultants Pte Ltd

## ADJUSTMENT ON REPAIR COST FOR VEHICLE NO. SLE 2974H

**PHOTOGRAPHS FOR VEHICLE NO. : SLE 2974H**

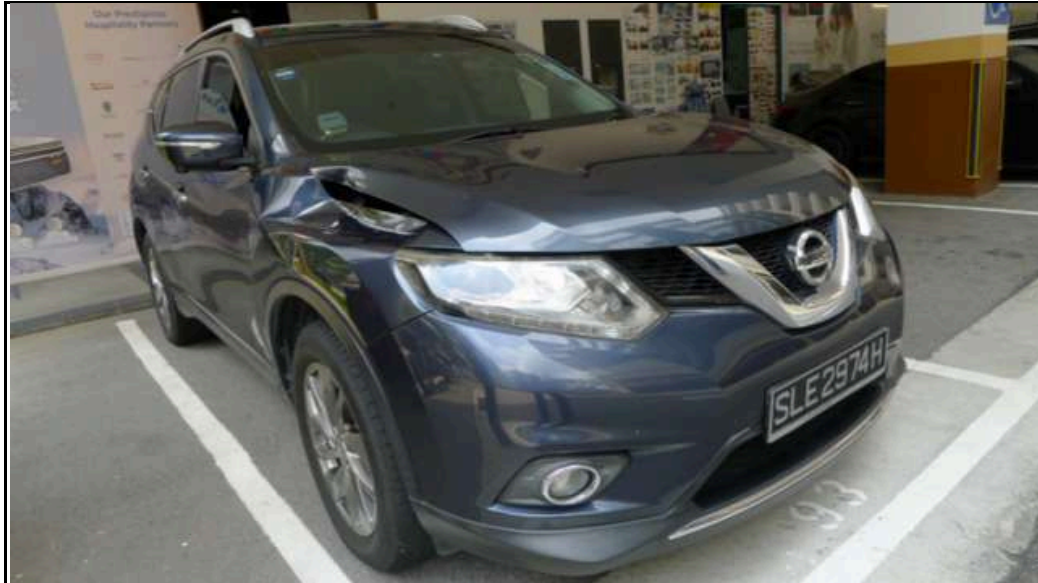
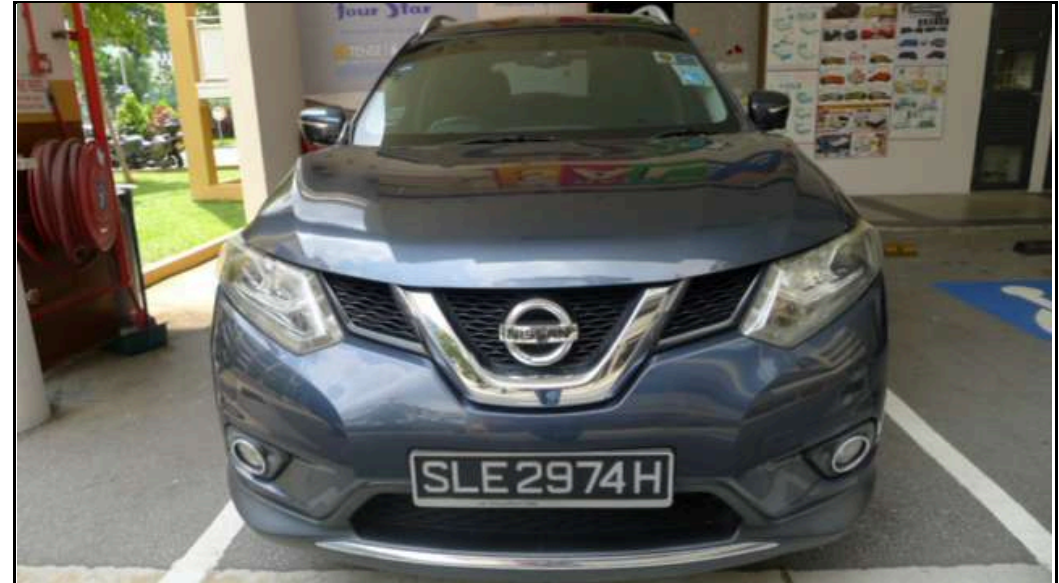
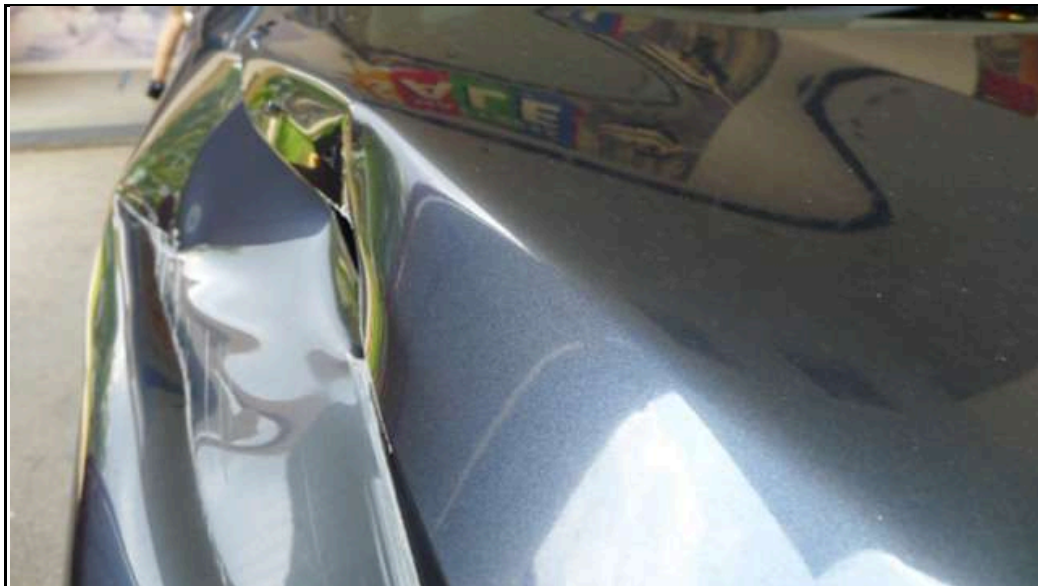
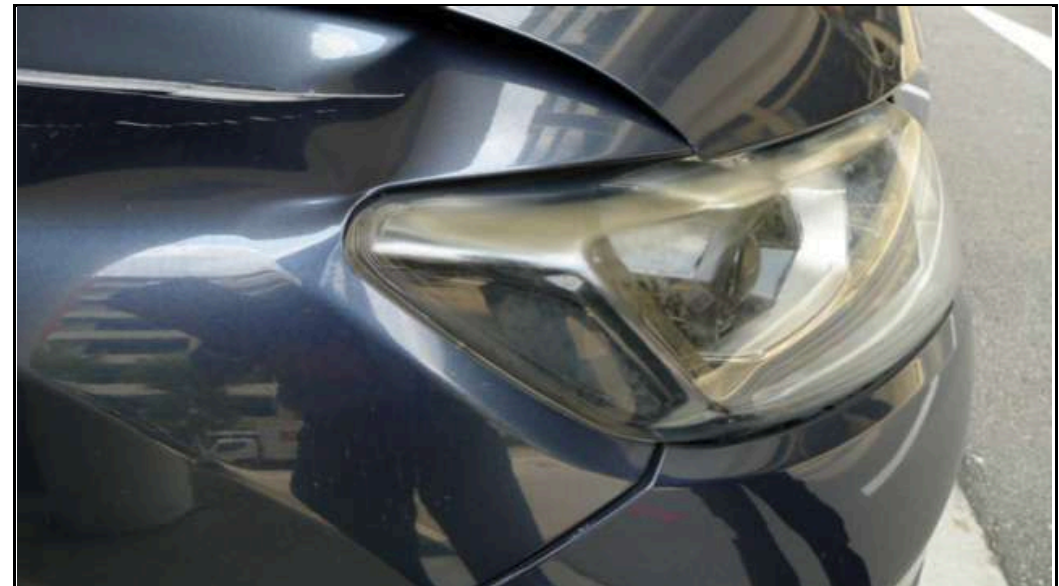
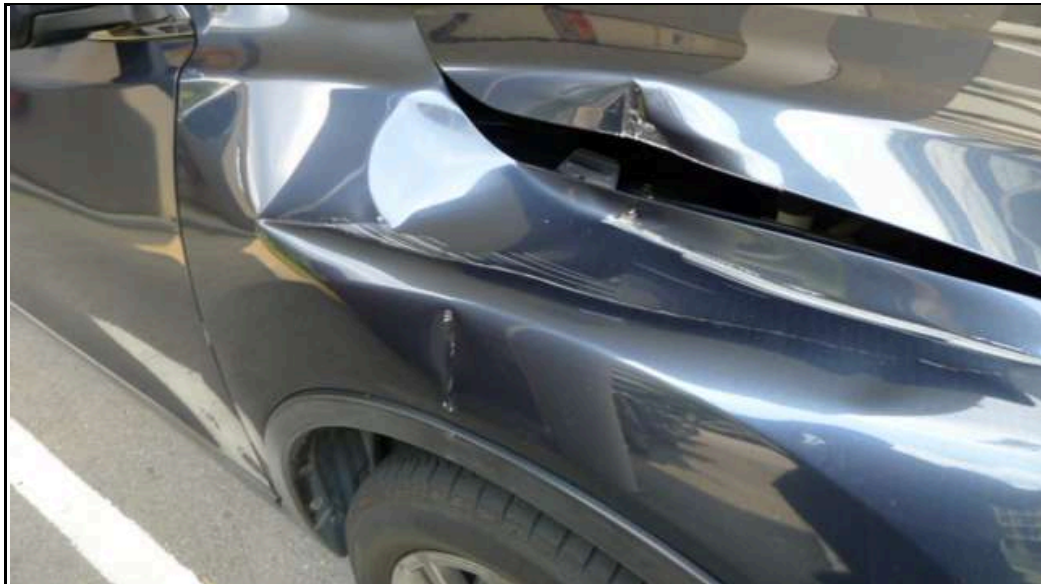
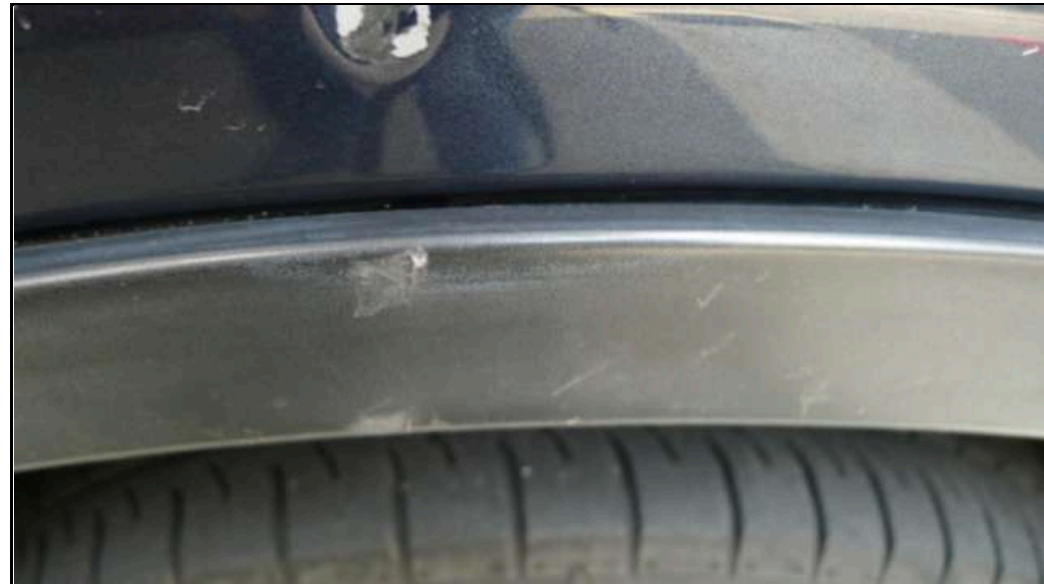
| Affiliated to Federation Internationale Des Experts En Automobile | | | | |
|---|---|---|---|---|
| | THE VEHICLE SUSTAINED DAMAGES AT THE O/S FRONT PORTION.<br>DAMAGES SEE DETAILS. | | | |

| Qty | Description of Parts | Condition | Estimate By Workshop (\$) | Our Adjusted (\$) |
|---|---|---|---|---|
| 1 | FRONT HEADLAMP RH | MOUNTING CRACKED | 3,121.43 | 2,689.50 |
| | TO STRAIGHTEN AND PANEL BEATING FRONT FRAME MEMBERS, FRONT PILLAR. TO REMOVE AND REFIT ABOVE PARTS.INCLUSIVE OF THE REPAIR OF FENDER BRACKET,FRONT HEADLAMP BRACKET RH,WHEELHOUSE RH AND WHEELHOUSE UPPER PANEL RH. | | 600.00 | 450.00 |
