LKK Auto Consultants Pte Ltd

Ref: CD/LPC24110105/Aua3q2(N)

1. Policy Particulars :- THIRD PARTY CLAIM

ADJUSTMENT ON REPAIR COST FOR VEHICLE NO. SLB 3676C

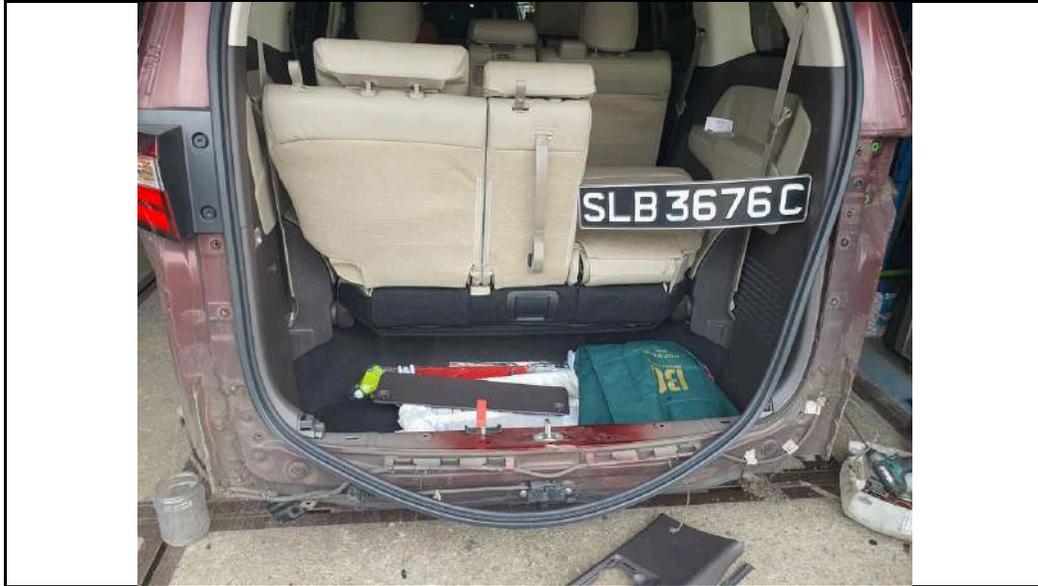
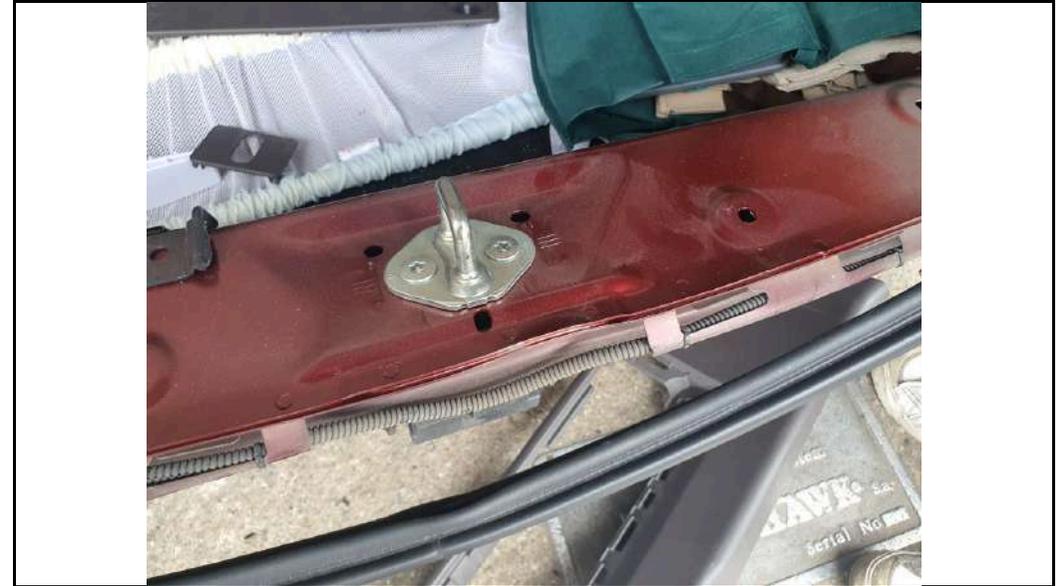
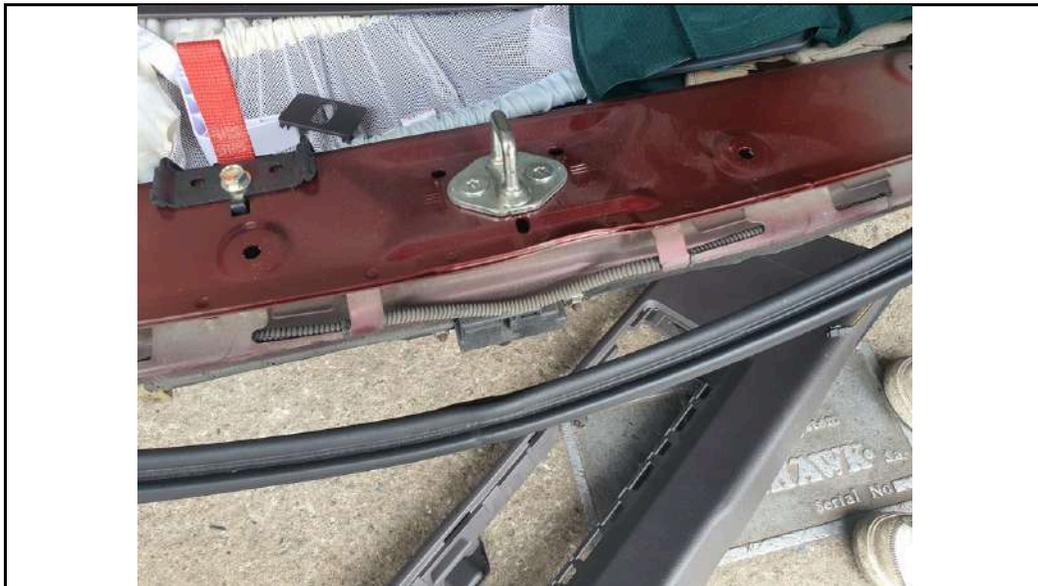
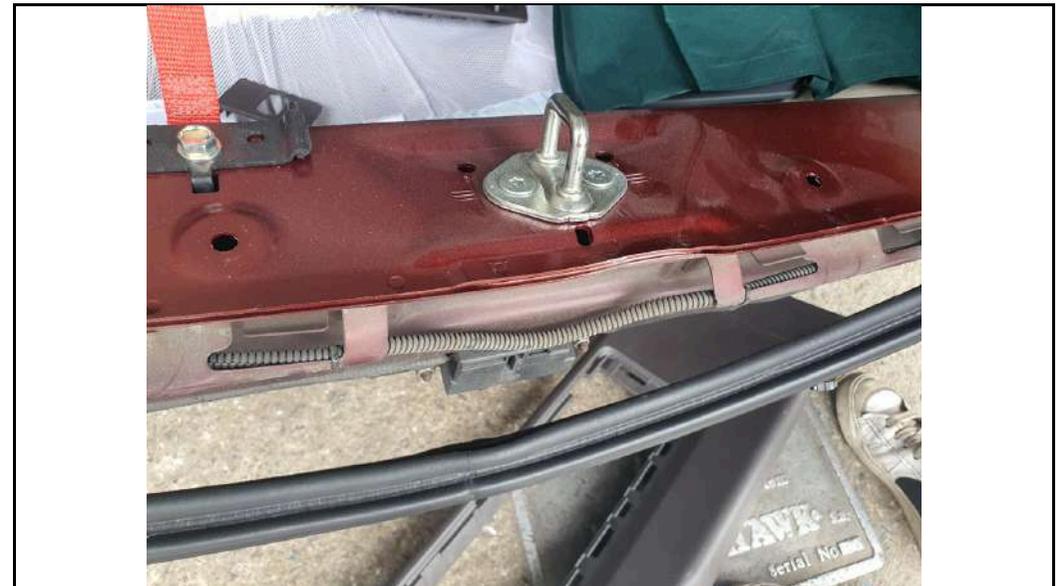
PHOTOGRAPHS FOR VEHICLE NO. : SLB 3676C

THE VEHICLE SUSTAINED DAMAGES AT THE REAR PORTION.
DAMAGES SEE DETAILS.
