LKK Auto Consultants Pte Ltd

Affiliated to Federation Internationale Des Experts En Automobile				
LONPAC INSURANCE BHD 300 BEACH ROAD #17-04/07 THE CONCOURSESINGAPORE 199555			Ref: CD/LPC24110569/Kma3q2(N)	
			Date: 06/01/2025	
			Code: LPC2

ADJUSTMENT ON REPAIR COST FOR VEHICLE NO. SDV 8811K

PHOTOGRAPHS FOR VEHICLE NO. : SDV 8811K

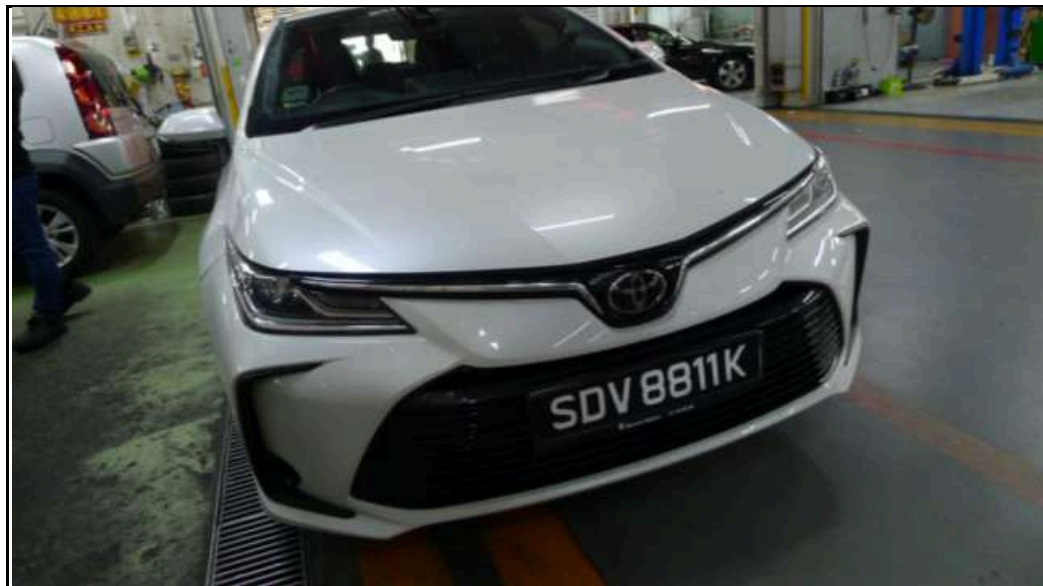
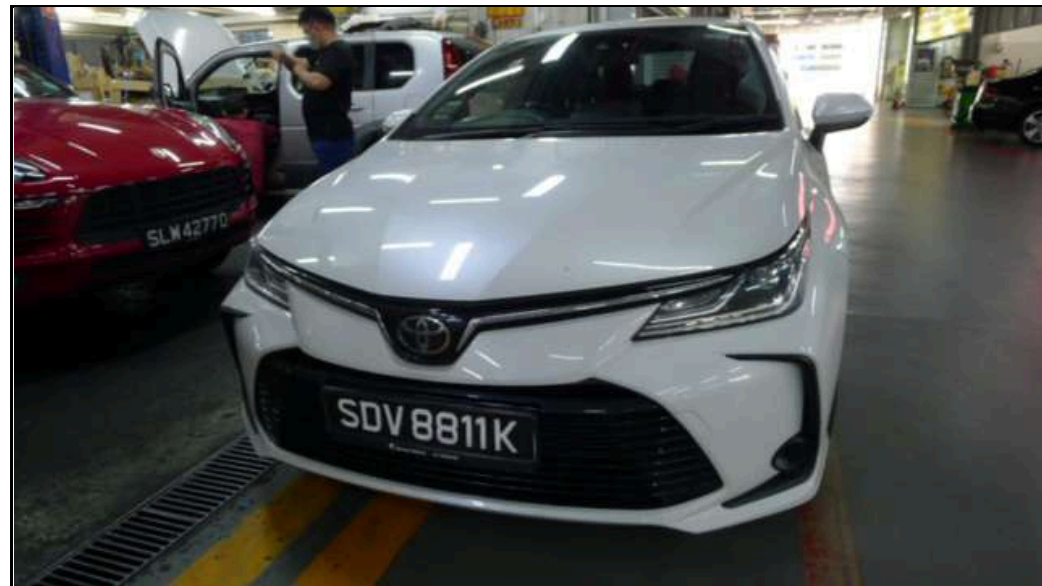
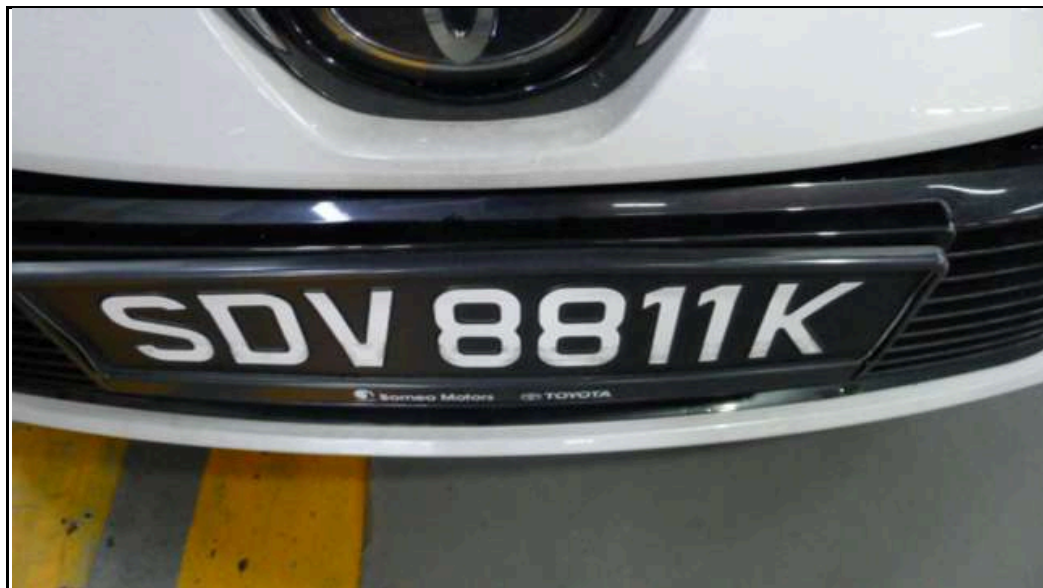
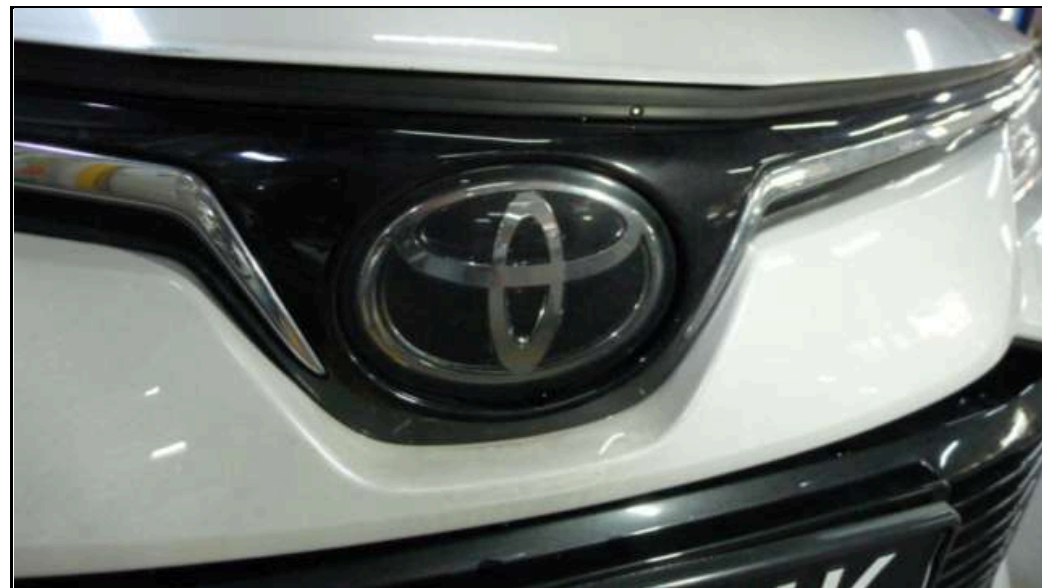
4. Description of Damages				
	THE VEHICLE SUSTAINED DAMAGES AT THE FRONT PORTION. DAMAGES SEE DETAILS.			
5. General Information				
	Accident Date	20/11/2024	Inspection Date	28/11/2024
	Survey held at	AH LIM MOTOR COMPANY NO 10 ANG MO KIO IND PK 2A #01-09 AMK AUTOPOINT SINGAPORE 568047		
5a. Remarks				
	A)THE INSPECTION WAS CONDUCTED ON A"WITHOUT PREJUDICE" BASIS. B)IN ACCORDANCE TO YOUR INSTRUCTIONS, WE HAVE NOT AUTHORISED REPAIRS.			
5b. Estimate Days of Repair				
	ESTIMATED NORMAL PERIOD FOR REPAIR:		2 Working Days
