2. Vehicle Particulars & Condition			
Make & Model	LEXUS UX200 (A)	c.c	1987
Engine No.	HIDDEN	Year of Reg.	2020
Chassis No.	JTHY35BH702021411	Colour	METALLIC GREY
Odometer	68167 KM	Steering	IN ORDER
Brakes	IN ORDER	Modification	STANDARD ALLOY RIM
General	GOOD

ADJUSTMENT ON REPAIR COST FOR VEHICLE NO. SMT 2810G

PHOTOGRAPHS FOR VEHICLE NO. SMT 2810G

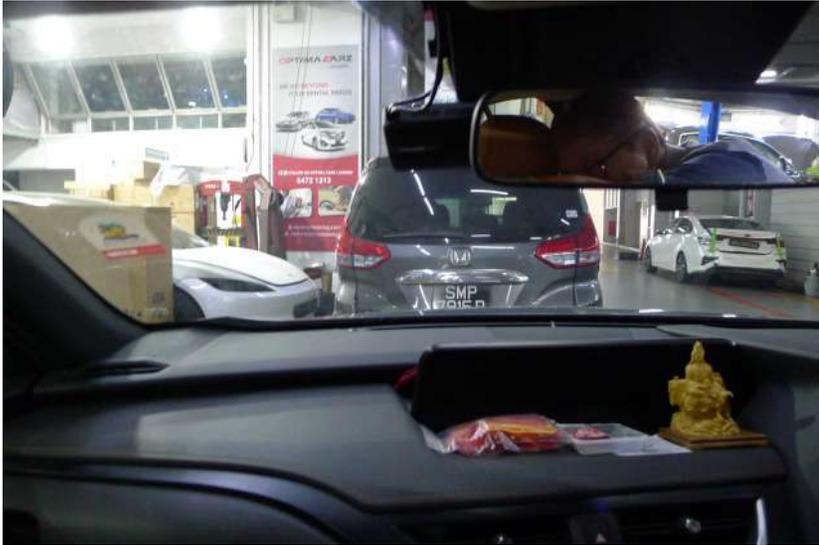
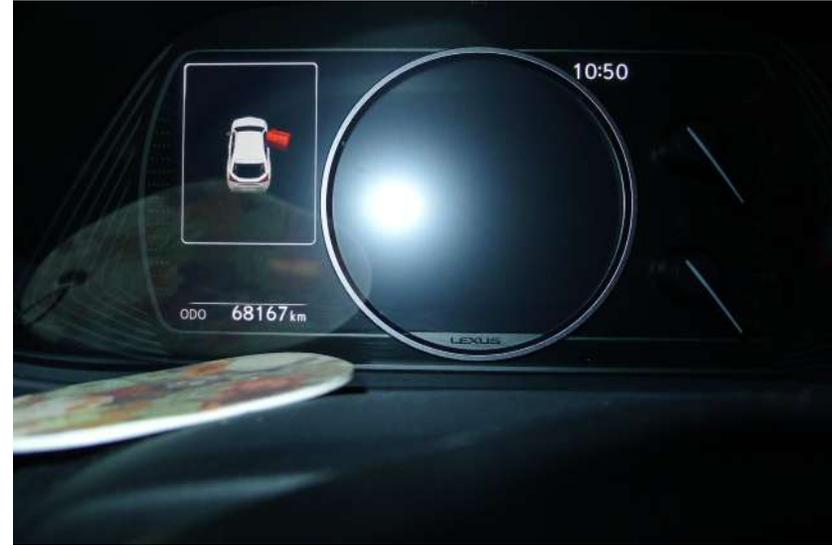
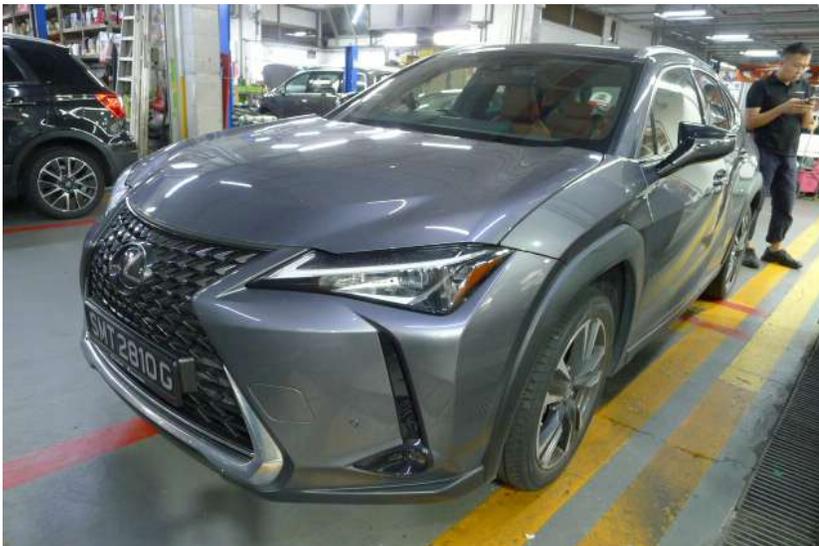
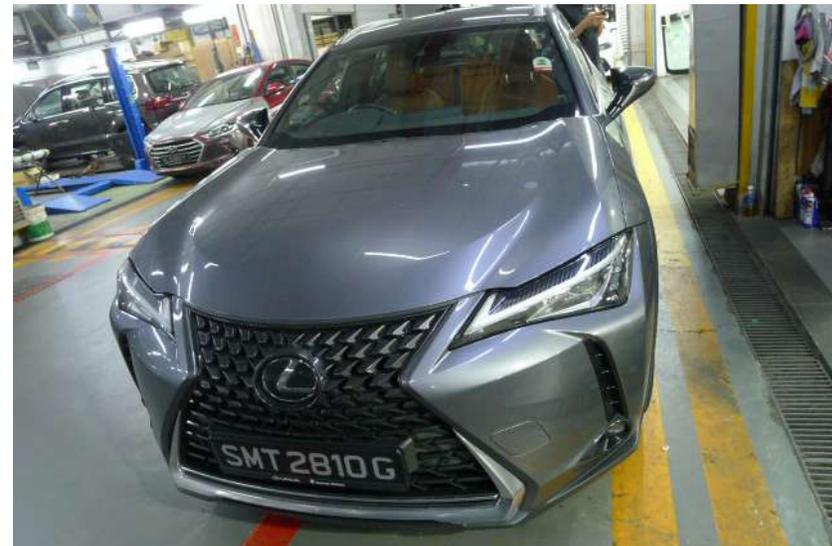
INSPECTION

4. Description of Damages			
THE VEHICLE SUSTAINED DAMAGES AT THE N/S FRONT BODY. DAMAGES SEE DETAILS.			
5. General Information			
Accident Date	29/11/2024	Inspection Date	27/12/2024
Survey held at	OPTIMA WERKZ PTE LTD 6, KUNG CHONG ROAD SINGAPORE 159143		
5a. Remarks			
A)THE INSPECTION WAS CONDUCTED ON A"WITHOUT PREJUDICE" BASIS. B)IN ACCORDANCE TO YOUR INSTRUCTIONS, WE HAVE NOT AUTHORISED REPAIRS.			
5b. Estimate Days of Repair			
ESTIMATED NORMAL PERIOD FOR REPAIR:		4 Working Days
