## LKK Auto Consultants Pte Ltd

### PROFESSIONAL SERVICE FEE

Vehicle No. SHC 3808G  
Insured Veh. PC 7496B  
Claim No. SNM24D204047C02  
Policy No. DMB1SNW00013862305  
Accident Date 14/07/2024  
Inspection Date 16/07/2024

## ADJUSTMENT ON REPAIR COST FOR VEHICLE NO SHC 3808G

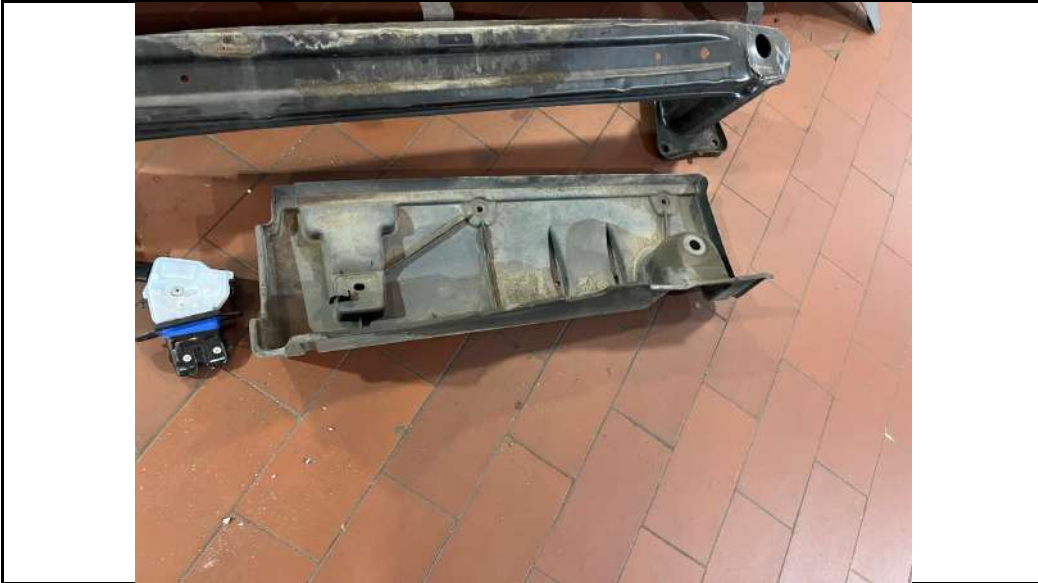
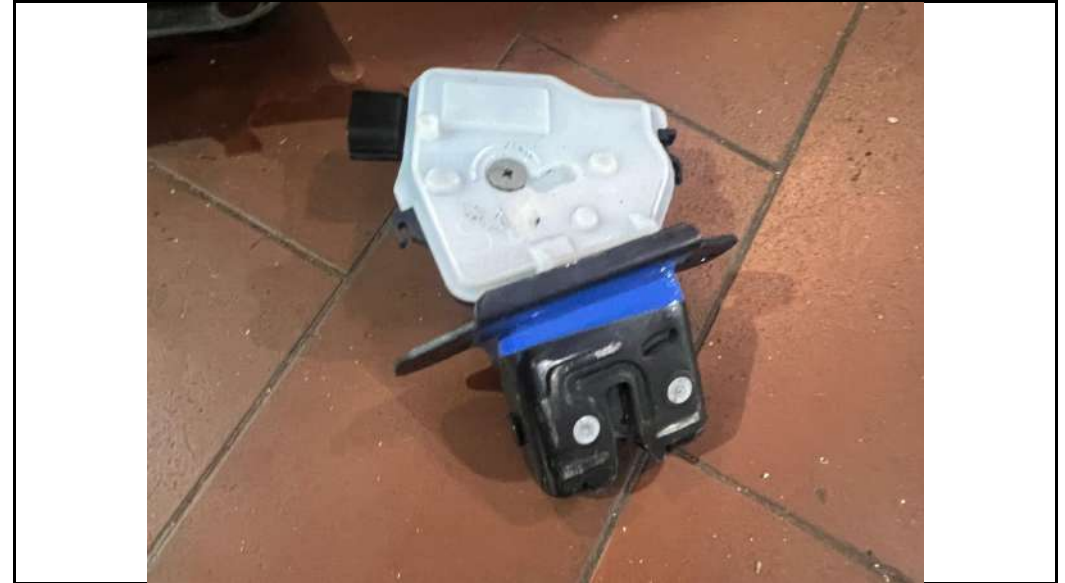
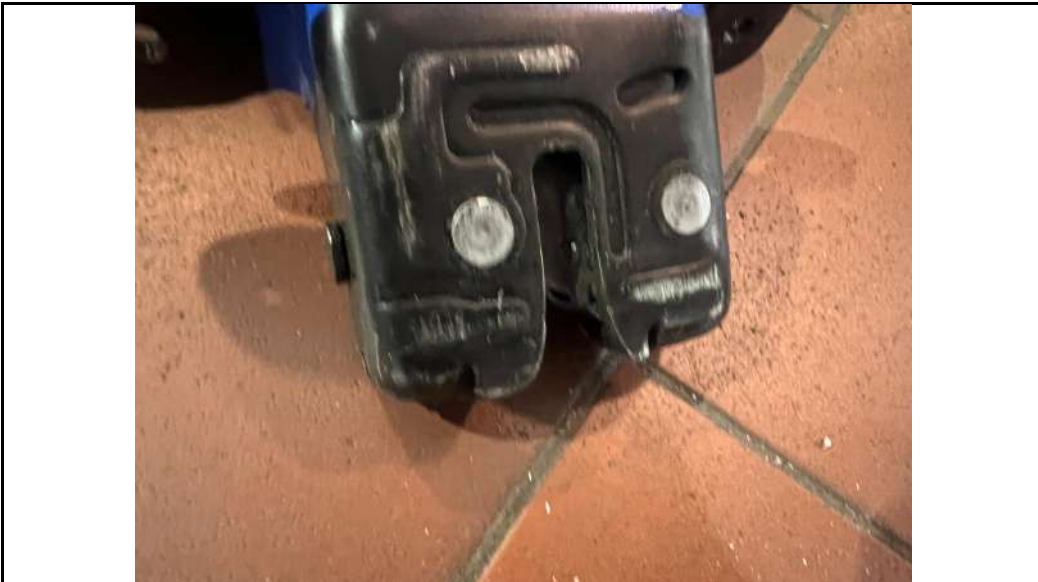
**PHOTOGRAPHS FOR VEHICLE NO. : SHC 3808G**

THE VEHICLE SUSTAINED DAMAGES AT THE REAR PORTION.

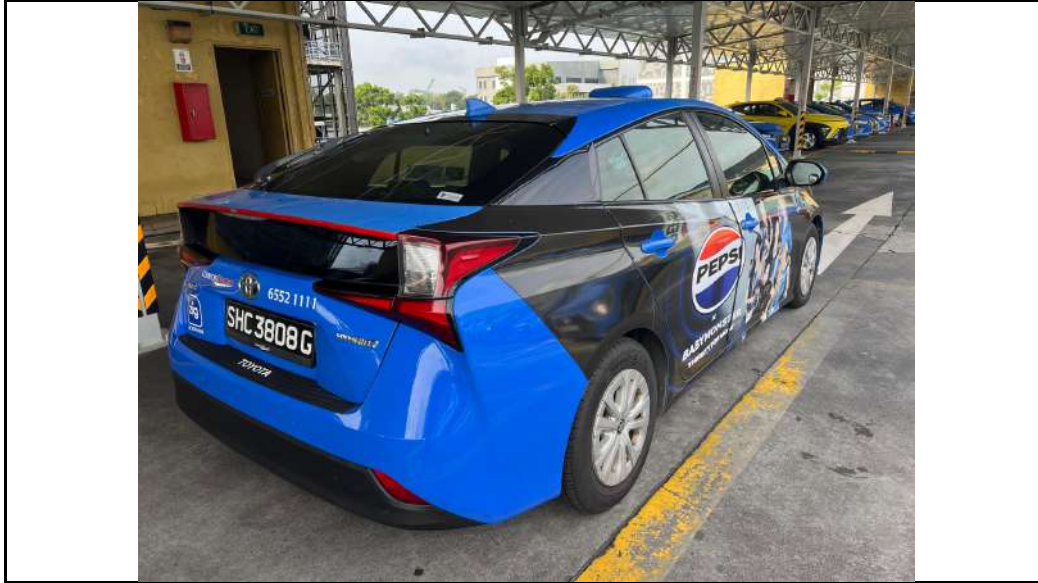
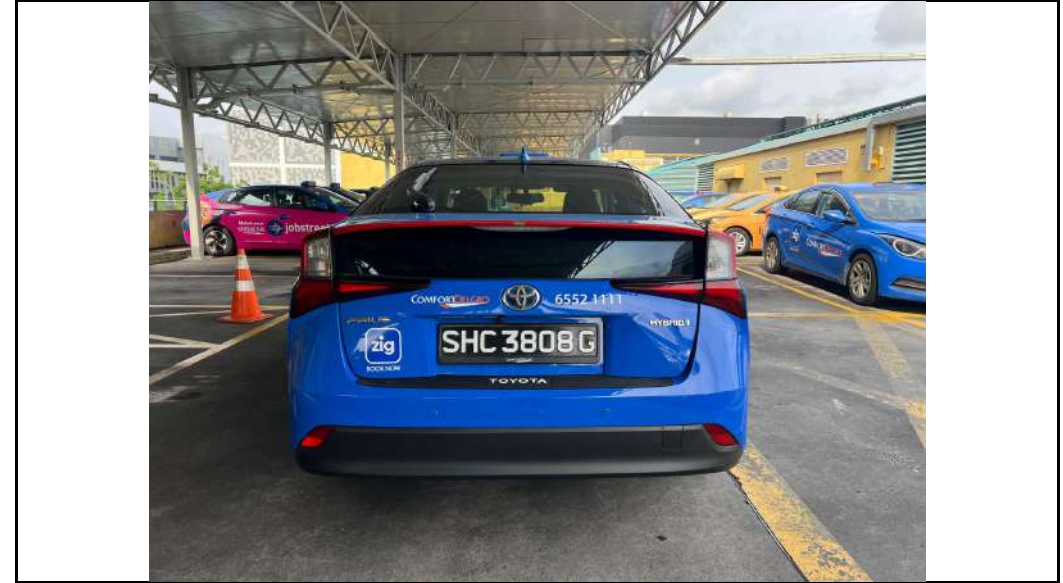
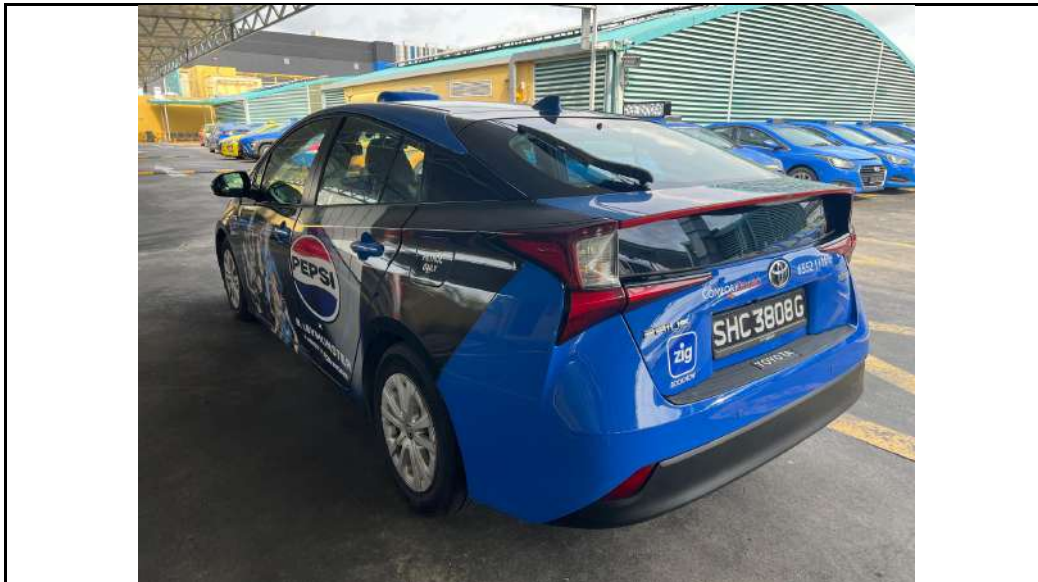
### PHOTOGRAPHS FOR VEHICLE NO. : SHC 3808G

REINSPECTION PHOTOS (Page 1 of 1)
