Vehicle No. SMX 5566X  
Insured Veh. XE 7447M  
Claim No. SNM24D203745  
Policy No. DMCVSNA00097142302  
Accident Date 23/06/2024  
Inspection Date 15/07/2024

# LKK Auto Consultants Pte Ltd

## ADJUSTMENT ON REPAIR COST FOR VEHICLE NO SMX 5566X

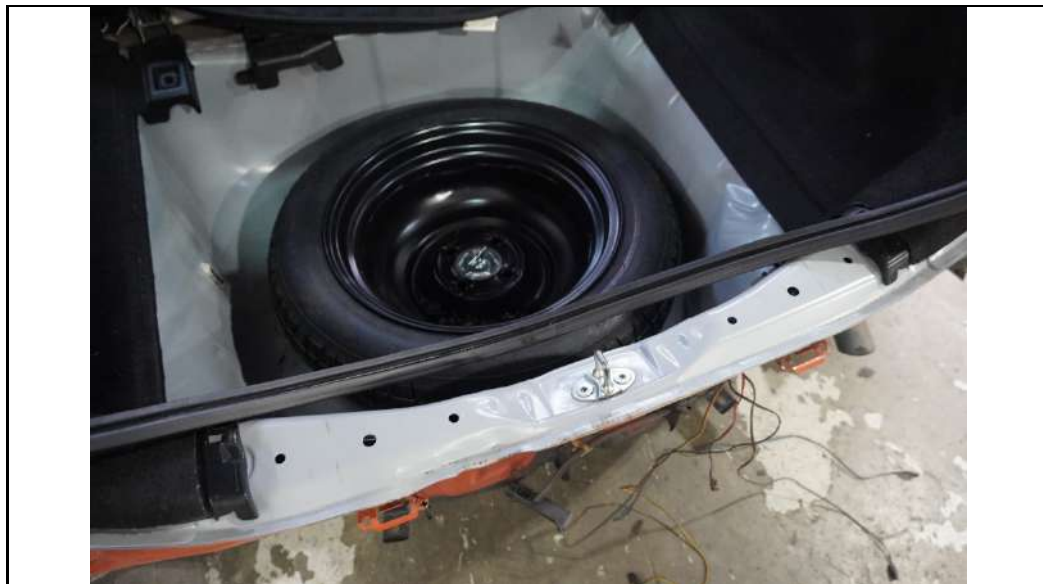
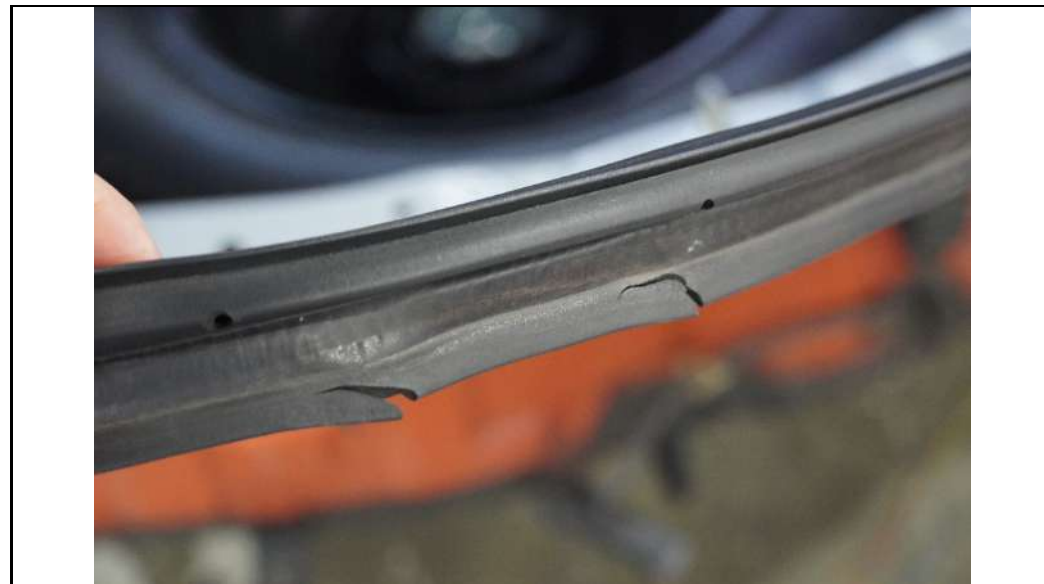
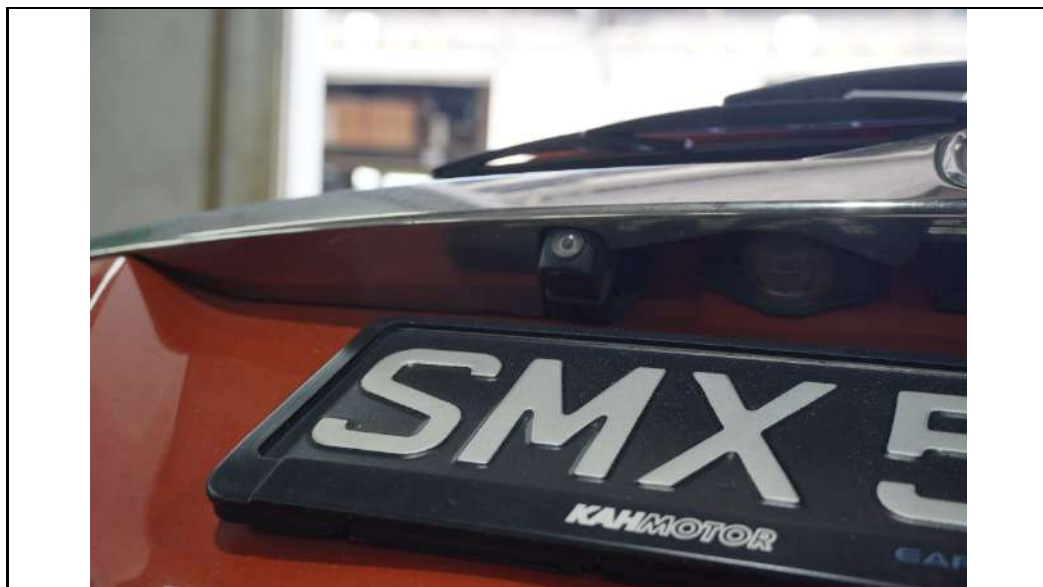
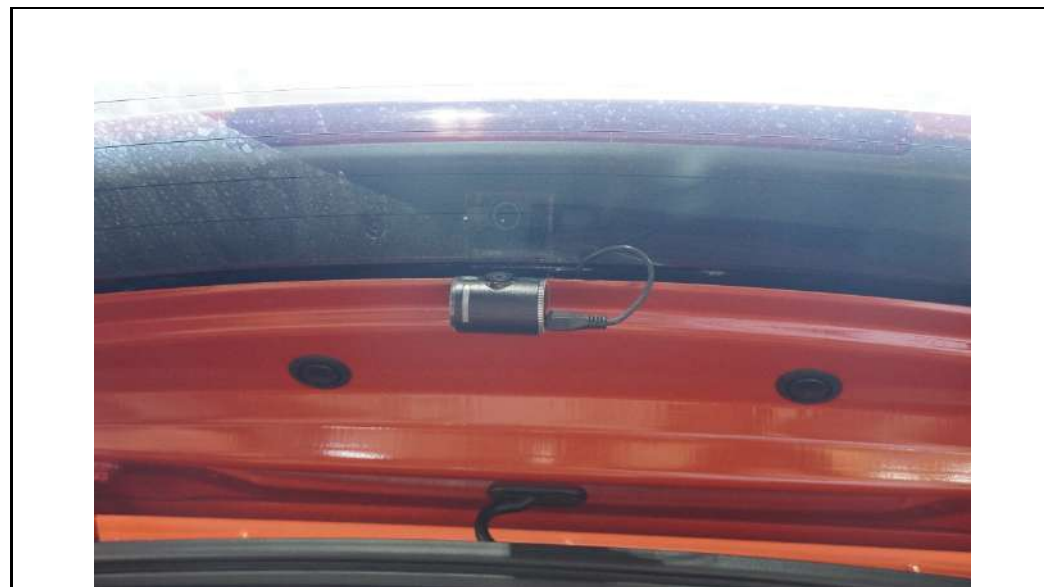
**PHOTOGRAPHS FOR VEHICLE NO. : SMX 5566X**

THE VEHICLE SUSTAINED DAMAGES AT THE REAR PORTION.
