**LKK Auto Consultants Pte Ltd**

**PROFESSIONAL SERVICE FEE**

Vehicle No. SNK 5491J  
Insured Veh. SHC 3479Y  
Claim No. D24006542MFCT/CTPL/TPD 2  
Policy No. D-24101861MFCT  
Accident Date 26/07/2024  
Inspection Date 02/08/2024

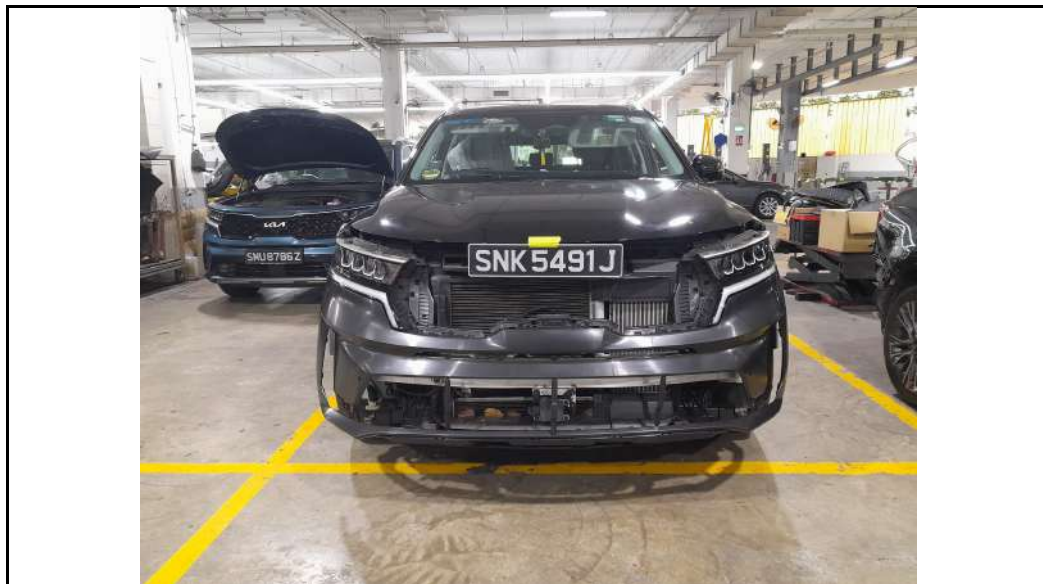
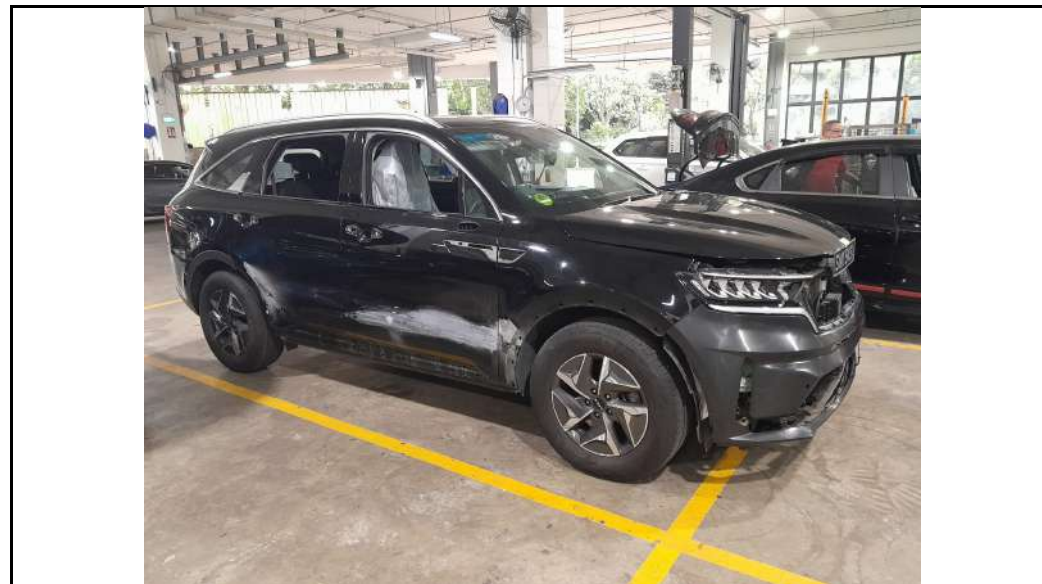
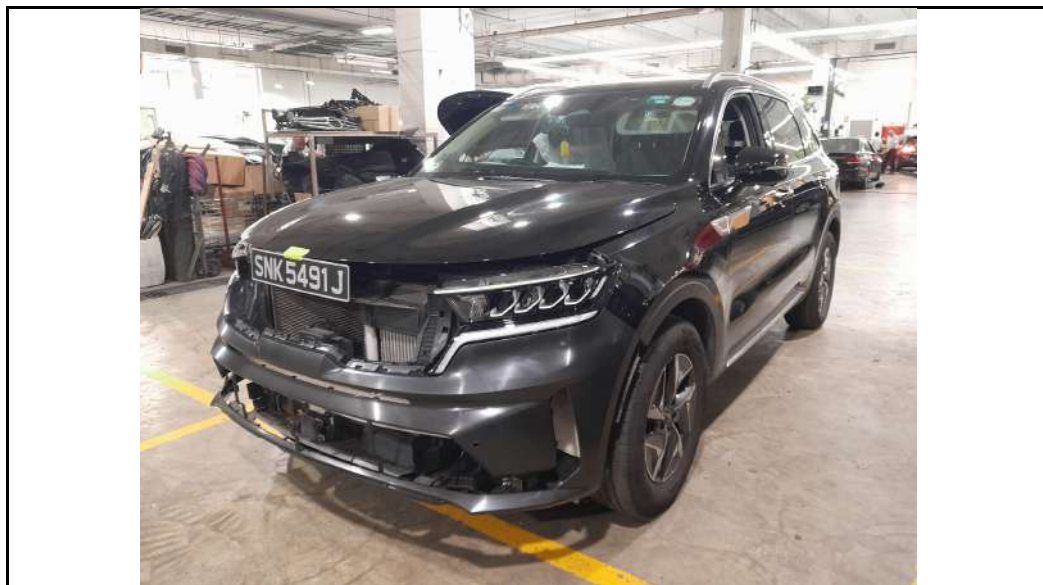
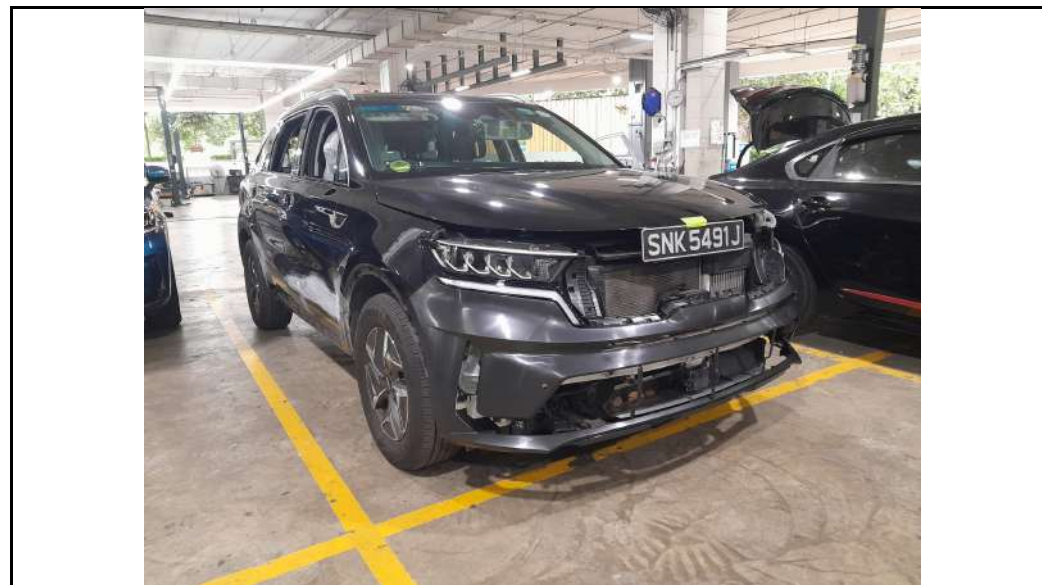
### PHOTOGRAPHS FOR VEHICLE NO. : SNK 5491J

| Affiliated to Federation Internationale Des Experts En Automobile | | | | |
|---|---|---|---|--|
| THE VEHICLE SUSTAINED DAMAGES AT THE O/S BODY. | | | | |

REINSPECTION PHOTOS (Page 1 of 1)

| Labour | | | | |
|---|---|---|---|---|
| | RENEW FRT BUMPER ,FRT RH FENDER ,FRT RH DOOR ,REPAIR RR RHS DOOR AND RENEW DAMAGED PARTS.INCLUSIVE OF THE REPAIR OF PANEL ASSY-FRONT DOOR ,RH,PANEL ASSY -FENDER ,RH. | | \$3,840.00 | \$1,920.00 |
