Insured Vehicle No	: SKZ5425H	Accident Date	: 03/09/2017
TP Vehicle No	: SDL282S	Assignment Date	: 04/09/2017
Make	: BMW 640i	Est. Duration of Repair	: 15.00
Date of Inspection	: 12/09/2017		
Inspection At	: PERFORMANCE MOTORS LIMITED (ALEXANDRA) 303 ALEXANDRA ROAD, SIME DARBY PERFORMANCE CENTRE SINGAPORE 159941

### Point of Impact / General Description of Damages

The vehicle sustained impact / damages n/s body and portion and parts claimed are consistent to the accident.

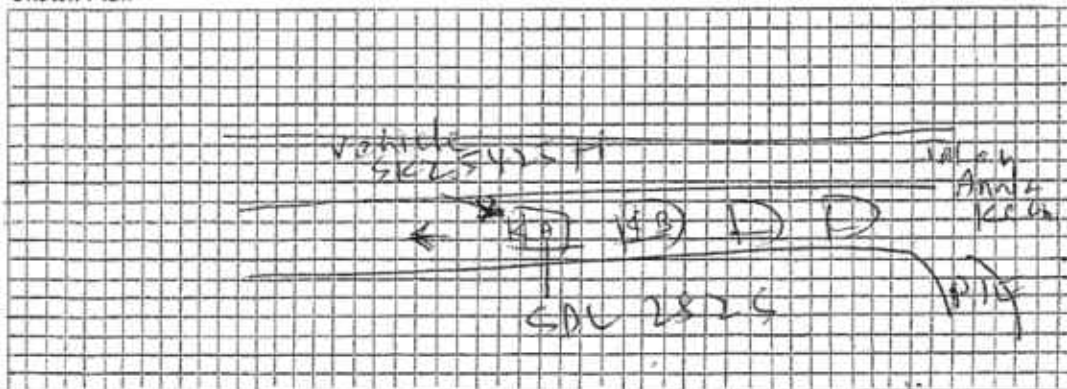
Sketch Plan

Type Of Accident COLLISION - HEAD TO REAR  
 Weather Conditions CLEAR  
 Road Surface DRY
