REF: CS1 / LPC17020854 / C v b s 2

OD/TP Re-inspection / Evaluation

To Inspect Vehicle No: SKI 5148P Insured: WPR 2378

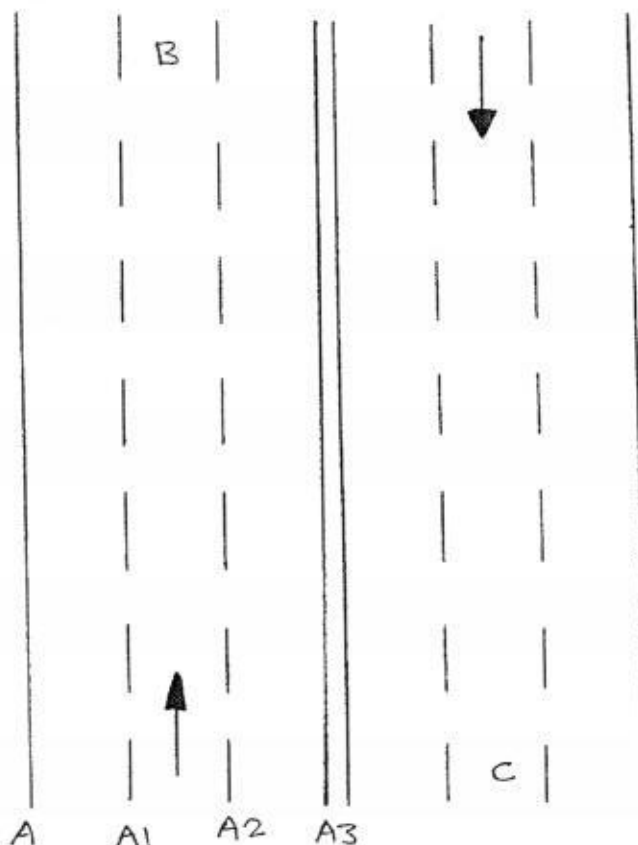
(Ukuran Tidak Mengikut Scale)

**KENDERAAN TERLIBAT TIADA DI TEMPAT KEJADIAN SEMASA PEMERIKSAAN DIJALANKAN**
