REF: CSI/LAW17021942/Avbsz

OD/TP Re-inspection / Evaluation

To Inspect Vehicle No: GBD 8118Y  
at Workshop m/s N-5, G.D.S. Insured: SKA 9188m

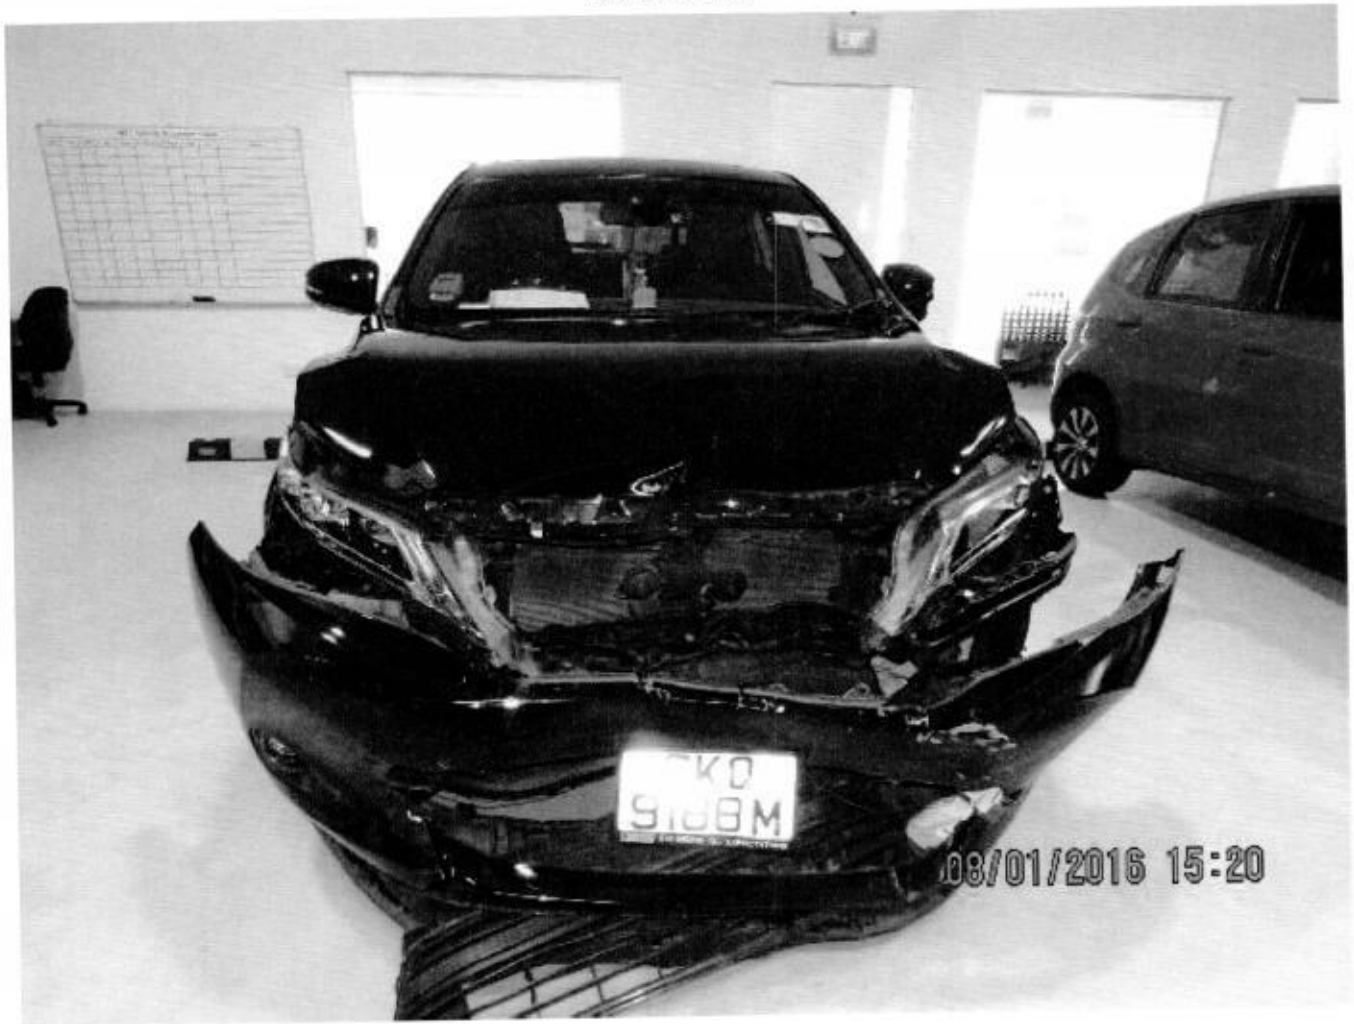
Accident Photo

On 08/01/2016 at about 1200hrs, I was travelling in my car registration number SKQ9188M along Jalan Bukit Merah towards Queensway and I was on the second lane of three lanes. While driving, my handphone rang and I was distracted by the sound. I turn and look at my handphone. When I turn my head back to the front, it was too late for me to react and my car hit a van G3D81 18Y in front of me. The lorry swerve to the left and my car kept moving forward and hit a taxi SH5382C. The taxi driver was conveyed to hospital.
