TP / CS / TP17022042 / Kvb2

## ASSIGNMENT

## 2. Vehicle Particulars & Condition

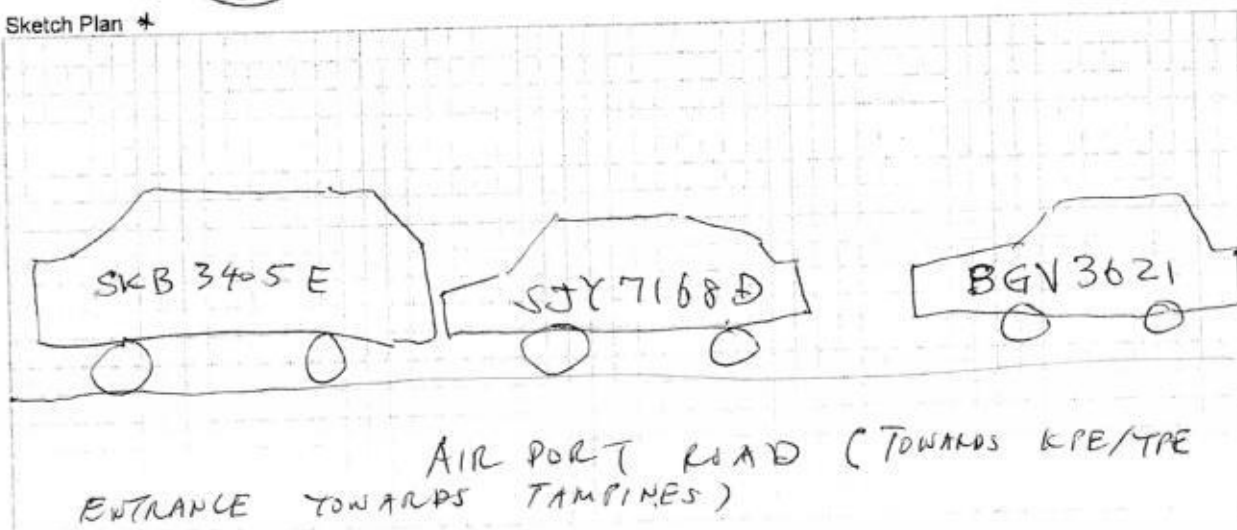
Sketch Plan \*

Type Of Accident	CHAIN COLLISION
Weather Conditions	CLEAR
Road Surface	DRY
