From LKK Auto Consultants Pte Ltd (LKK_HQ), sent on 15/12/2017 11:53 AM.
To MSIG_FFWY1
Subject Pre-repair Inspection

PARTICULARS OF DAMAGED VEHICLE

VEHICLE DAMAGE INSPECTION REPORT

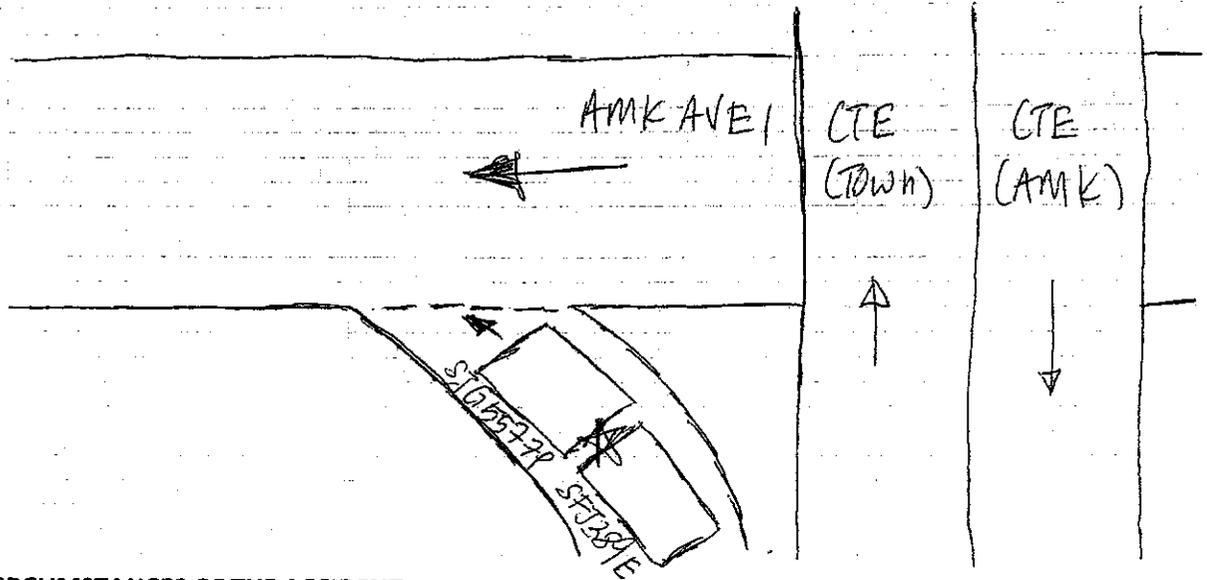
SKETCH PLAN

DESCRIBE CIRCUMSTANCES OF THE ACCIDENT

On 23rd Nov 2017, at around 11 pm, The driver, Atvin Lee, was driving the car, SJ65577P, a ~~toyota~~ Honda CRV, was waiting at the stop line of the filter lane before going onto the main road Ang Mo Kio Ave 1. The car was stationary as there are vehicles along the main road. A Toyota car, SFJ389E, driven by Lim Yong Huat, had a collision with my car's rear and caused an accident. Both drivers proceeded to exit the cars to check for damages. My Honda car suffered damages to the rear and Toyota car suffered frontal damages as well. Both drivers proceeded to exchanged drivers' details. My Honda car has an in car camera and I have photos of the scene and damages to both cars. The weather that night is clear and no adverse weather condition.
