ASSIGNMENT

Veh No: SYN1860K Yr Regn: 6 2 09   
Type: Car / M.Cycle / Bus / Van / Lorry / Taxi / Prime Mover /   
Truck / Trailer or GA   
Make: Suzuki, SX4 C.C. 1586   
Colour: Maroon A/C: Insured / Std / NI / NA   
Sp. Reading: 131741 T/Radio: Insured / Std / NI / NA   
Eng/No:   
C/No: JSAGY4C215 00203055   
Gen. Cond: Good / Fair / Poor / Burnt   
Steering: In order / Jammed / Leaked / Burnt or   
Brake: In order / Jammed / Leaked / Burnt or   
Modi: Nil / SRim / STD A/Rim or   
Tyre Size: F: 195/65R15   
R:

## VEHICLE DAMAGE INSPECTION REPORT

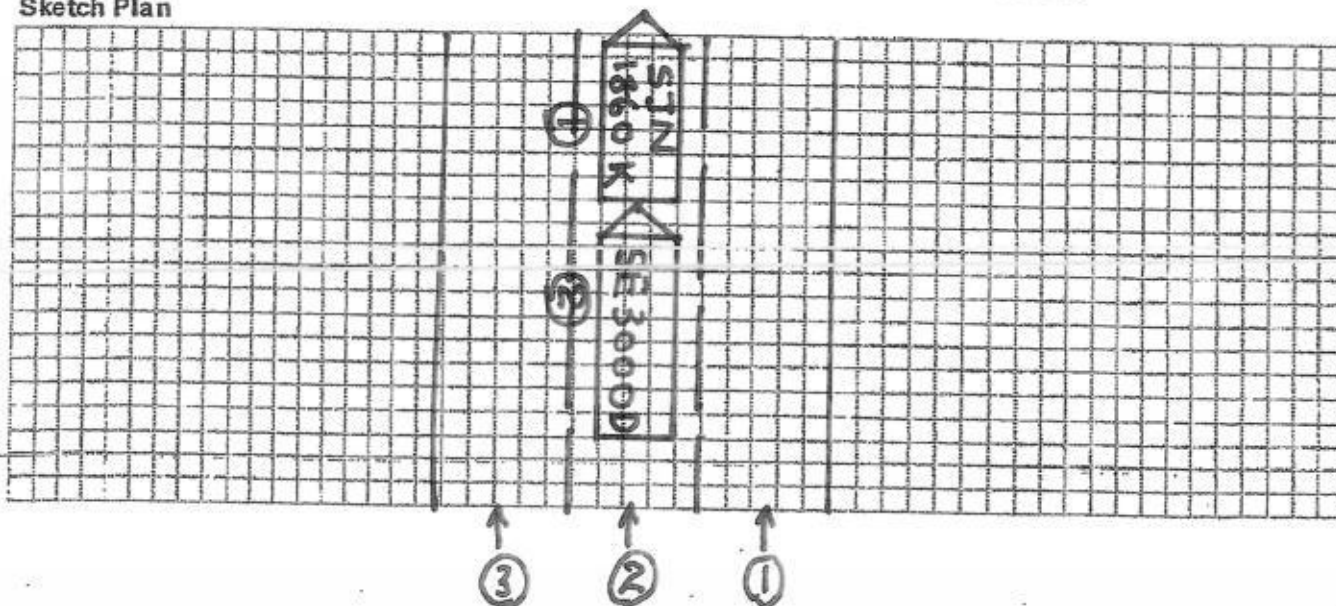
### Sketch Plan

Describe Circumstances of the Accident

ON THE 1<sup>ST</sup> DEC 2017 AT ABOUT 9.30AM I WAS DRIVING MY SUZUKI SX4 SJN 1860 K, ALONG DUNEARN ROAD ON LANE 2 TOWARDS CITY.
