OD/TP Re-inspection / Evaluation
To Inspect Vehicle No: SFS 133D Insured: SJR 4532Y
at Workshop m/s Kok Wang Car Tel: 9183 5633
of 1 Soon Lee St #06-40
Policy No: 287737180MV Claim No: 539336/TT
Sum Insured: _____ Excess: _____
Make of Veh: _____ D.O.A. 02122017
(Client's Record)

DESCRIBE CIRCUMSTANCES OF THE ACCIDENT

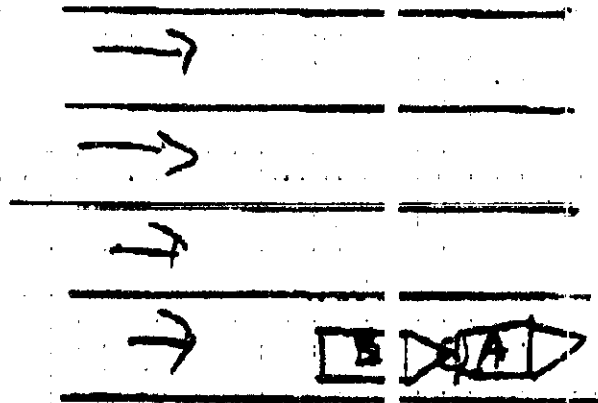
SKETCH PLAN

A-SF1133D
B-SJR4877

On 02/12/17, around 1210HRS, I was driving towards
 ME Twas on the most right lane. Suddenly vehicle
 B at the back of my vehicle bang bang against
 my vehicle SF 133D causing damage to the rear
 of my vehicle.
