To Inspect Vehicle No: XD 1032X

Policy No: 28639715 MKC

Claim No: M5314409

Particulars of Damaged Vehicle

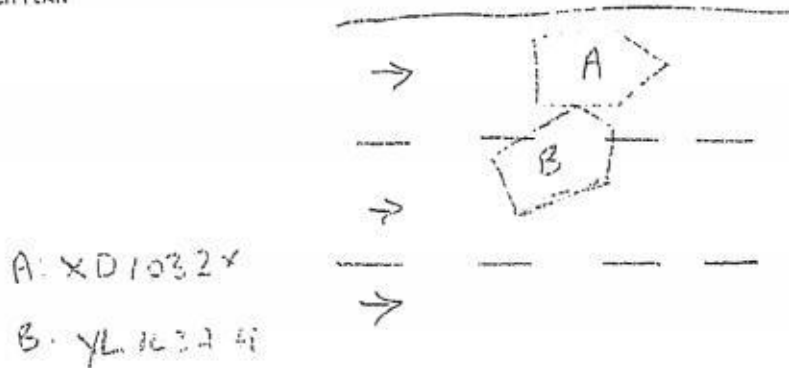
SKETCH PLAN

0A. 20/10/17 @ 9.45 am
Location SLE two turf club Ave
I was driving on the left lane of SLE
when veh B swerved into my lane and hit
the right side of my vehicle, before
swerving back to his lane He later stopped
further in front, on the left lane.
no at fault
witness by / clear
TP driver: Ramalingam Nagarajan
G 25034226
