1.	and Mala	-	:- THIRD PARTY CLAIM			
	ured Veh.	GBB 4558Y	Veh. Inspected	SKU 3997M		
	icy No.	DMCPHQ17-001056	Coverage (\$)	0.00		
	im No.		Excess (\$)	0.00		
	ign From		Assign Date	14/05/2018

2.			culars & Condition			
	ke & Model	TOYOTA HIACE (A)	c.c	2982		
\vdash	jine No.	HIDDEN	Year of Reg.	2015		
	ssis No.	JTFST22P500022329	Colour	WHITE		
	ometer	224715	Steering	IN ORDER		
Bra		IN ORDER	Modification	NIL		
1 - 1 -	neral	GOOD

ADJUSTMENT ON REPAIR COST FOR VEHICLE NO. SKU 3997M

PHOTOGRAPHS FOR VEHICLE NO. SKU 3997M

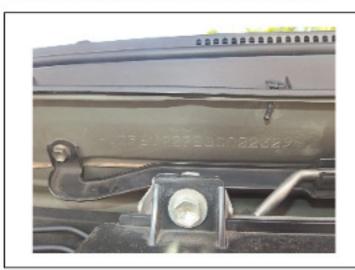
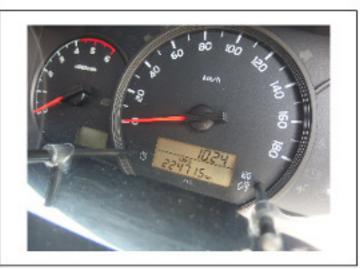
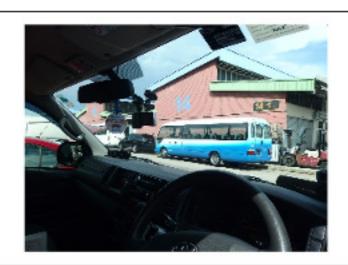
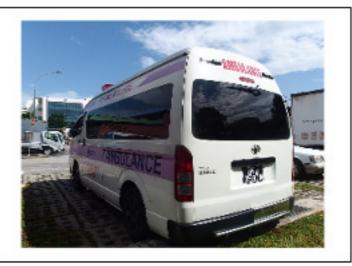
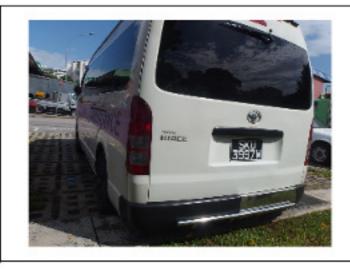
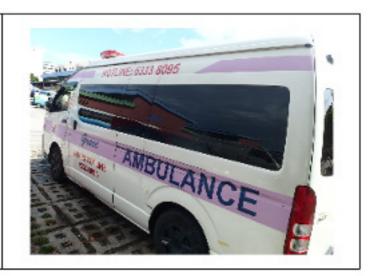
INSPECTION

4.			on of Damages			
THE	VEHICLE SUS	STAINED DAMAGES AT THE N/S	REAR PORTION.			
DAM	DAMAGES SEE DETAILS.					
5.		General	Information			
Acc	ident Date	08/02/2018	Inspection Date	14/05/2018		
Sur	vey held at	JIN AUTO SERVICES PTE LTD				
		BLK 14 DEFU LANE 10 #01-412 SINGAPORE 539195				
5a.		Re	emarks			
	A)THE INSPECTION WAS CONDUCTED ON A"WITHOUT PREJUDICE" BASIS. B)IN ACCORDANCE TO YOUR INSTRUCTIONS, WE HAVE NOT AUTHORISED REPAIRS.					
5b. Estimate Days of Repair						
EST	IMATED NORI	MAL PERIOD FOR REPAIR:	3 Working Days
