2.		Vehicle Partic	culars & Condition		
	Make & Model	TOYOTA HIACE COMMUTER (A)	c.c	2982	
	Engine No.	HIDDEN	Year of Reg. 2017		
	Chassis No.	KDH2230027204	Colour	WHITE	
	Odometer	58029	Steering	IN ORDER	
	Brakes	IN ORDER	Modification	NIL	
	General GOOD

ADJUSTMENT ON REPAIR COST FOR VEHICLE NO. PC 5420H

PHOTOGRAPHS FOR VEHICLE NO. PC 5420H

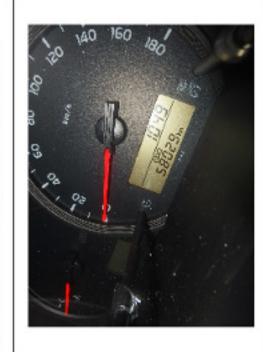
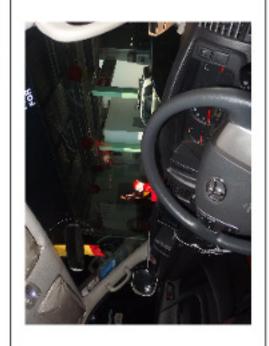
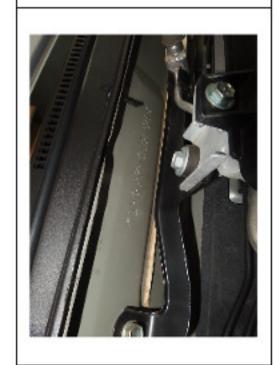
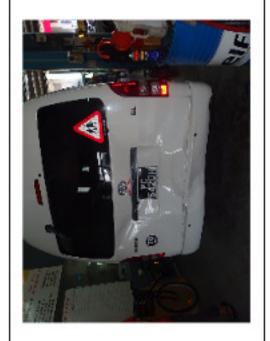
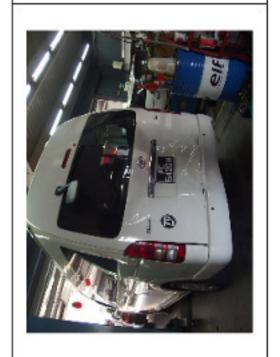
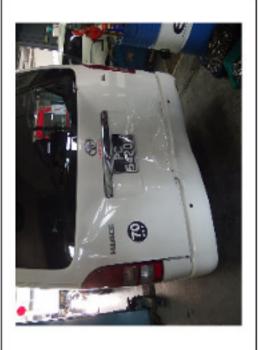
4.		•	on of Damages		
	THE VEHICLE SUS	STAINED DAMAGES AT THE REA	AR PORTION.		
	DAMAGES SEE DI	ETAILS.			
5.		General	Information		
	Accident Date	28/03/2018	Inspection Date	05/04/2018	
	Survey held at	LEE BROTHERS AUTOMOTIVE	PTE LTD		
	1 KAKI BUKIT AVENUE 6 #02-47 AUTOBAY SINGAPORE 417883				
5a.		Re	emarks		
	A)THE INSPECTION WAS CONDUCTED ON A"WITHOUT PREJUDICE" BASIS. B)IN ACCORDANCE TO YOUR INSTRUCTIONS, WE HAVE NOT AUTHORISED REPAIRS.				
5b.	5b. Estimate Days of Repair				
	ESTIMATED NORMAL PERIOD FOR REPAIR: 5 Working Days

Qty	Description of Parts	Condition	Estimate By Workshop (\$))	Our Adjusted (\$)
	REPLACEMENT OF PARTS			
1	REAR TAILGATE	BADLY DENTED	2,150.70	2,150.70
2	REAR TAILGATE HINGE RH/LH @\$68.95	NOT NECESSARY	137.90	-
2	REAR TAILGATE DAMPER RH/LH @\$399.15	NOT NECESSARY	798.30	-
1	REAR TAILGATE RUBBER	TWISTED	399.45	399.45
1	REAR TAILGATE LOCK	TWISTED / JAMMED	509.10	509.10
1	REAR TAILGATE LOCK CATCH	NOT NECESSARY	59.10	-
1	REAR TAILGATE INNER TRIM	DEFORMED / TORN	688.90	688.90
1	REAR TAILGATE EMBLEM 'LOGO'	NECESSARY	78.10	78.10
1	REAR TAILGATE EMBLEM 'HIACE'	NECESSARY	65.10	65.10
1	REAR TAILGATE EMBLEM 'GL'	NECESSARY	40.20	40.20
1	REAR TAILGATE CHROME MOULDING	CRACKED	210.20	210.20
2	REAR TAILGATE NUMBER PLATE LAMP @\$79.10	NOT NECESSARY	158.20	-
1	REAR BUMPER	DISTORTED	517.10	517.10
4	REAR BUMPER BRACKET @\$65.10	BENT	260.40	260.40
2	REAR BUMPER SIDE RETAINER LH/RH @\$145.20	NOT NECESSARY	290.40	-
2	REAR TAILLAMP RH/LH @\$325.50	CRACKED	651.00	651.00

Qty	Description of Parts	Condition	Estimate By Workshop (\$))	Our Adjusted (\$)
1	SET REAR BUMPER CLIP (SN)	NECESSARY	45.00	45.00
1	SET REAR NUMBER PLATE (SN)	CRACKED	50.00	40.00
1	SET REAR REVERSE CAMERA (SN)	SHORTED	280.00	280.00
1	REAR DOOR EMERGENCY DOOR STICKER (SN)	NECESSARY	30.00	15.00
			815.00	660.00
	<u>LABOUR</u>			
	TO KNOCK OUT DENT ,CUT /WELD REAR END PANEL AND REPLACE ACCIDENT PARTS .		1,200.00	900.00
	TO SPRAY PAINTING ON ACCIDENT PORTION .		1,200.00	800.00
	TO CHECK WIRING .		30.00	20.00
	TO TRANSFER REAR TAILGATE PARTS.		120.00	60.00
	TO REMOVE, REPLACE REVERSE SENSOR .		100.00	50.00
	TO REMOVE ,REFIX CUSHION AND INNER TRIM .		180.00	60.00
	TO REMOVE ,REFIX REAR WINDSCREEN .		180.00	100.00
	TO REMOVE,REPLACE EXHAUST SYSTEM.	NOT NECESSARY	180.00	-
	TO TUFF KOTE.		120.00	80.00
			3,310.00	2,070.00
	GRAND TOTAL		12,565.63	8,219.06
