Affiliated to Federation Internationale Des Experts En Automobile				
EQ INSURANCE COMPANY LTD		Ref : CC4/EQI18007116/Kps3q2		
5 MAXWELL ROAD #17-00 TOWER BLOCK MND COMPLEXSINGAPORE 069110		Date : 14-07-2020

## ADJUSTMENT ON REPAIR COST FOR VEHICLE NO. FBM 6460Z

PHOTOGRAPHS FOR VEHICLE NO. FBM 6460Z

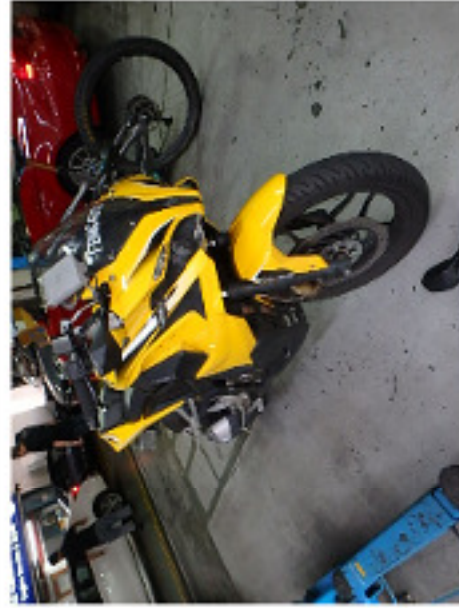
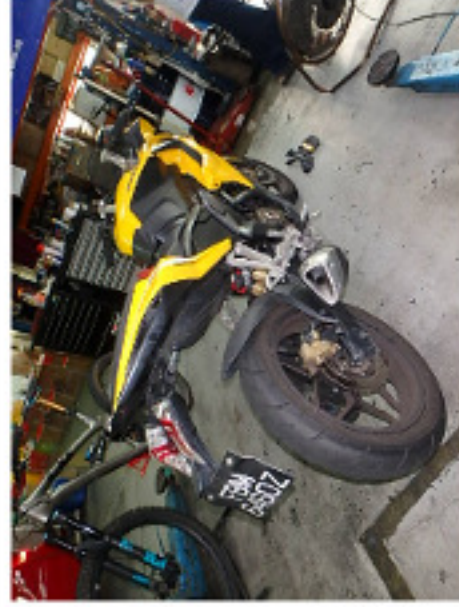
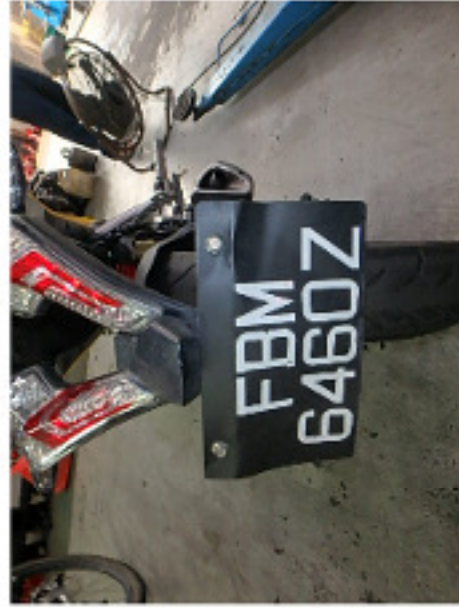
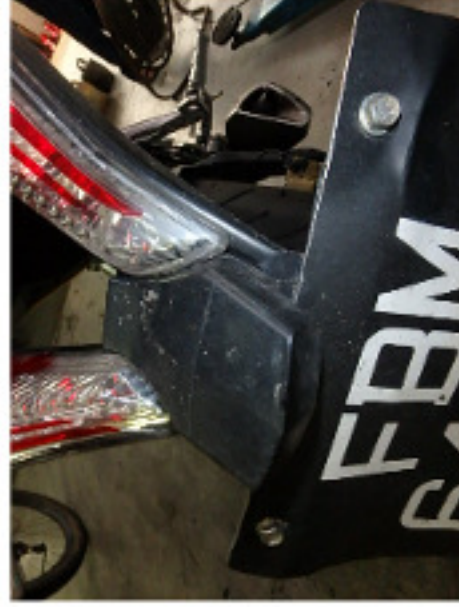
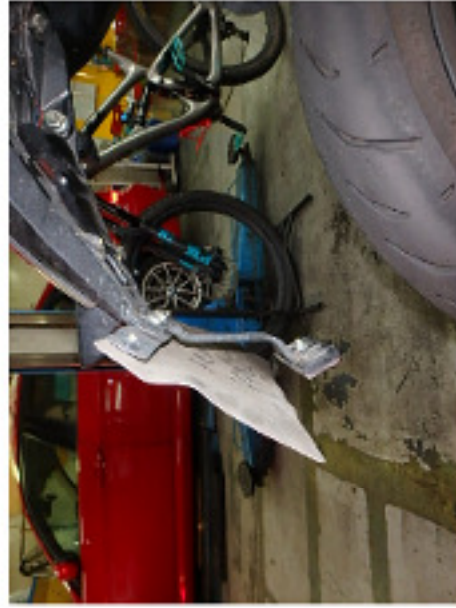
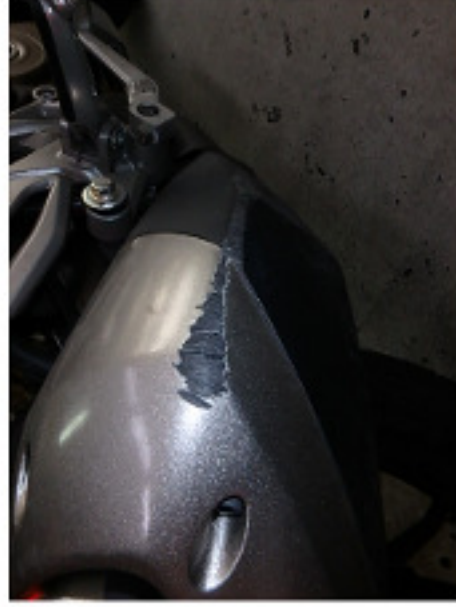
INSPECTION

<b>R/H Front Tyre</b>	100/80 R17	MRF	4 mm
	<b>L/H Front Tyre</b>			mm
	<b>R/H Rear Tyre</b>	130/70 R17	MRF	4 mm
	<b>L/H Rear Tyre</b>			mm
<b>4. Description of Damages</b>				
	THE VEHICLE SUSTAINED DAMAGES AT THE REAR PORTION AND O/S BODY. DAMAGES SEE DETAILS.			
<b>5. General Information</b>				
	<b>Accident Date</b>	14/04/2018	<b>Inspection Date</b>	02/05/2018
	<b>Survey held at</b>	SUPREME AUTO SERVICE PTE LTD 176 SIN MING DRIVE #02-01 SIN MING AUTOCARE SINGAPORE 575721		
<b>5a. Remarks</b>				
	A)THE INSPECTION WAS CONDUCTED ON A"WITHOUT PREJUDICE" BASIS. B)IN ACCORDANCE TO YOUR INSTRUCTIONS, WE HAVE NOT AUTHORISED REPAIRS.			
<b>5b. Estimate Days of Repair</b>				
	ESTIMATED NORMAL PERIOD FOR REPAIR:		<b>3 Working Days</b>

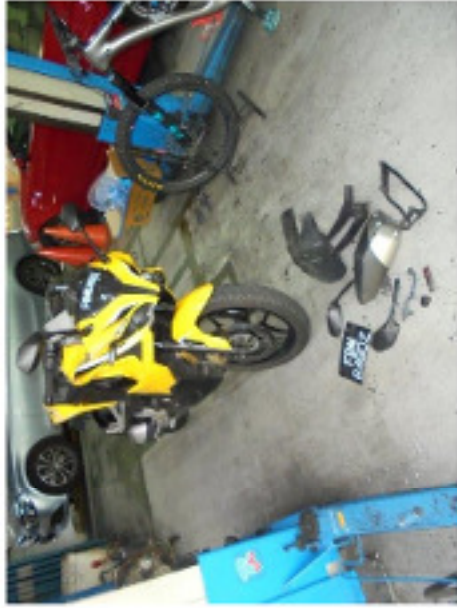
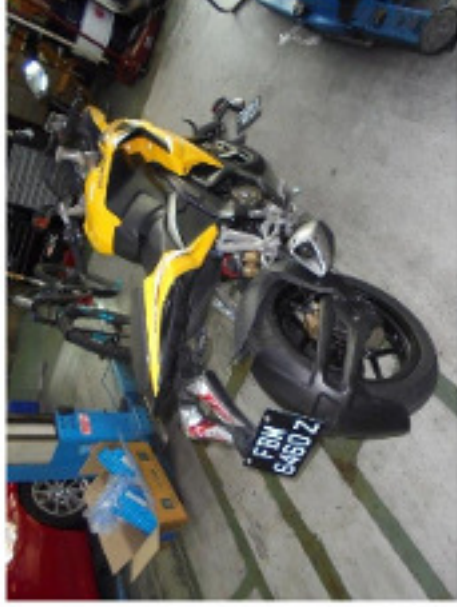
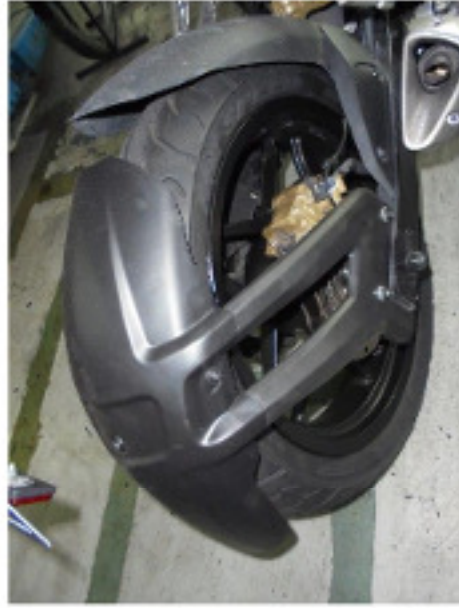
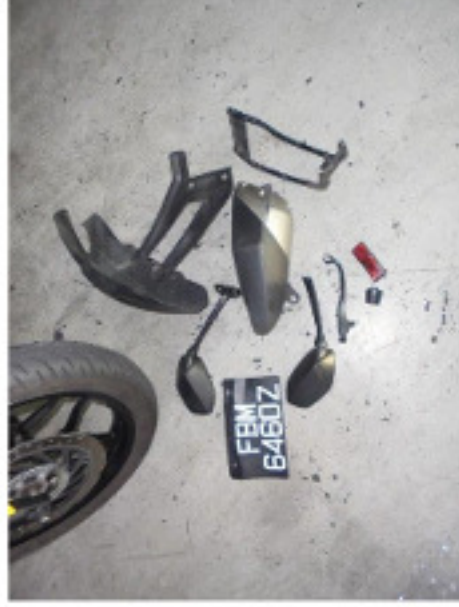
PHOTOGRAPHS FOR VEHICLE NO. FBM 6460Z

RE-INSPECTION
