ASSIGNMENT FORM

To Inspect Vehicle No: SFB 6911A

Claim No: 1718/18/VCO0/020525

3. DESCRIPTION OF DAMAGES

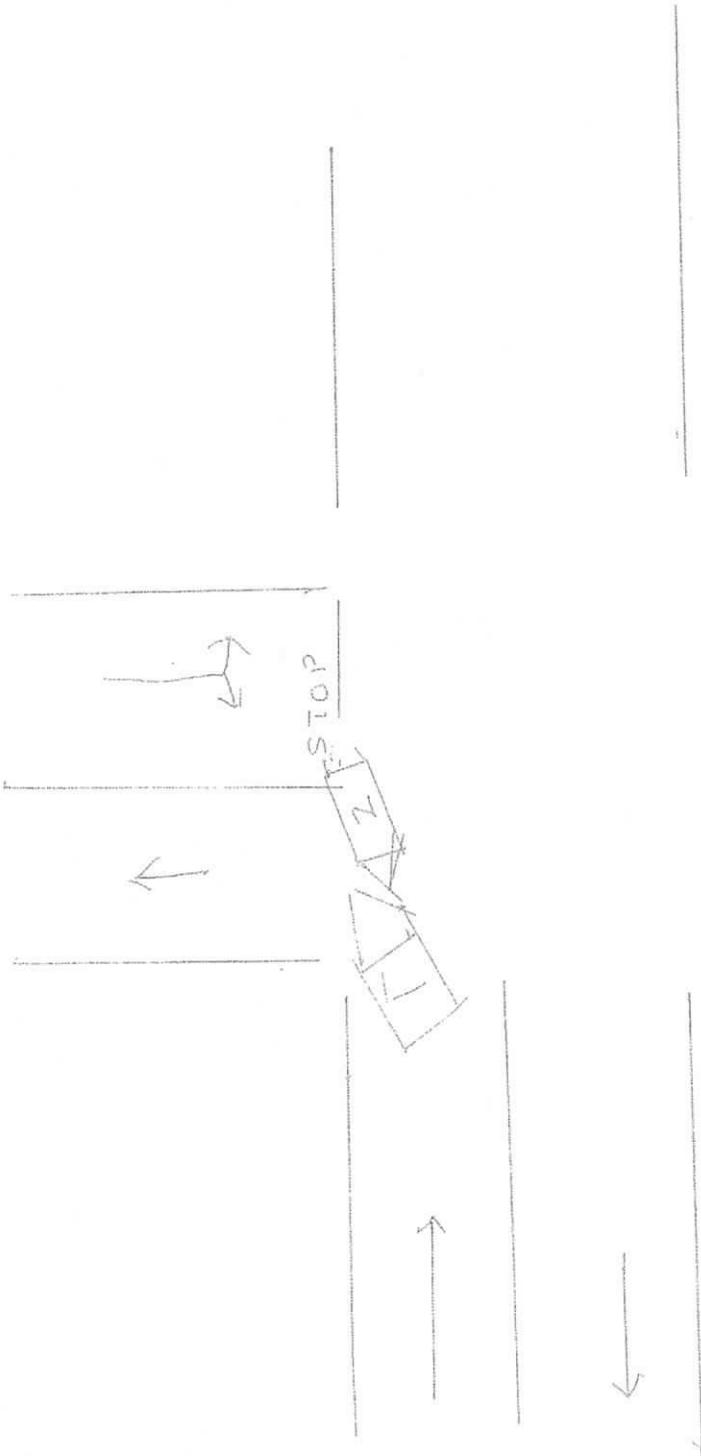
Sketch Plan A

- ① SF 6 6911-11
- ② GZ-5824-14

BIK 514
Hungary Ave 10

On 09/04/18 at about 6.50 a.m., I was driving my vehicle SFB 6911A to leave the carpark. A vehicle of GZ 5834-H came in from the carpark did not stop at the stop line and bang into my vehicle SFB 6911-A right side cause my: head light, Bumper & Bonnet & front portion of my vehicle damage.
