To Inspect Vehicle No: SHA 9723M

Insured Vehicle No : SLL7922M  
TP Vehicle No : SHA9723M  
Make : HYUNDAI I40  
Date of Inspection : 25/09/2018  
Inspection At : Chunni Motor Work Pte Ltd (HQ)  
Blk 10 Ang Mo Kio Industrial Park 2A, #03-19 AMK Autopoint  
Singapore 568047  
Accident Date : 18/09/2018  
Assignment Date : 24/09/2018  
Est. Duration of Repair : 10 days

**Point of Impact / General Description of Damages**

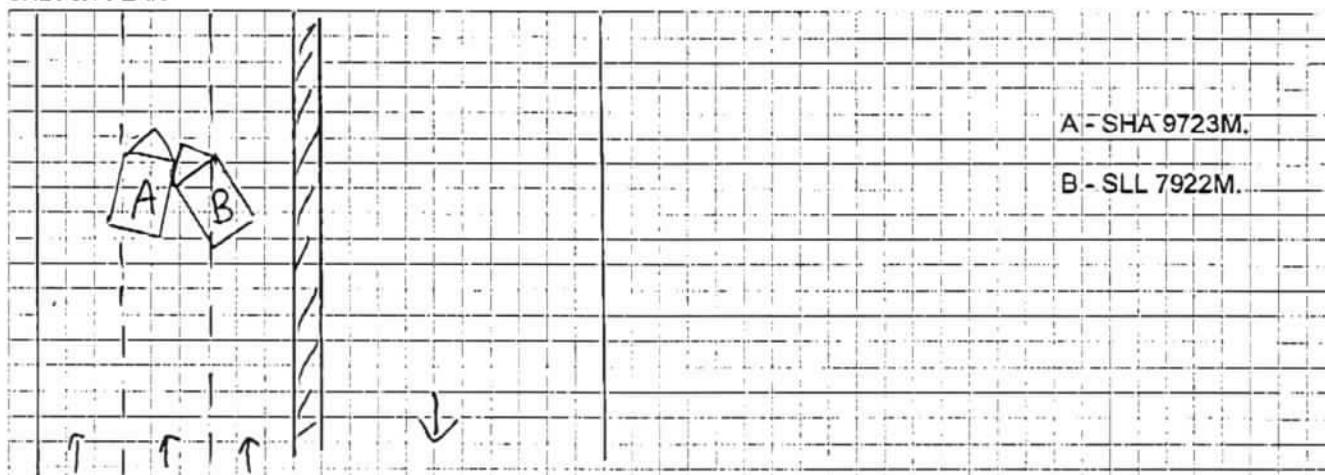
**SKETCH PLAN**

A - SHA 9723M.

B - SLL 7922M.

Type Of Accident SIDE SWIPE  
Weather Conditions CLEAR  
Road Surface DRY
