LKK Auto Consultants Pte Ltd

ADJUSTMENT ON REPAIR COST FOR VEHICLE NO. SLL 5487R

PHOTOGRAPHS FOR VEHICLE NO. SLL 5487R

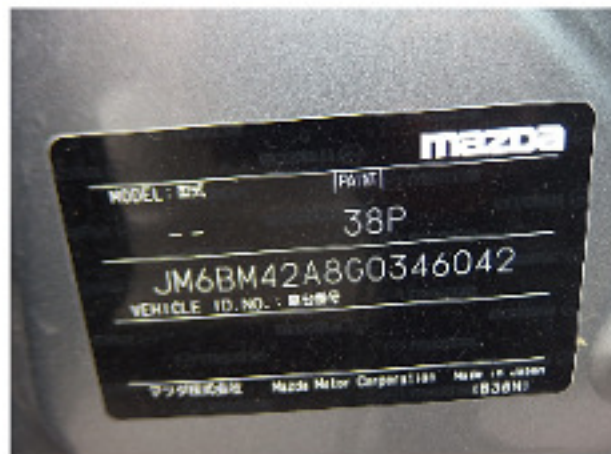
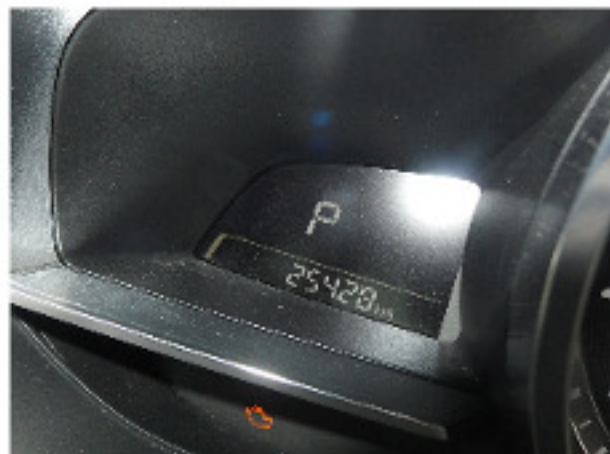
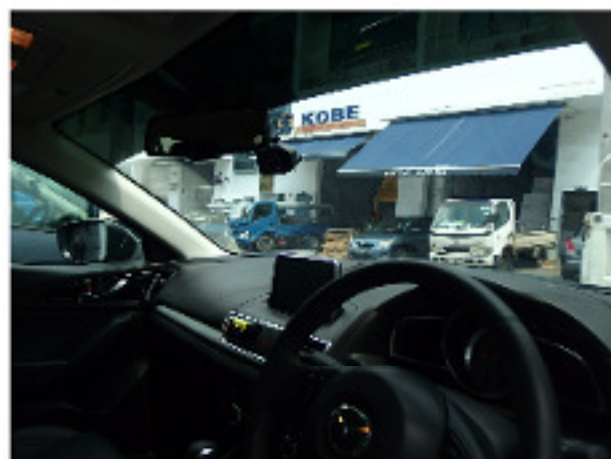
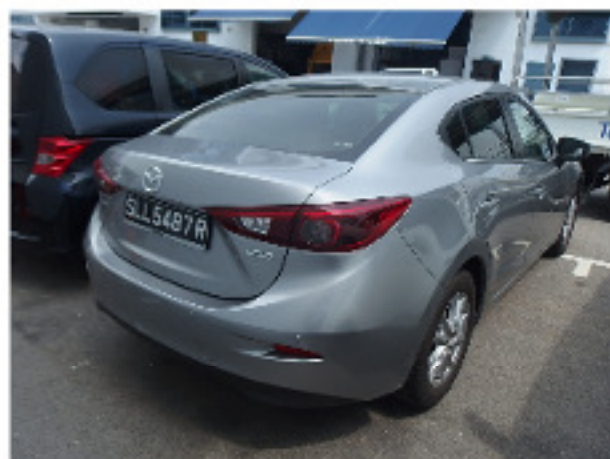
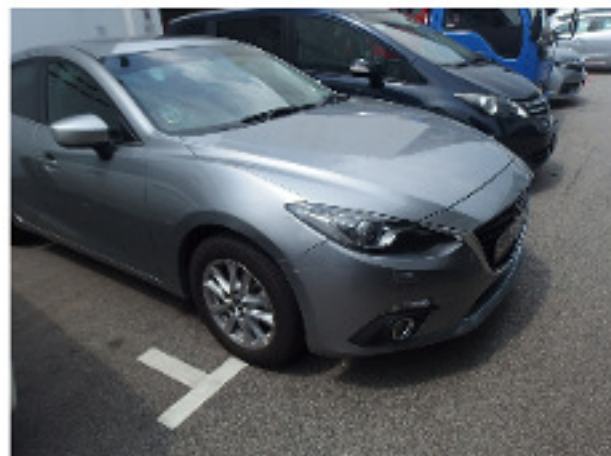
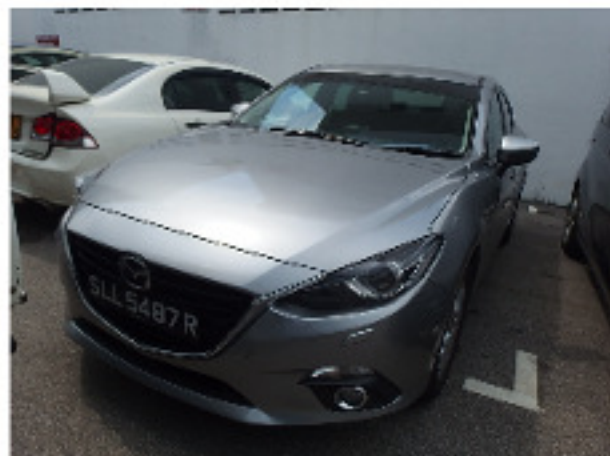
4. Description of Damages				
	THE VEHICLE SUSTAINED DAMAGES AT THE O/S FRONT PORTION AND O/S BODY. DAMAGES SEE DETAILS.			
5. General Information				
	Accident Date	25/09/2018	Inspection Date	26/09/2018
	Survey held at	ZOOM AUTOWERKS PTE LTD 832 SIMS AVENUE #12-884 EUNOSVILLE SINGAPORE 400832		
5a. Remarks				
	A)THE INSPECTION WAS CONDUCTED ON A"WITHOUT PREJUDICE" BASIS. B)IN ACCORDANCE TO YOUR INSTRUCTIONS, WE HAVE NOT AUTHORISED REPAIRS.			
5b. Estimate Days of Repair				
	ESTIMATED NORMAL PERIOD FOR REPAIR:		4 Working Days
