Vehicle No. SHD 7105U

### ADJUSTMENT ON REPAIR COST FOR VEHICLE NO. SHD 7105U

PHOTOGRAPHS FOR VEHICLE NO. SHD 7105U

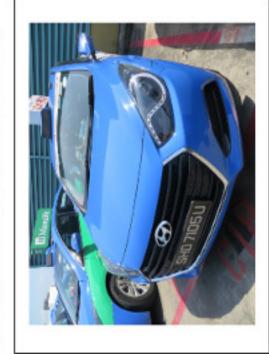
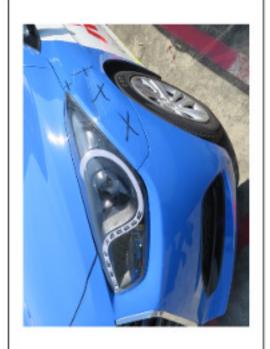
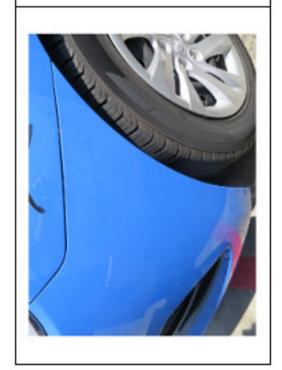
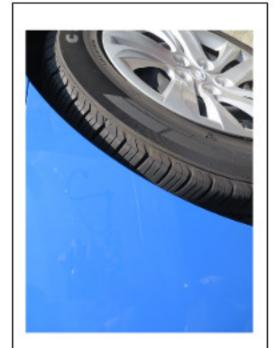
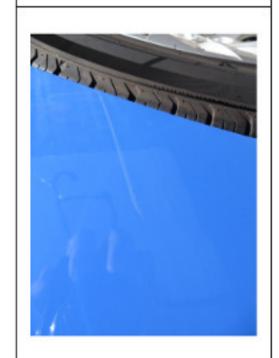
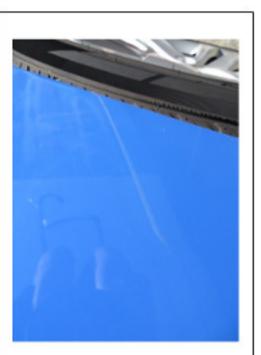
| | Affiliated to Federation Internationale Des Experts En Automobile | | | | | | |
|---|---|---|---|---|--|--|--|
| | THE VEHICLE SU | STAINED DAMAGES AT THE N/S | FRONT PORTION. | | | | |

INSPECTION

| Qty | Description of Parts | Condition | Estimate By Workshop (\$)) | Our Adjusted<br>(\$) |
|---|---|---|---|---|
| | PANEL BEATING.INCLUSIVE OF THE REPAIR OF FRONT FENDER AND LH WING MIRROR. | | 440.00 | 200.00 |
