LKK Auto Consultants Pte Ltd

PROFESSIONAL SERVICE FEE

Vehicle No. FBF 3126X
Insured Veh. GY 7797Z
Claim No. 18/18/18/VC05/020989
Policy No. Z18VC05000234
Accident Date 04/10/2018
Inspection Date 09/10/2018

ADJUSTMENT ON REPAIR COST FOR VEHICLE NO. FBF 3126X

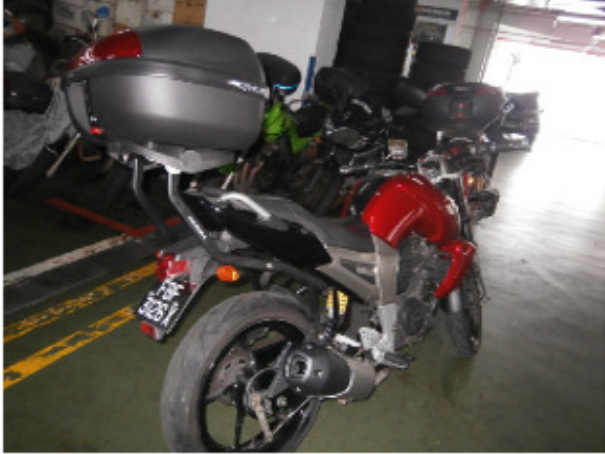
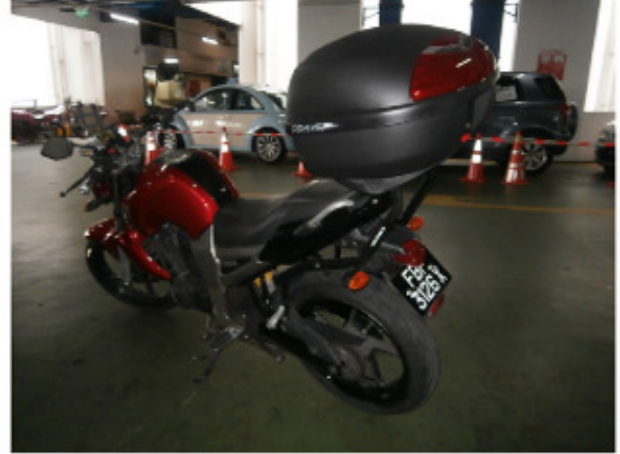
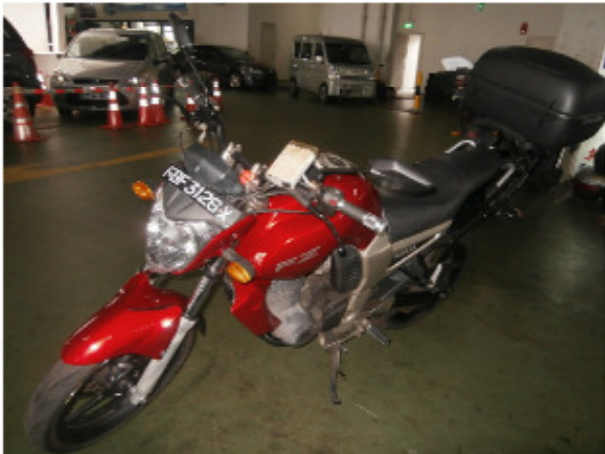
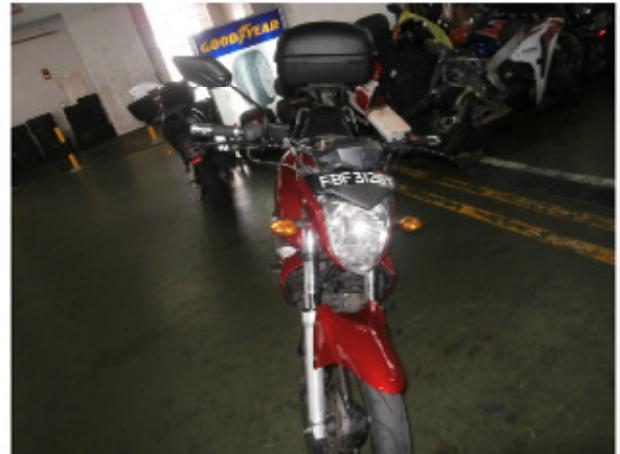
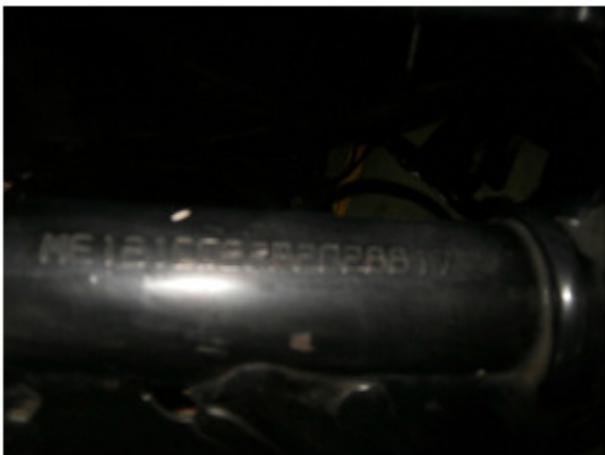
PHOTOGRAPHS FOR VEHICLE NO. FBF 3126X

RE-INSPECTION

THE VEHICLE SUSTAINED DAMAGES AT THE REAR, FRONT PORTION AND O/S BODY.
DAMAGES SEE DETAILS.
