AUTOMAX SURVEY

Report Ref : TP18050040

Koh Wei Hao
c/o D's Graffiti Concepts Pte Ltd
Synergy @ KB 25
Kaki Bukit Road 4
06 - 26
Singapore 417800
THIRD PARTY SURVEY
ACCIDENT OCCURED ON 17 May 2018

Registration No : SLQ 8391 L
Model : HYUNDAI ELANTRA AD 1.6
Year / Capacity : 2017 / 1598cc
Chassis No : KMHD841CMJU508467

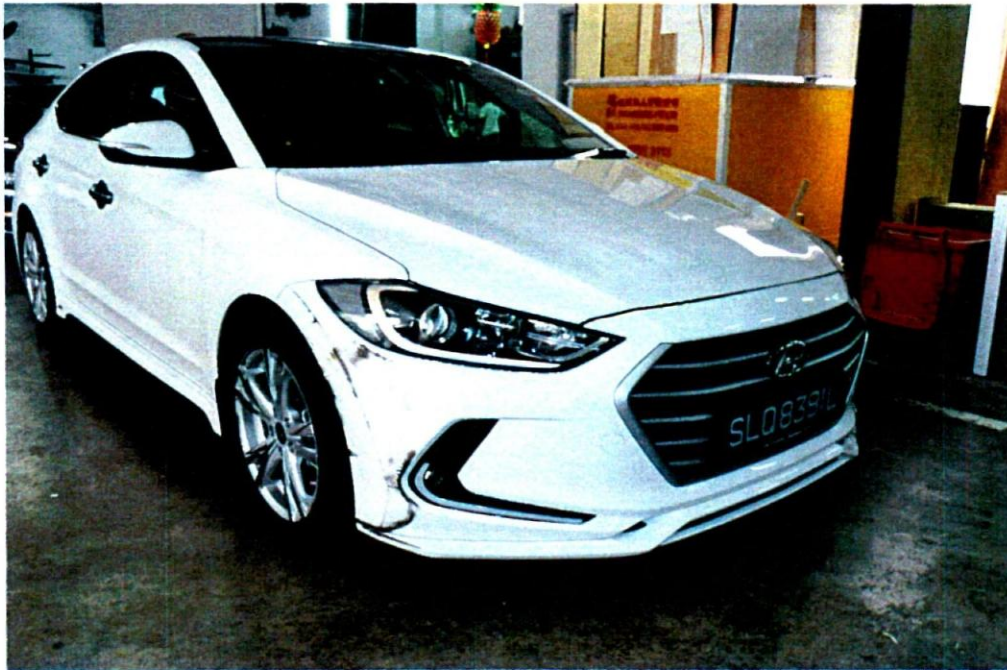
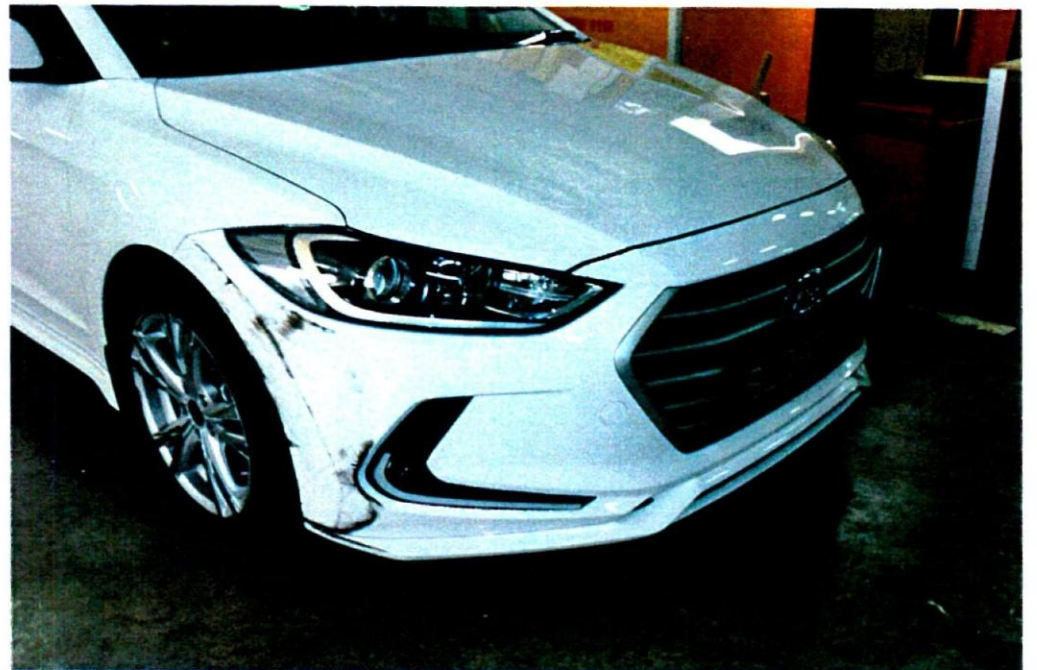
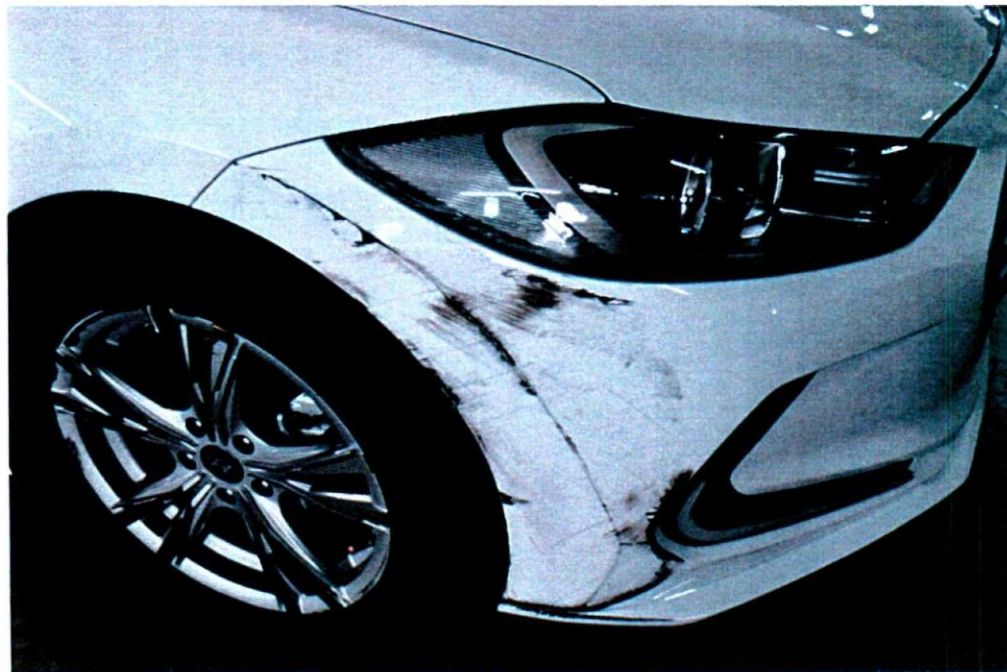
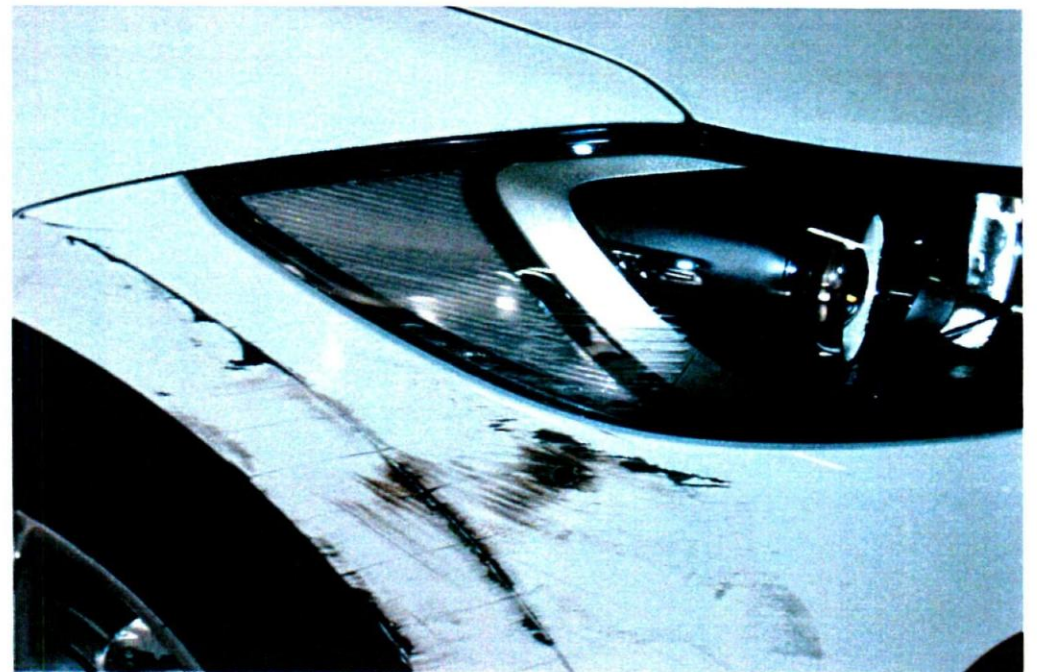
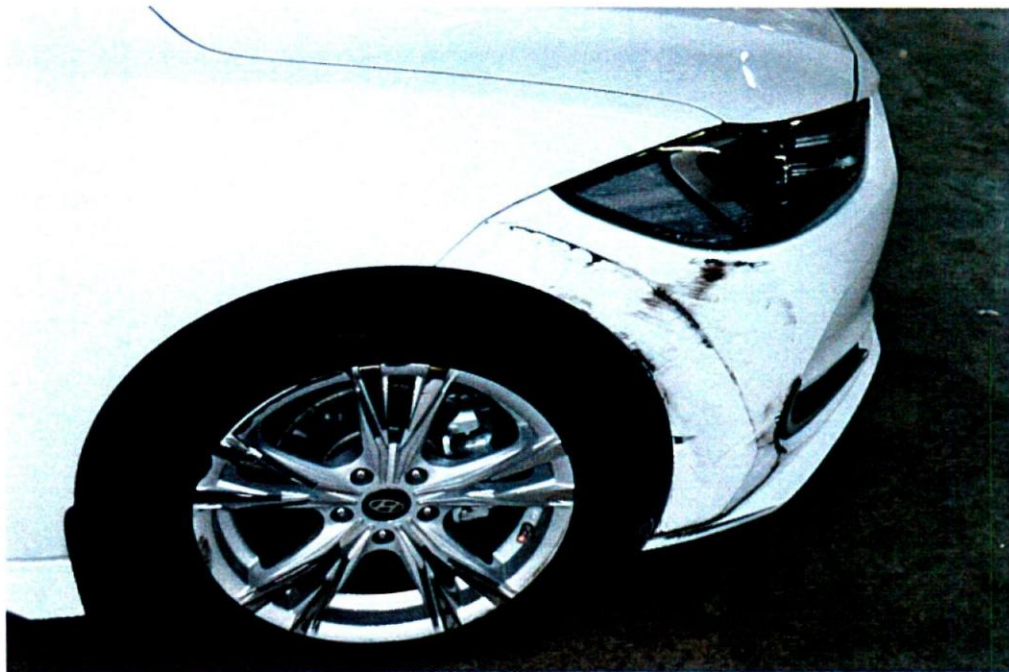
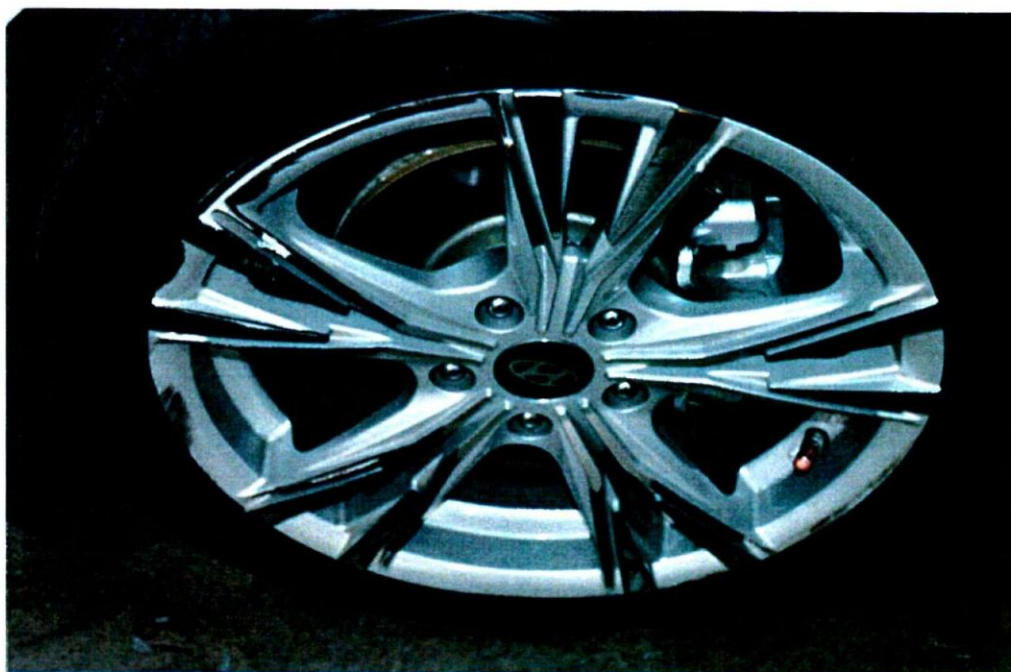
At the time of inspection, we noted that the vehicle has sustained an impact damages on the **front side** portion(s). For more detail of the damages, please see photograph attached.
