REF: C01 / ICS18010379 / Bth

To Inspect Vehicle No: SBU 1300T Insured: SLJ 6797A  
at Workshop m/s Motor Image Tel:  
of 19 Lorong 8 Toa Payoh  
Policy No: Claim No: DMPC1700260H / DL  
Sum Insured: Excess:  
Make of Veh: D.O.A. 11.04.2017  
(Client's Record)

ESTIMATE : ACCIDENT/BODY REPAIRS  
WORKSHOP : TOA PAYOH  
CONTACT NO : 64730333  
REFERENCE : INS/IC/CHI/0159/2017  
DATE : 25-APR-2017

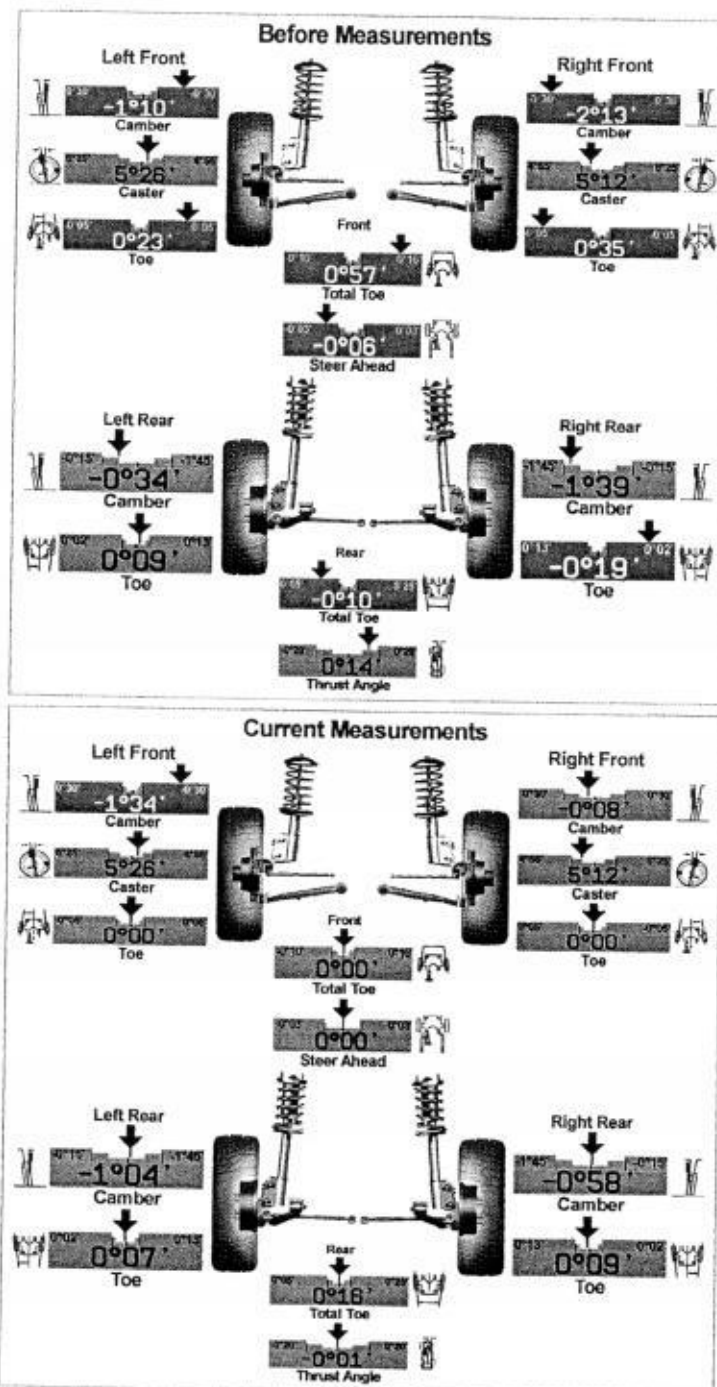
**Subaru 2013-15 Forester SJ**  
**4-Wheel Total Alignment**

Work Order: R000039  
 Name 2: YAP KOK CHENG DERRICK  
 License: SBU1300T  
 Year: 14  
 Technician: ALBERT  
 Odometer: 48785  
 Date: 11.5.17 10:40
