Vehicle No. SHB 228E  
Insured Veh. YN 8255J  
Claim No. SNM19D201477C02/5  
Policy No. DMCVSN3068131800  
Accident Date 01/04/2019  
Inspection Date 02/04/2019

### ADJUSTMENT ON REPAIR COST FOR VEHICLE NO. SHB 228E

### PHOTOGRAPHS FOR VEHICLE NO. SHB 228E

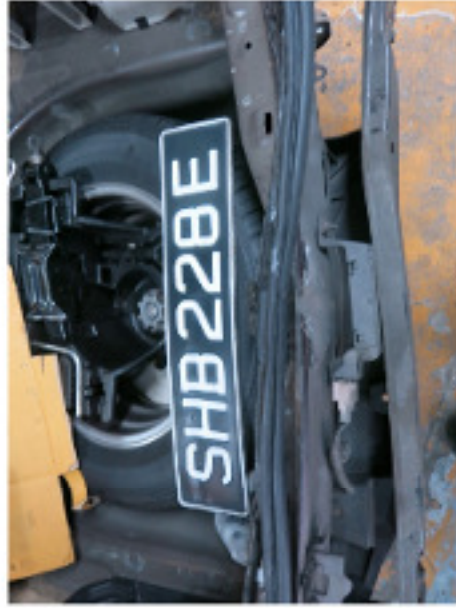
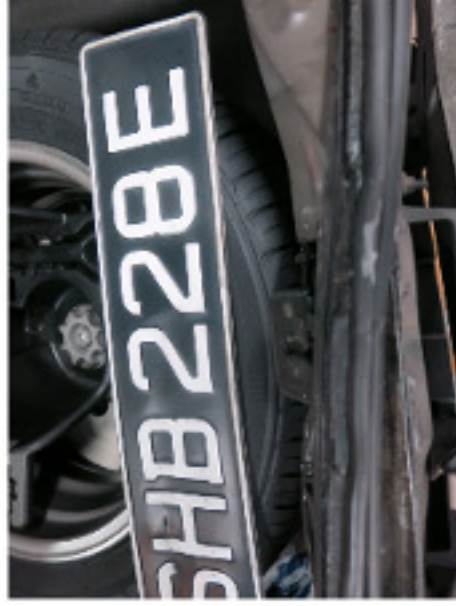
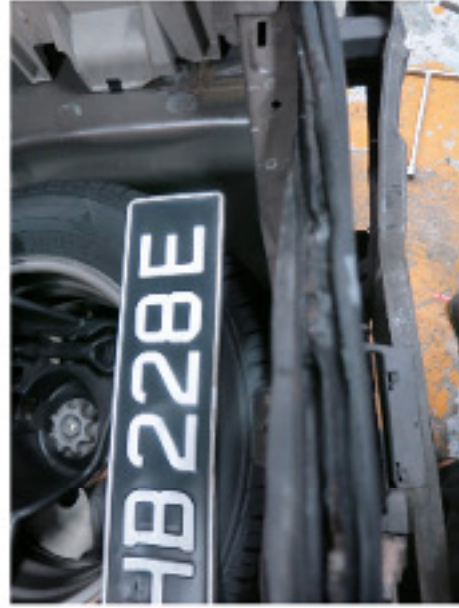
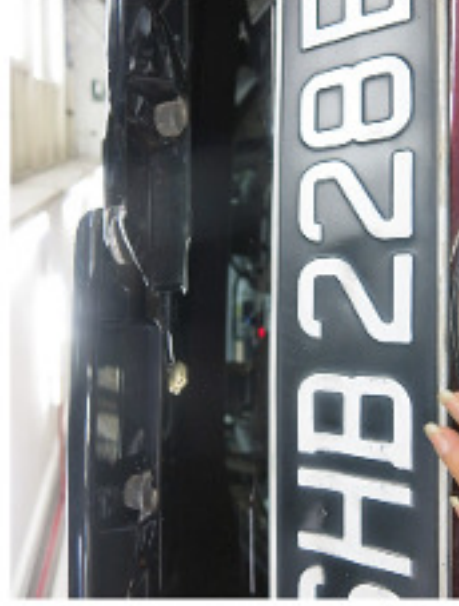
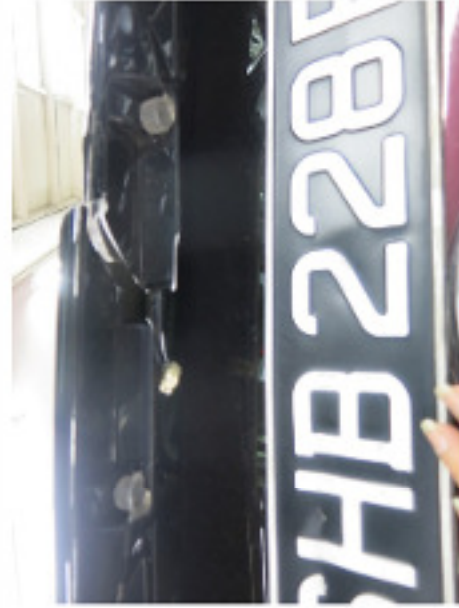
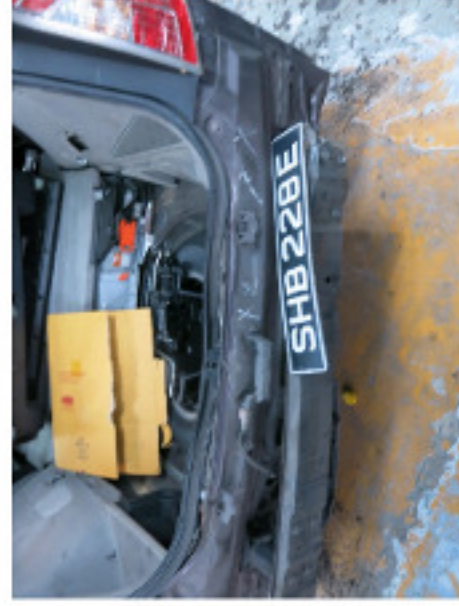
PHOTOGRAPHS FOR VEHICLE NO. SHB 228E

RE-INSPECTION

| Affiliated to Federation Internationale Des Experts En Automobile | | | | |
|---|---|---|---|--|
| THE VEHICLE SUSTAINED DAMAGES AT THE FRONT AND REAR PORTION.<br>DAMAGES SEE DETAILS. | | | | |
