2.		Vehicle Partic	culars & Condition		
	Make & Model	TOYOTA ISIS (A)	c.c	1794	
	Engine No.	HIDDEN	Year of Reg.	2008	
	Chassis No.	ZNM100056124	Colour	WHITE	
	Odometer	184994	Steering	IN ORDER	
	Brakes	IN ORDER	Modification	SPORTS RIM	
	General	GOOD

ADJUSTMENT ON REPAIR COST FOR VEHICLE NO. SLB 5228A

PHOTOGRAPHS FOR VEHICLE NO. SLB 5228A

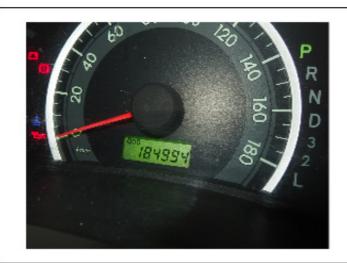
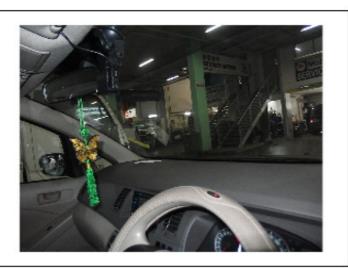
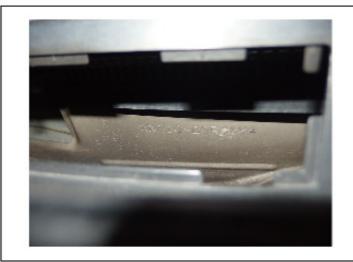
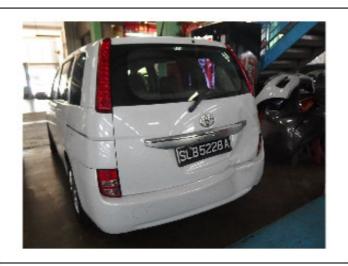
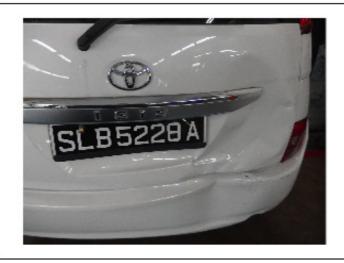
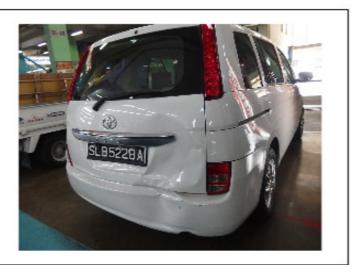
4.		•	on of Damages		
	THE VEHICLE SUS	STAINED DAMAGES AT THE REA	AR PORTION.		
	DAMAGES SEE DI	ETAILS.			
5.		General	Information		
	Accident Date	03/04/2019	Inspection Date	04/04/2019	
	Survey held at	FASTECH AUTO PTE LTD			
		1 KAKI BUKIT AVENUE 6 #01-46/48/50 AUTOBAY SINGAPORE 417883			
5a.		Re	emarks		
		ON WAS CONDUCTED ON A"WIT CE TO YOUR INSTRUCTIONS, W		REPAIRS.	
5b.	b. Estimate Days of Repair				
	ESTIMATED NORI	MAL PERIOD FOR REPAIR:	5 Working Days

INSPECTION
