## LKK Auto Consultants Pte Ltd

### 1. Policy Particulars :- THIRD PARTY CLAIM

### ADJUSTMENT ON REPAIR COST FOR VEHICLE NO. SLK 6916T

### PHOTOGRAPHS FOR VEHICLE NO. SLK 6916T

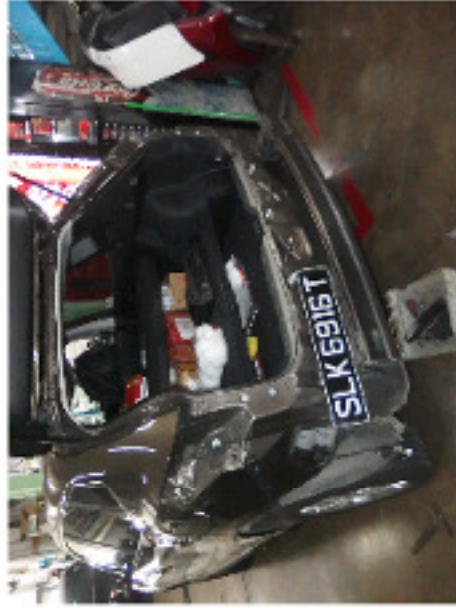
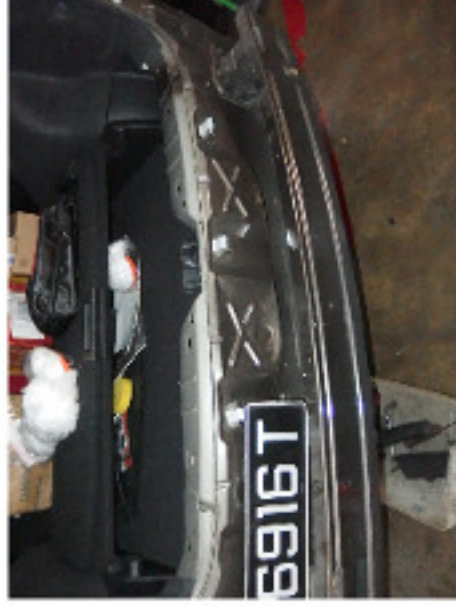
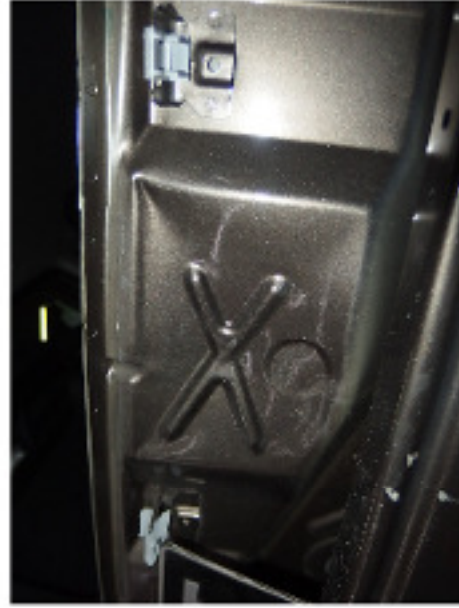
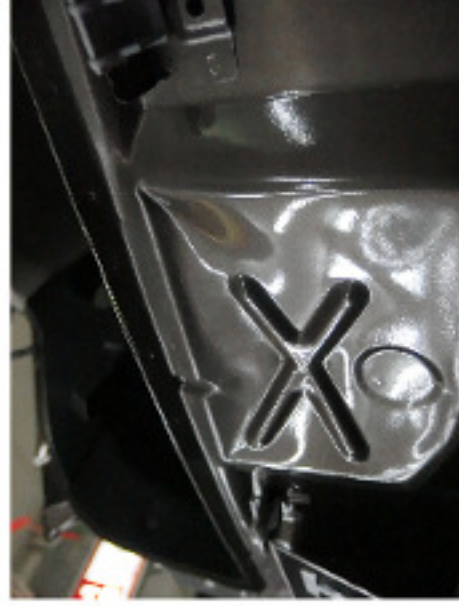
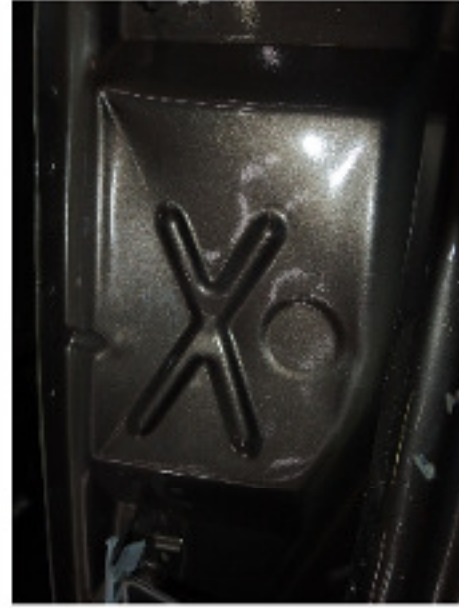
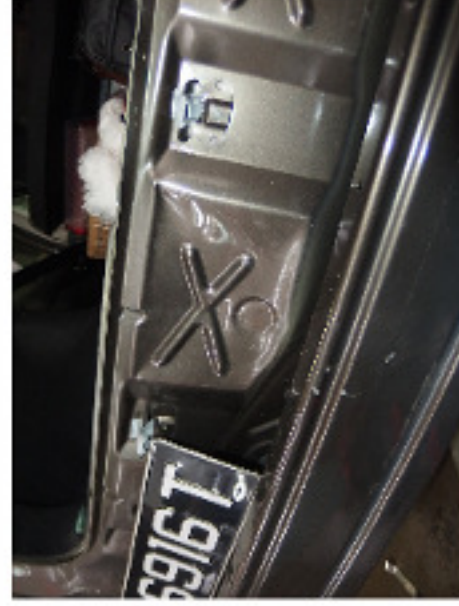
RE-INSPECTION

PHOTOGRAPHS FOR VEHICLE NO. SLK 6916T

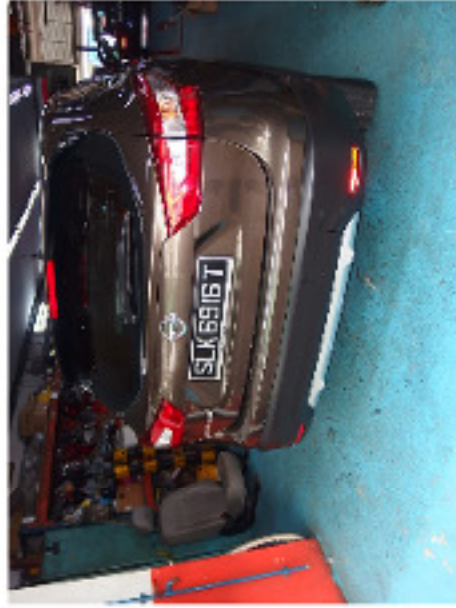
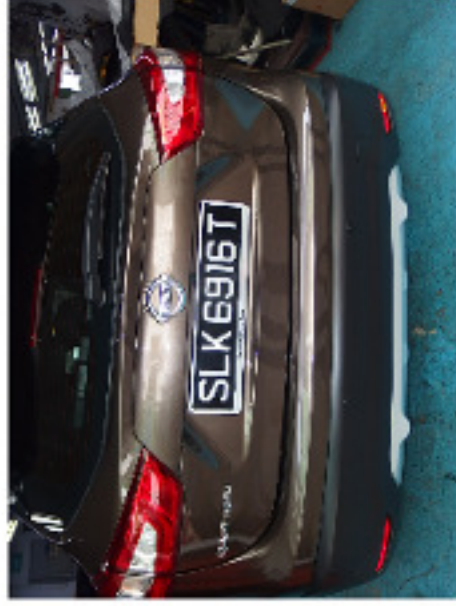
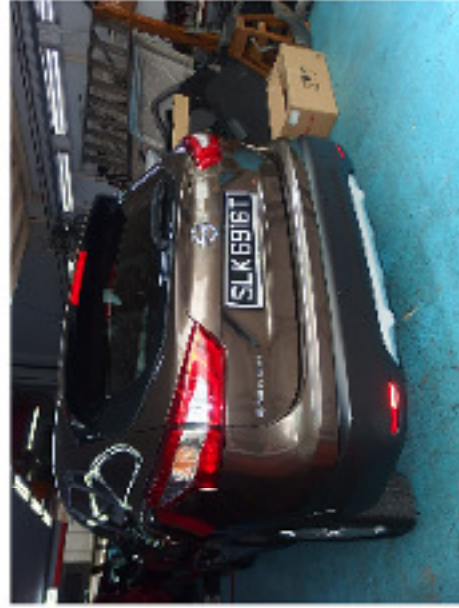
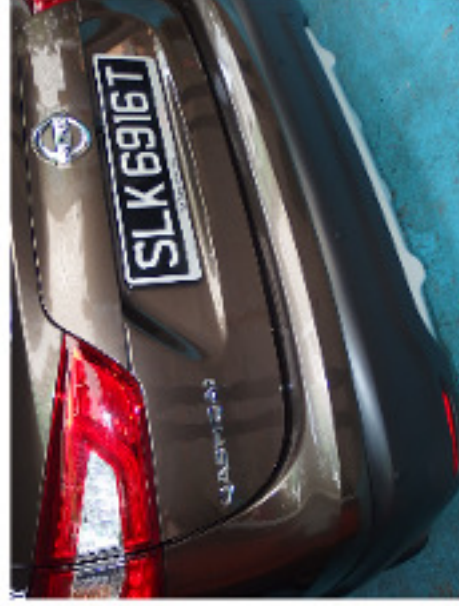
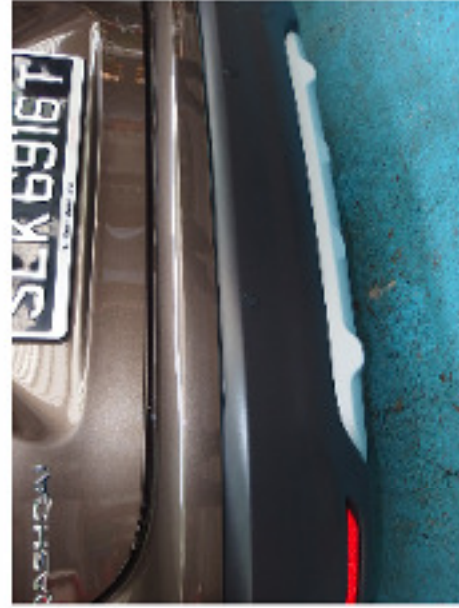
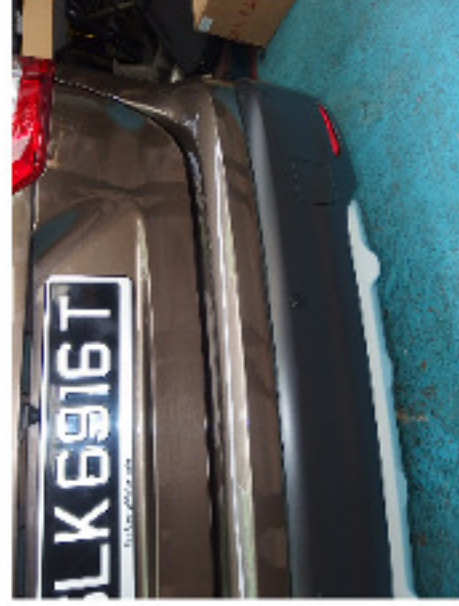
PHOTOGRAPHS FOR VEHICLE NO. SLK 6916T

RE-INSPECTION

THE VEHICLE SUSTAINED DAMAGES AT THE REAR PORTION. DAMAGES SEE DETAILS.
--
