## LKK Auto Consultants Pte Ltd

Vehicle No. SME 5452R  
Insured Veh. GBA 4910T  
Claim No. DM19HO00868-JG  
Policy No. DMCPHQ18-004517  
Accident Date 26/03/2019  
Inspection Date 17/04/2019

## ADJUSTMENT ON REPAIR COST FOR VEHICLE NO. SME 5452R

PHOTOGRAPHS FOR VEHICLE NO. SME 5452R

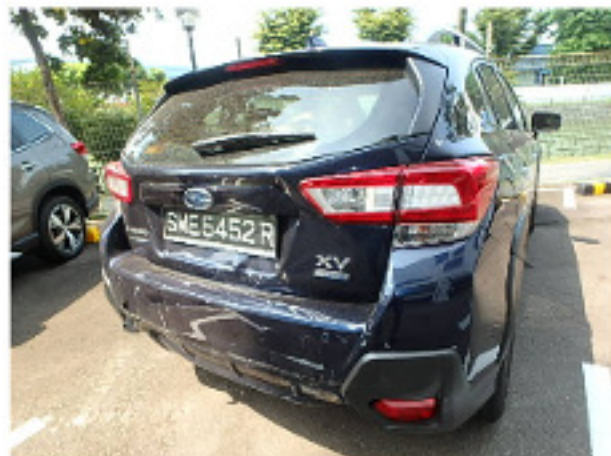
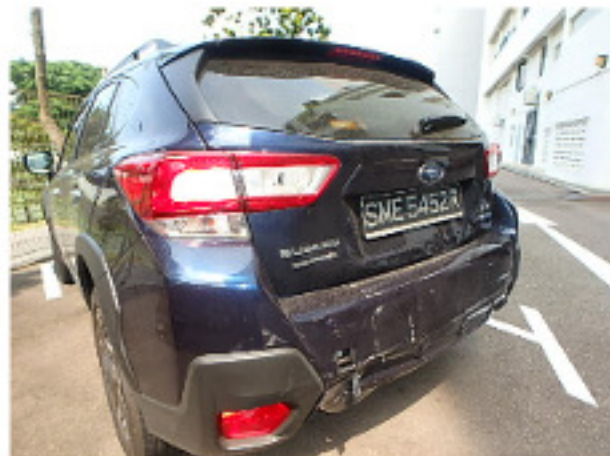
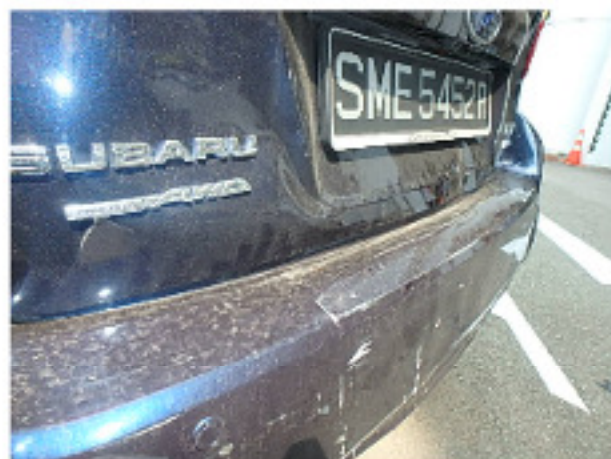
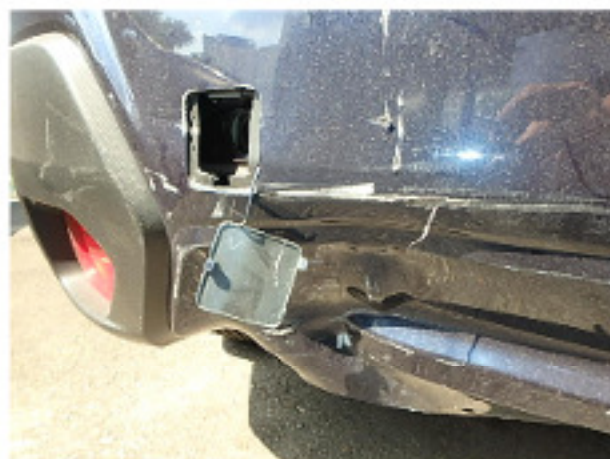
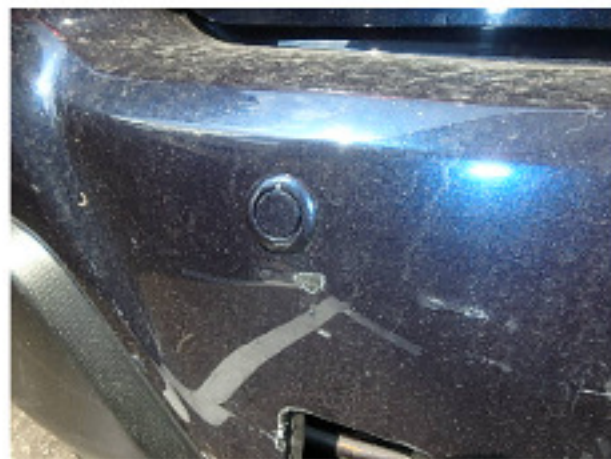
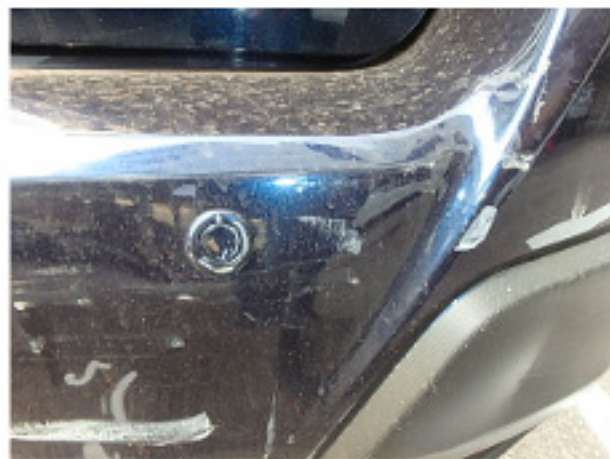
| Affiliated to Federation Internationale Des Experts En Automobile | | | | |
|---|---|---|---|---|
| | THE VEHICLE SUSTAINED DAMAGES AT THE REAR PORTION.<br>DAMAGES SEE DETAILS. | | | |

INSPECTION

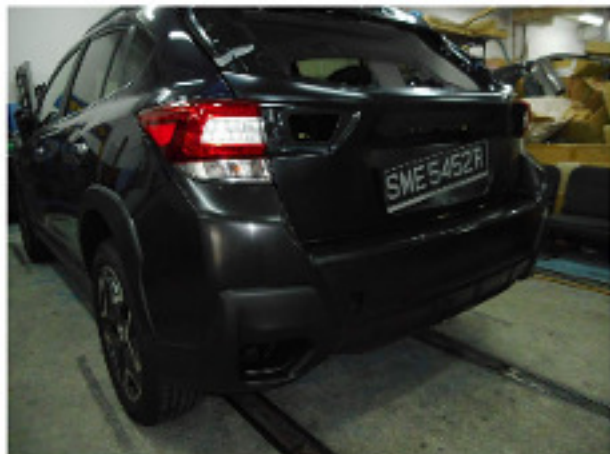
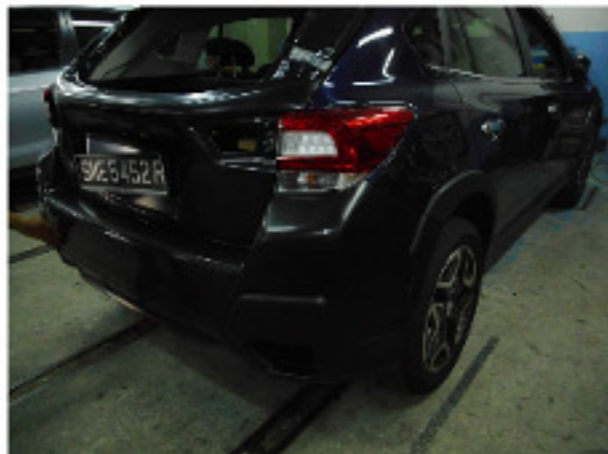
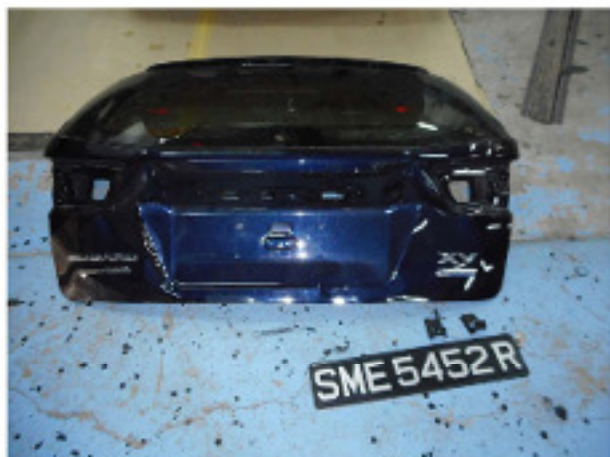
PHOTOGRAPHS FOR VEHICLE NO. SME 5452R

RE-INSPECTION
