LKK Auto Consultants Pte Ltd

ADJUSTMENT ON REPAIR COST FOR VEHICLE NO. GBG 7194S

PHOTOGRAPHS FOR VEHICLE NO. GBG 7194S

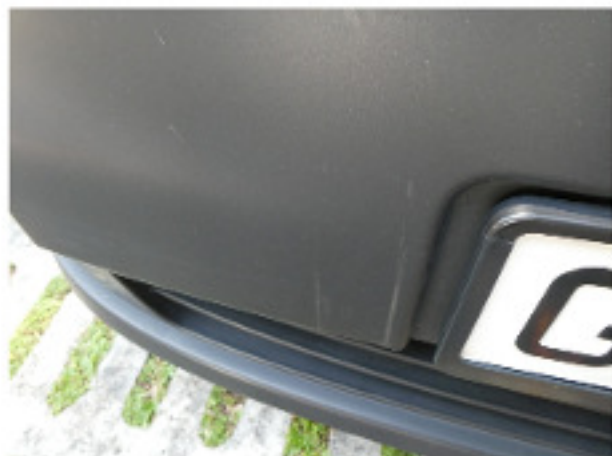
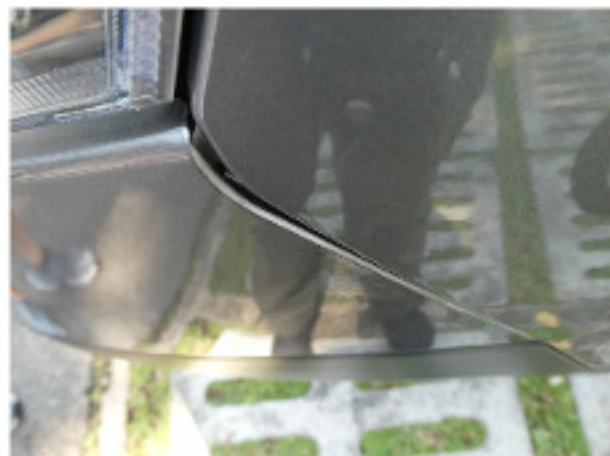
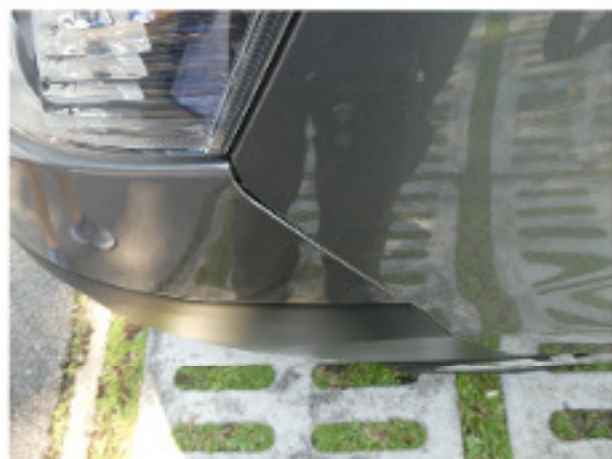
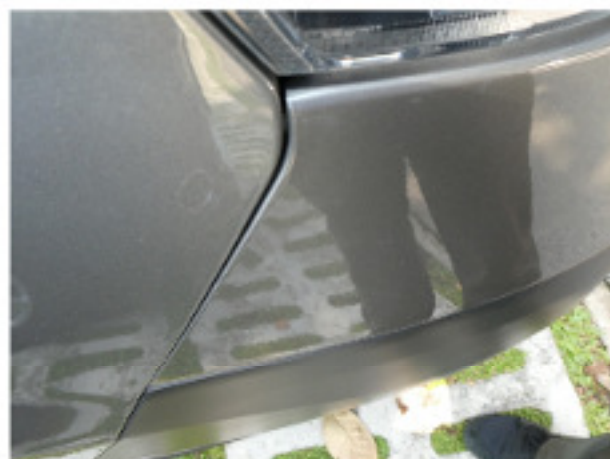
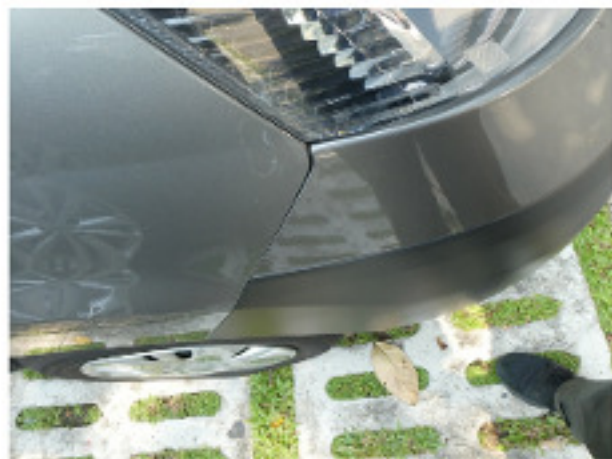
4. Description of Damages				
THE VEHICLE SUSTAINED DAMAGES AT THE FRONT PORTION. DAMAGES SEE DETAILS.				
5. General Information				
Accident Date	02/02/2019	Inspection Date	07/05/2019	
Survey held at	913 BUKIT TIMAH			
Repairer	TAN CHONG MOTOR SALES PTE LTD			
5a. Remarks				
A)THE INSPECTION WAS CONDUCTED ON A"WITHOUT PREJUDICE" BASIS. B)IN ACCORDANCE TO YOUR INSTRUCTIONS, WE HAVE NOT AUTHORISED REPAIRS.				
5b. Estimate Days of Repair				
ESTIMATED NORMAL PERIOD FOR REPAIR:		4 Working Days

Qty	Description of Parts	Condition	Estimate By Workshop (\$))	Our Adjusted (\$)
<u>REPLACEMENT OF PARTS</u>				
1	EMBLEM (N)	NECESSARY	48.50	48.50
1	MALE ASSY - HOOD (N)	NOT NECESSARY	54.30	-
1	HOOD (N)	BENT	1,157.90	1,157.90
1	GUIDE- RH (N)	NOT NECESSARY	37.70	-
1	GUIDE - AIR, FRONT RH (N)	NOT NECESSARY	30.20	-
1	GUIDE - LH (N)	NOT NECESSARY	37.70	-
1	GUIDE - AIR, FRONT (N)	NOT NECESSARY	21.50	-
29	CLIP BUMPER / GRILLE @ \$1.20 (N)	NECESSARY	34.80	34.80
1	MOULDING ASSY U SHAPE RAD GRILLE (N)	NOT NECESSARY	205.50	-
1	GRILLE - RADIATOR (N)	CRACKED	278.10	278.10
1	COVER BRACKET FRT BUMPER TOW (N)	NOT NECESSARY	56.30	-
1	ARMATURE ASSY - F (N)	NOT NECESSARY	1,014.80	-
1	ENERGY ABSORBER (N)	NOT NECESSARY	240.20	-
1	BUMPER - FRONT RH HEADLAMP GARNISH (N)	TO REPAIR SEE LABOUR	329.30	-
1	BUMPER - FRONT LH HEADLAMP GARNISH (N)	TO REPAIR SEE LABOUR	329.30	-
1	BRKT - BPR SIDE, R (N)	NOT NECESSARY	20.90	-
1	BRKT - BPR SIDE, L (N)	NOT NECESSARY	20.90	-

1	FASCIA FRT (N)	CUT	682.10	682.10
1	RH HEADLAMP (N)	CRACKED	625.80	625.80
1	LAMP HEADLAMP LH (N)	CRACKED	625.80	625.80
	LESS 20% DISCOUNT		-1,170.32	-690.60
			4,681.28	2,762.40
<u>SPECIAL NETT ITEMS</u>				
2	CLIP GRILLE @ \$5.70 (SN)	NECESSARY	11.40	11.40
1	SUNDRIES (SN)	NECESSARY	100.00	20.00
1	FRT LICENCE PLATE (SMART PLATE WITH CASING) LONG (SN)	DENTED	60.00	60.00
