LKK Auto Consultants Pte Ltd

ADJUSTMENT ON REPAIR COST FOR VEHICLE NO. SHC 5600A

PHOTOGRAPHS FOR VEHICLE NO. SHC 5600A

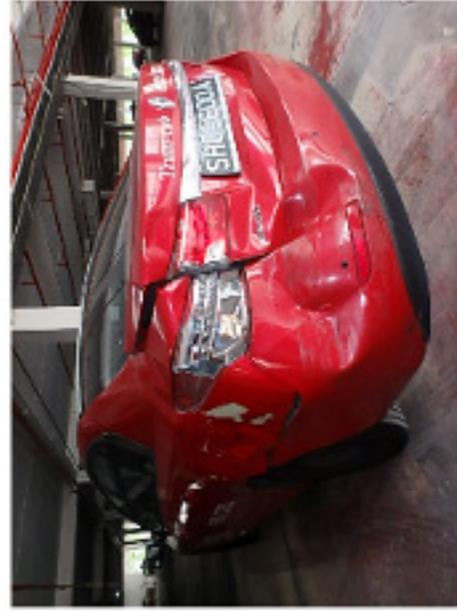
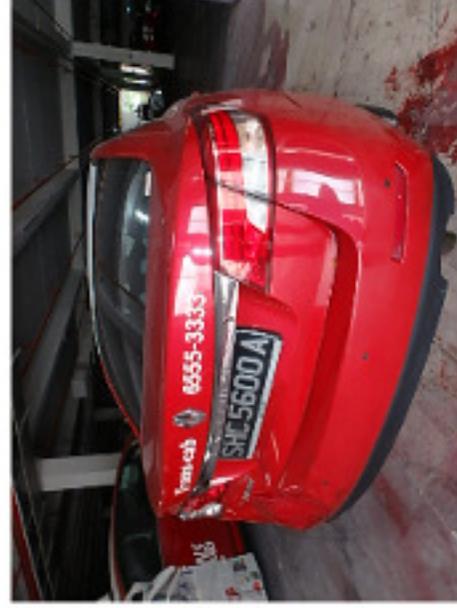
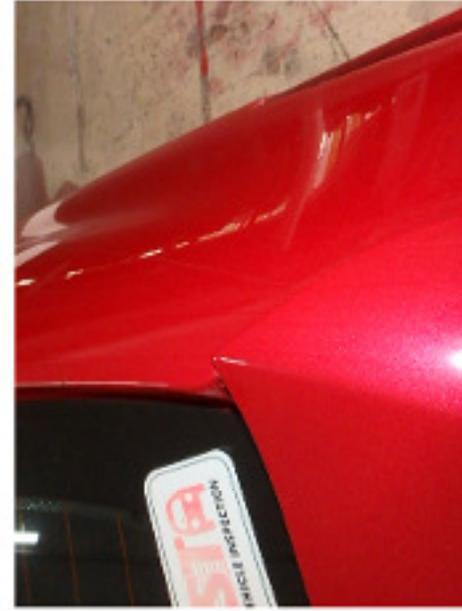
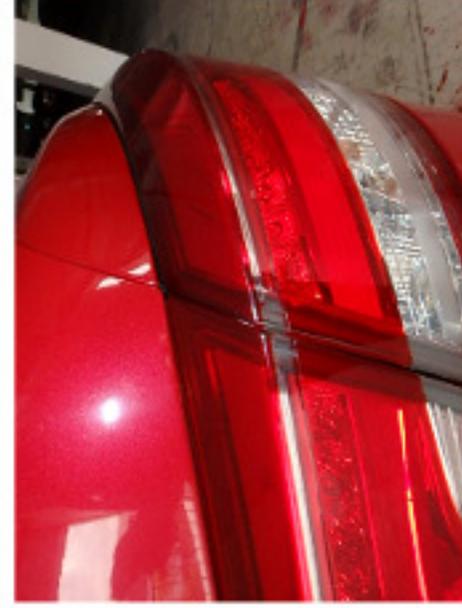
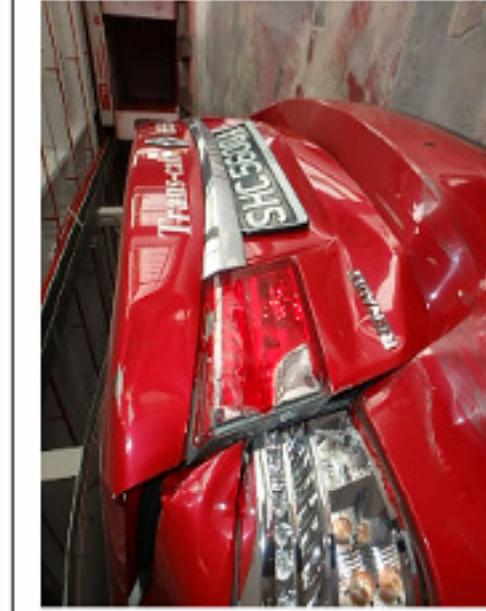
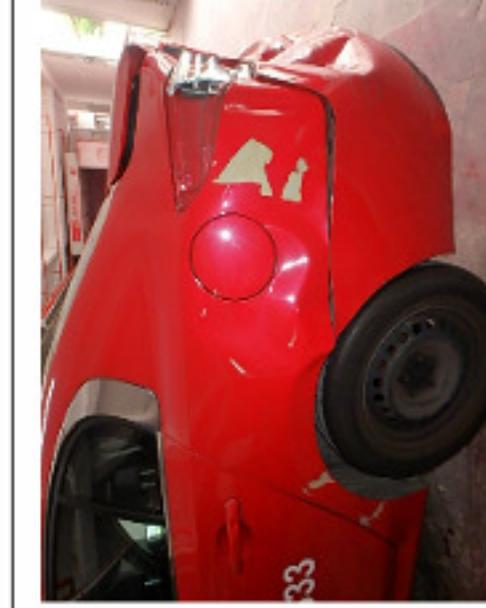
THE VEHICLE SUSTAINED DAMAGES AT THE REAR N/S PORTION. DAMAGES SEE DETAILS.
--	--

INSPECTION
