REF: CS/MKG 1900 94991 K&L352

To Inspect Vehicle No: SLK 366 L

Claim No: 594572

Manufacturer	TOYOTA
Model	PRIUS HYBRID 1.8 CVT
Exact Purpose for which vehicle was being used at time of accident	HIRE AND REWARD
Are you claiming under your own insurance policy for repair to your vehicle?	NO
If No, Please state action to be taken	THIRD PARTY
Vehicle Category	PRIVATE HIRE

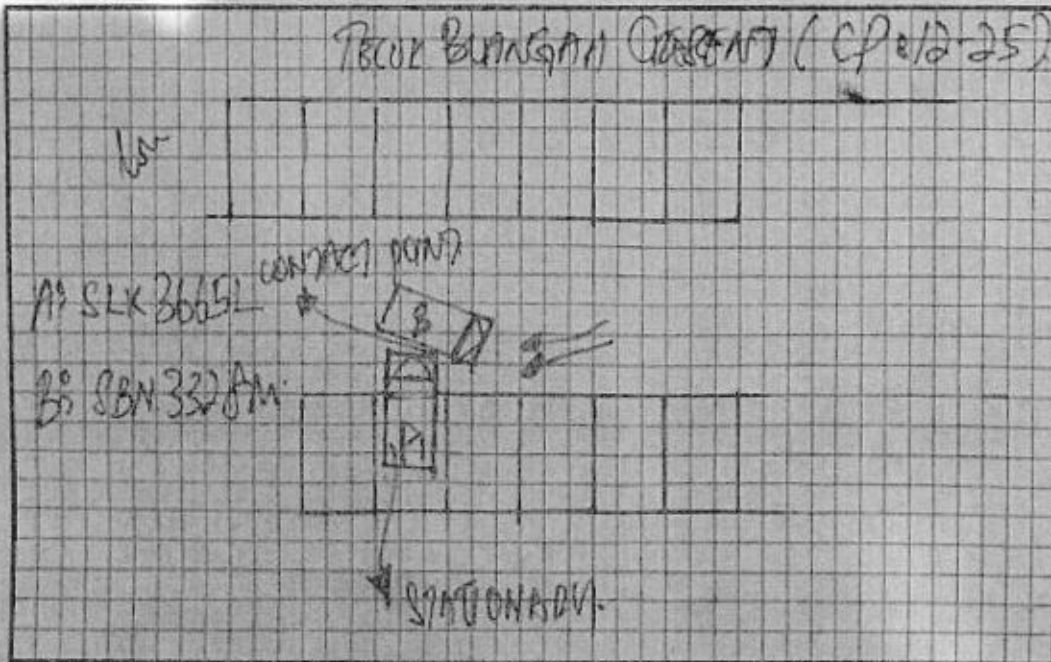
Sketch Plan

ON THE DATE AND TIME MENTIONED I HAD PARKED MY VEHICLE AT THE SAID MENTIONED CARPARK. AS I WAS ABOUT TO DRIVE OUT OF THE CARPARK LOT, I WAS VEHICLE B COMING FROM MY LEFT AND GAVE WAY TO HIM. SEEING VEHICLE B DROVE PASSED MY VEHICLE , I INCHED SLOWLY. THAT WAS WHEN I SAW VEHICLE B MADE A STOP. AND SUDDENLY MADE A REVERSED MOVE TOWARDS MY DIRECTION. SEEING THAT I STOPPED MY VEHICLE AND WHEN I SAW VEHICLE B KEPT ON REVERSING, I HONKED AT THE DRIVER FEW TIMES BUT VEHICLE KEPT ON COMING TOWARDS MY STATIONARY VEHICLE AND HIT THE FRONT RIGHT PORTION OF MY VEHICLE. THIS INCIDENT WAS CAPTURED IN A IN CAR VIDEO OF VEHICLE NO. SMG1881B, WHO AS AT THE SCENE AND WHO HAD FORWARDED THE FOOTAGE TO ME. NO ONE WAS INJURED, STATEMENT WAS READ TO ME AND I ACKNOWLEDGED IT.

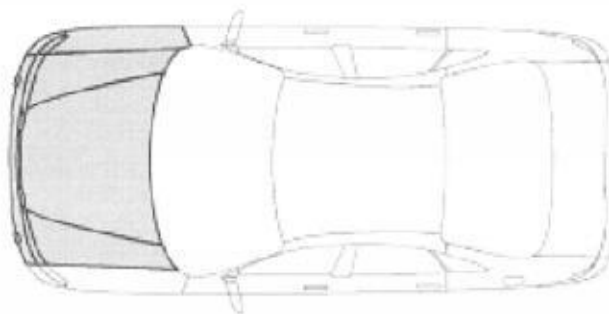
Damage Areas

The vehicle sustained impact / damages o/s front portion and parts claimed are consistent to the accident.
