LKK Auto Consultants Pte Ltd

ADJUSTMENT ON REPAIR COST FOR VEHICLE NO. SLV 3146K

PHOTOGRAPHS FOR VEHICLE NO. SLV 3146K

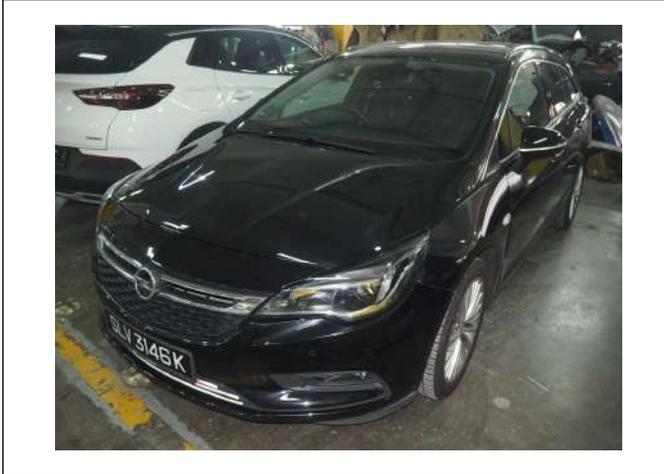
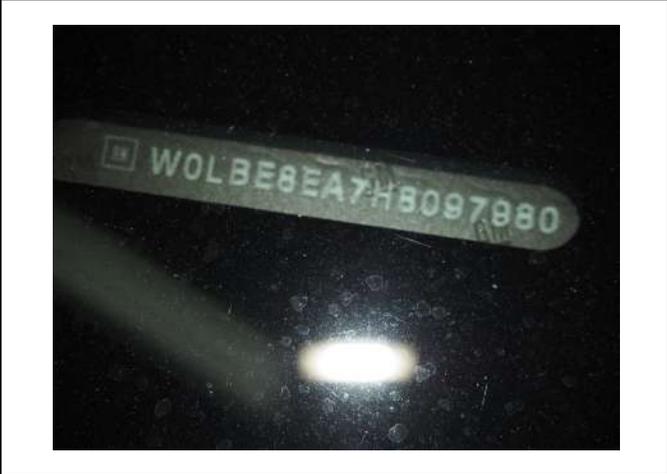
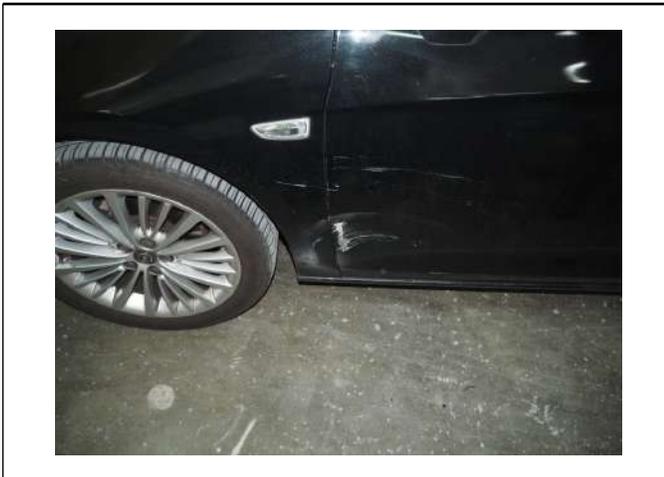
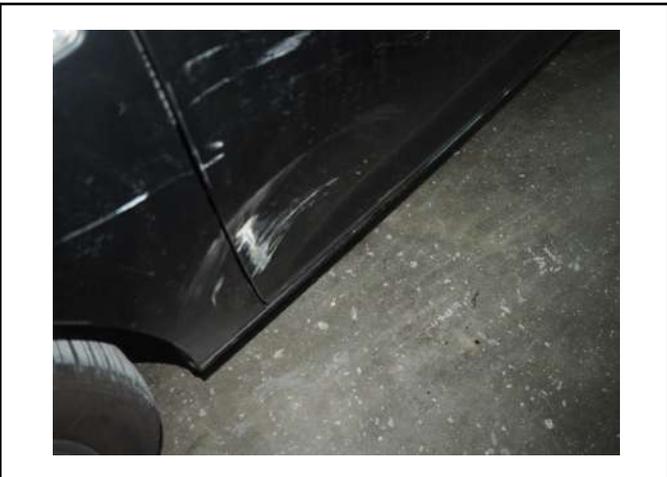
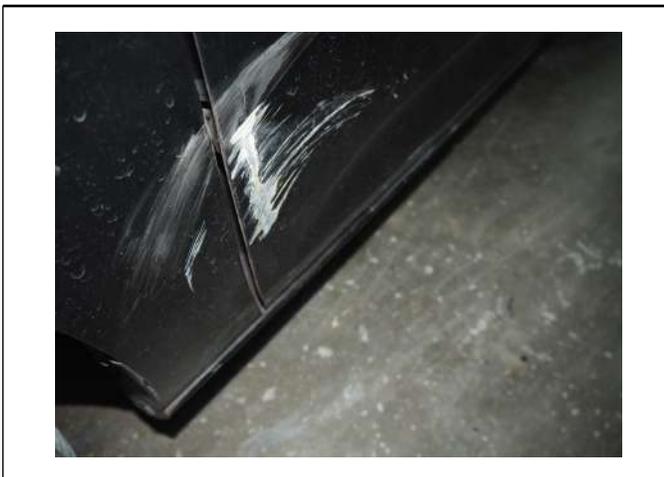
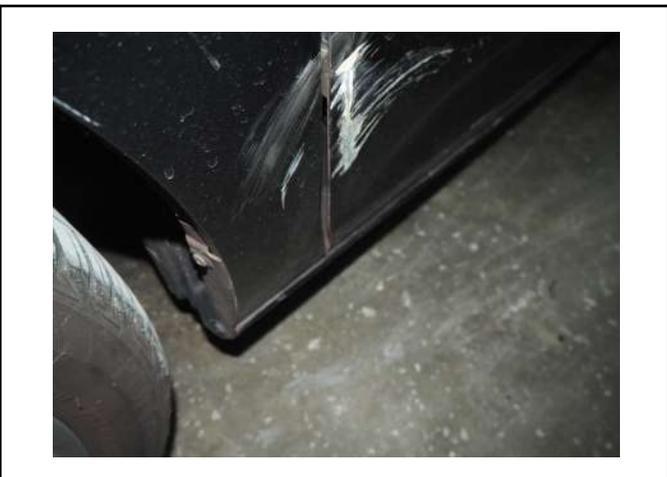
4. Description of Damages			
THE VEHICLE SUSTAINED DAMAGES AT THE N/S BODY. DAMAGES SEE DETAILS.			
5. General Information			
Accident Date	27/06/2019	Inspection Date	01/07/2019
Survey held at	XIN HUA WORKSHOP PTE LTD 23 KAKI BUKIT AVENUE 4 #04-01 (SOUTH WING) SINGAPORE 415933		
5a. Remarks			
A)THE INSPECTION WAS CONDUCTED ON A"WITHOUT PREJUDICE" BASIS. B)IN ACCORDANCE TO YOUR INSTRUCTIONS, WE HAVE NOT AUTHORISED REPAIRS.			
5b. Estimate Days of Repair			
ESTIMATED NORMAL PERIOD FOR REPAIR:		5 Working Days

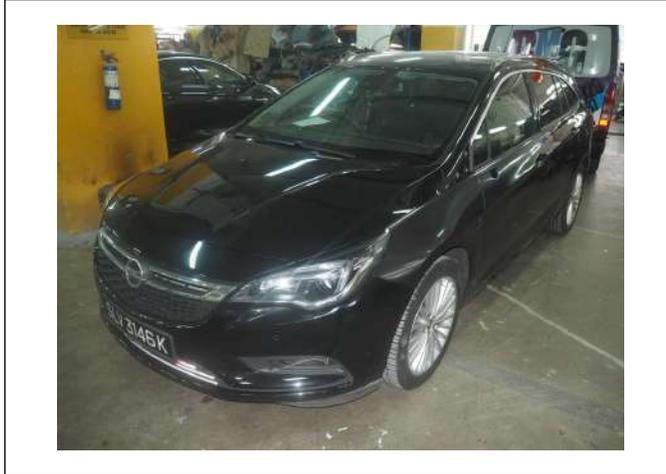
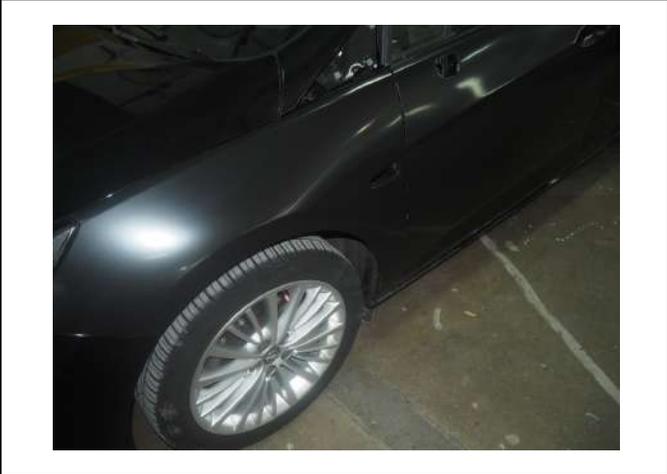
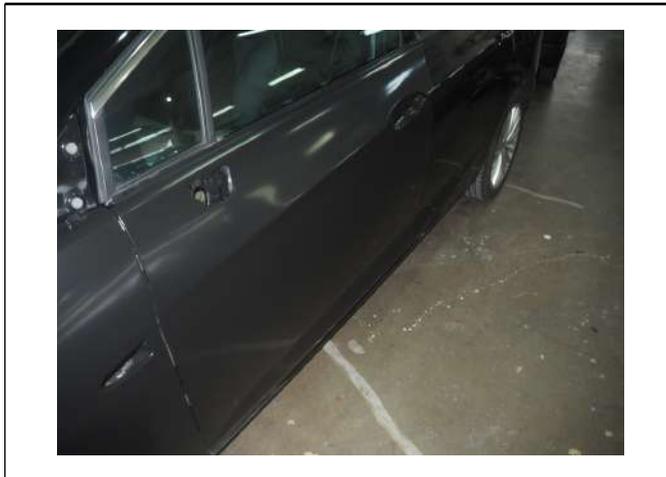
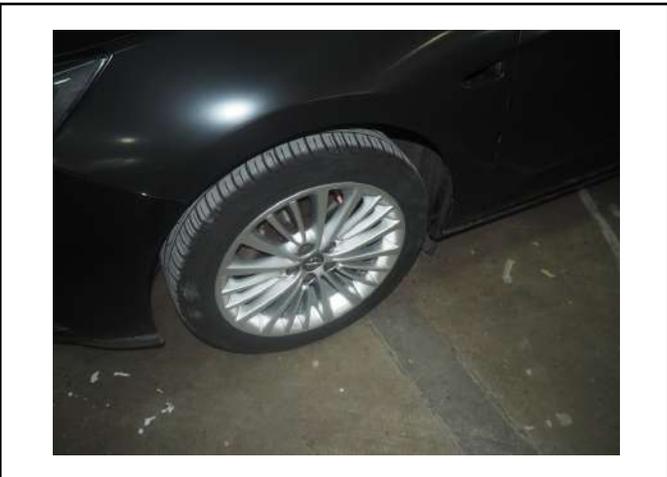
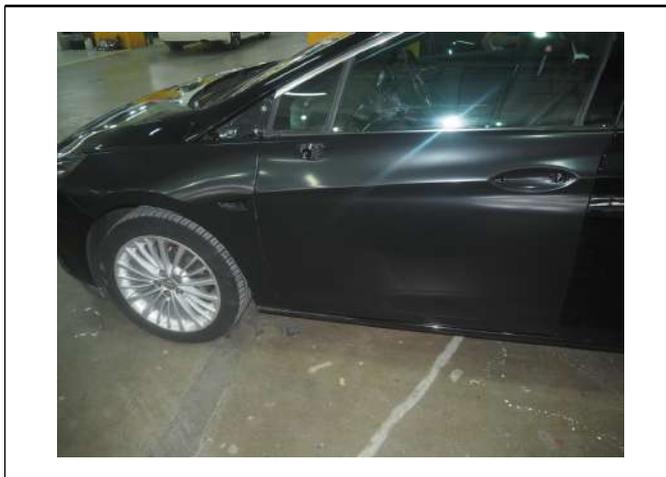
RE-INSPECTION

PHOTOGRAPHS FOR VEHICLE NO. SLV 3146K
