1.		Policy Particulars	:- THIRD PARTY CLAIM			
	Insured Veh.	XE 3606Y	Veh. Inspected	SHC 8896T		
	Policy No.	DMCVSN1764071801	Coverage (\$)	0.00		
	Claim No.	SNM19D203109	Excess (\$)	0.00		
	Assign From		Assign Date	03/07/2019

ADJUSTMENT ON REPAIR COST FOR VEHICLE NO. SHC 8896T

PHOTOGRAPHS FOR VEHICLE NO. SHC 8896T

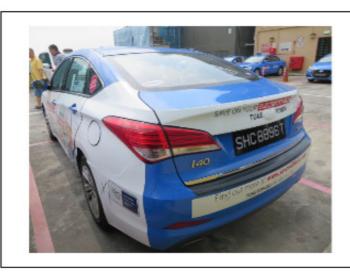
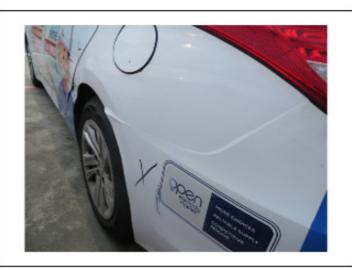
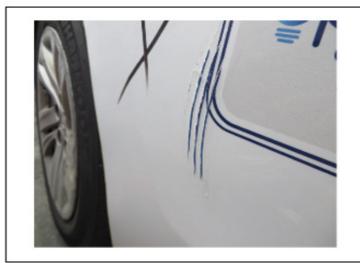
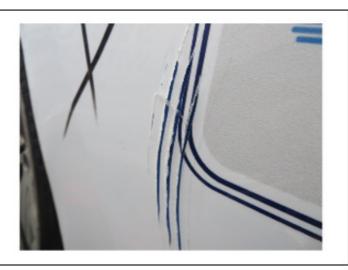
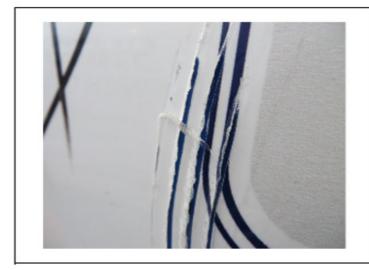
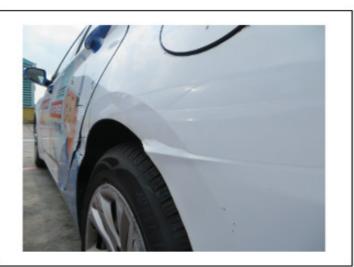
4.		•	on of Damages			
	THE VEHICLE SU	STAINED DAMAGES AT THE N/S	REAR PORTION.			
	DAMAGES SEE D					
5.		General	Information			
	Accident Date	02/07/2019	Inspection Date	03/07/2019		
	Survey held at	COMFORTDELGRO ENGINEER	RING PTE LTD			
		59 LOYANG DRIVE SINGAPORE 508969				
5a.		Re	emarks			
	A)THE INSPECTION WAS CONDUCTED ON A"WITHOUT PREJUDICE" BASIS. B)IN ACCORDANCE TO YOUR INSTRUCTIONS, WE HAVE NOT AUTHORISED REPAIRS.					
5b.	Estimate Days of Repair					
	ESTIMATED NOR	MAL PERIOD FOR REPAIR:	3 Working Days

Qty	Description of Parts	Condition	Estimate By Workshop (\$))	Our Adjusted (\$)
	REPLACEMENT OF PARTS			
1	REAR FENDER -LH	TO REPAIR SEE LABOUR	2,020.10	-
1	REAR WHEEL COVER -LH	GRAZED	107.10	107.10
1	REAR WHEEL RIM -LH	SERVICEABLE	325.30	-
1	REAR BUMPER	TO REPAIR SEE LABOUR	553.00	-
10	REAR BUMPER CLIPS @\$2.20	NOT NECESSARY	22.00	-
1	REAR DOOR -LH	BUCKLED	1,351.10	1,351.10
1	ROCKER COVER GARNISH -LH	TO REPAIR SEE LABOUR	341.40	-
	LESS 20% DISCOUNT		-944.00	-291.64
			3,776.00	1,166.56
	SPECIAL NETT ITEMS			
1	ADVERTISEMENT-LHR DOOR (SN)	NECESSARY	100.00	100.00
1	ADVERTISEMENT-LHR FENDER (SN)	NECESSARY	100.00	100.00
1	LHR DOOR APP STICKER (SN)	NECESSARY	80.00	80.00

280.00	280.00
	<u>LABOUR</u>			
	PANEL BEATING.INCLUSIVE OF THE REPAIR OF REAR FENDER -LH ,REAR BUMPER AND ROCKER COVER GARNISH -LH.		750.00	400.00
	SPRAY PAINTING CHARGE.		800.00	600.00
	WIRING CHARGE.	NOT NECESSARY	50.00	-
	REMOVE/REFIX REVERSE SENSOR .	NOT NECESSARY	100.00	-
	TUFF KOTE.		80.00	30.00

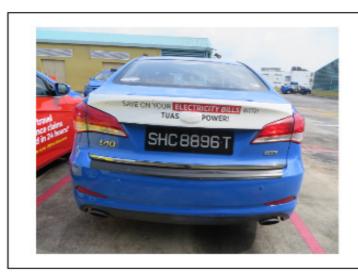
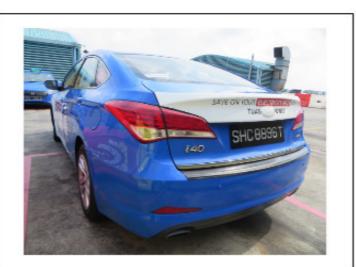
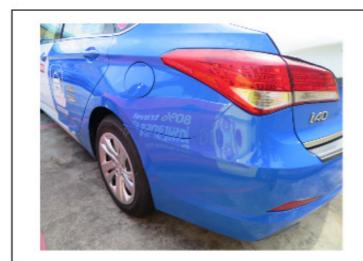
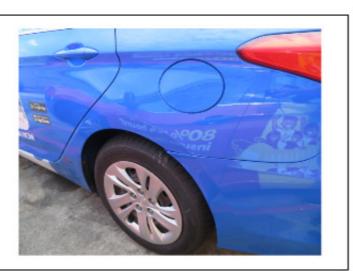
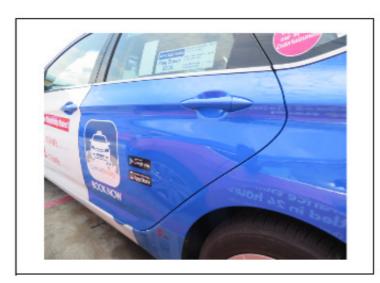
RE-INSPECTION

PHOTOGRAPHS FOR VEHICLE NO. SHC 8896T
