PROFESSIONAL SERVICE FEE

Vehicle No. SHC 5774G
Insured Veh. SKK 7099G
Claim No. SNM19D203143
Policy No. DMHCSN3069831800
Accident Date 03/07/2019
Inspection Date 08/07/2019

ADJUSTMENT ON REPAIR COST FOR VEHICLE NO. SHC 5774G

PHOTOGRAPHS FOR VEHICLE NO. SHC 5774G

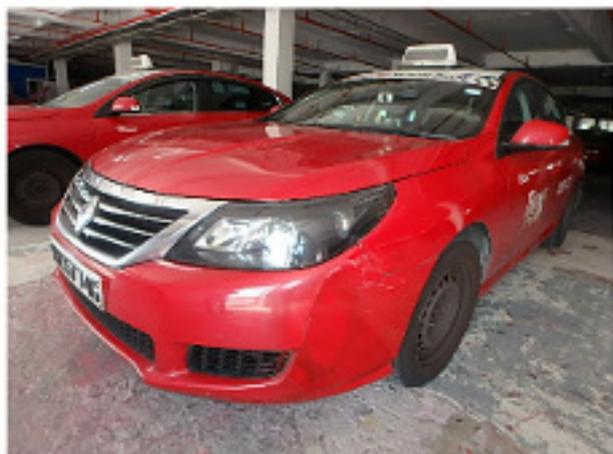
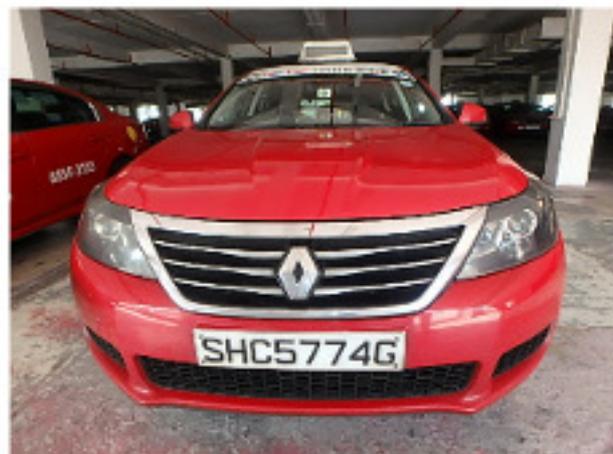
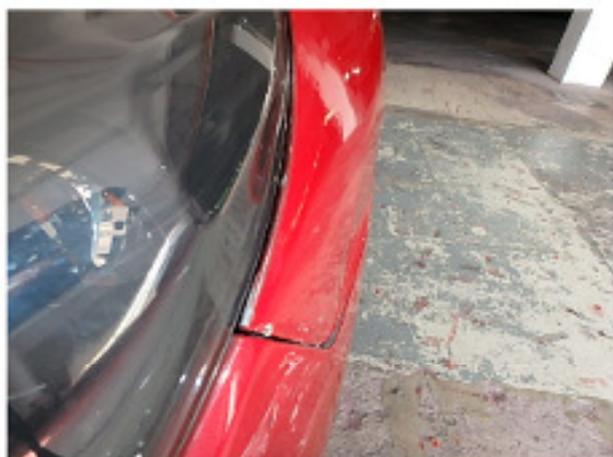
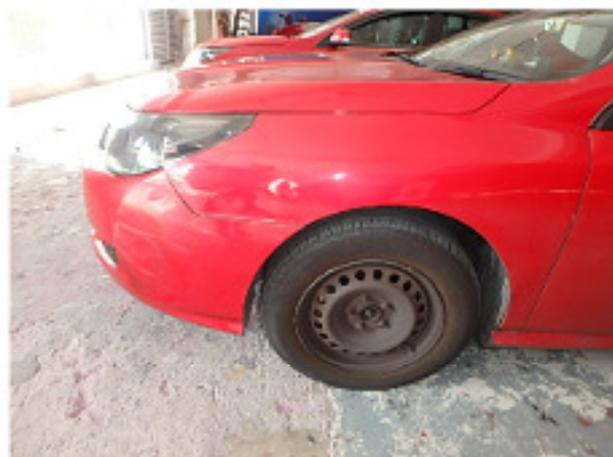
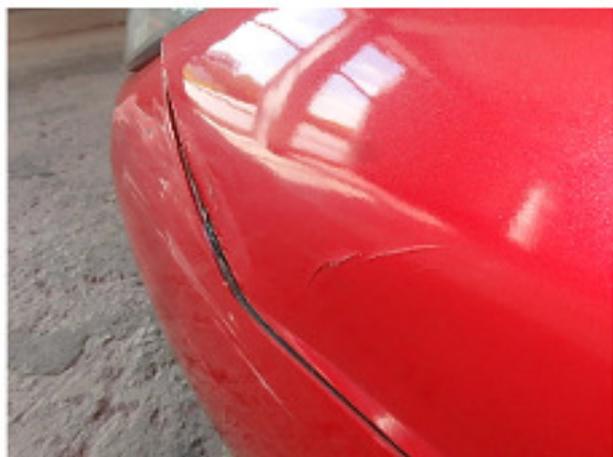
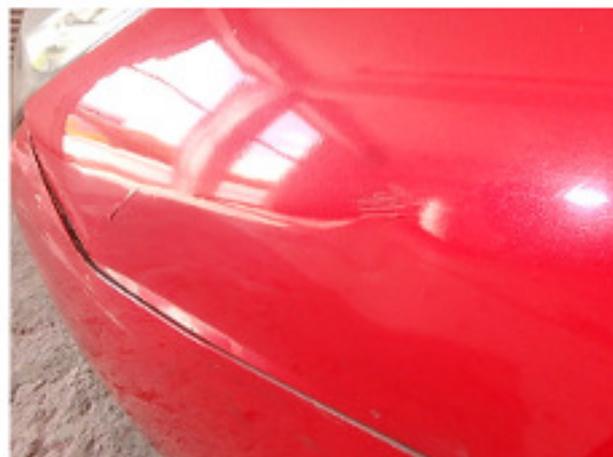
THE VEHICLE SUSTAINED DAMAGES AT THE N/S FRONT PORTION.
DAMAGES SEE DETAILS.

INSPECTION
