ASSIGNMENT (Office)

To Inspect Vehicle No: SCP 8890A Insured: SLZ 87202 - Toyota  
at Workshop m/s T & S moto Tel: 64845518 - Pirus Plus

Remark: The veh had commenced its repair at the time of inspection.

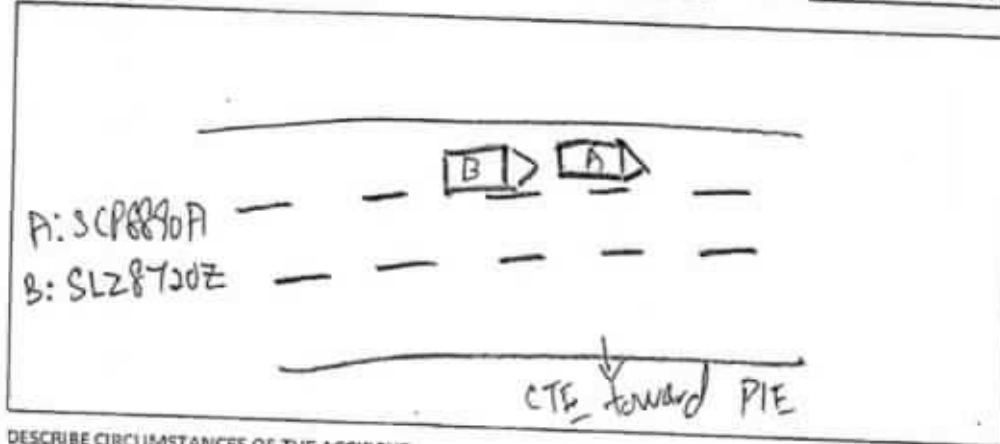
Sketch Plan Pg. 2

Date of accident: 9/4/2019 Time: 5.00pm Location: Along CTE towards PIE /  
 My Vehicle A: SCP8890A Vehicle B: SLZ8720Z Vehicle C: UPP Serangoon  
 SKETCH PLAN Exit

On 9 April 2019 5pm I was driving along CTE towards upper serangoon/PIE exit. It was raining heavily. Visibility was poor. Traffic was slow and congested. Suddenly the car in front of me braked to stop. I braked as well to avoid running into the car in front. But the car behind me SLZ8720Z crashed into my car with a loud bang. We moved to the side of the road to avoid blocking traffic on the highway.
