DAMAGE ASSESSMENT REPORT

ADJUSTMENT ON REPAIR COST FOR VEHICLE NO. SMC 7382G

PHOTOGRAPHS FOR VEHICLE NO. SMC 7382G

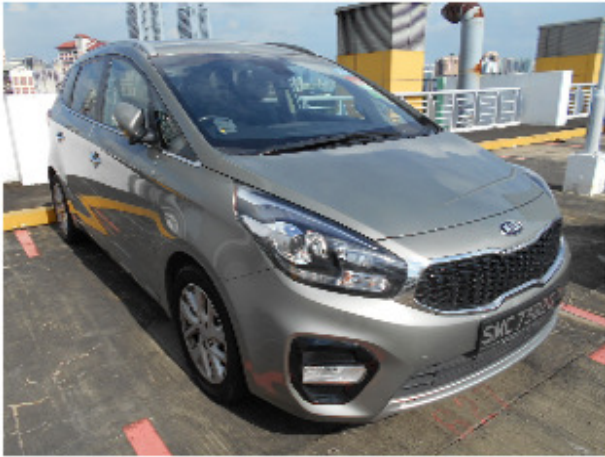
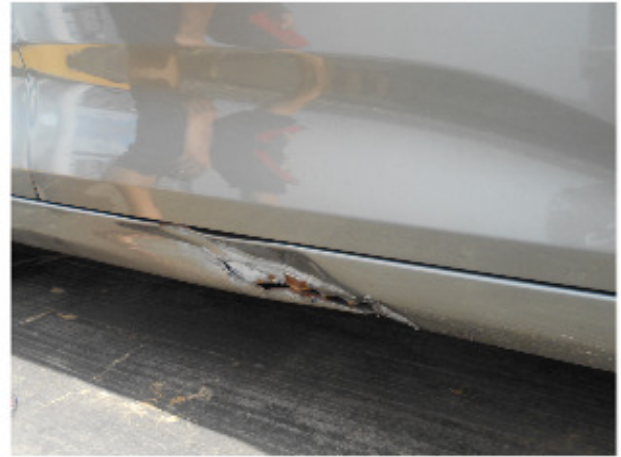
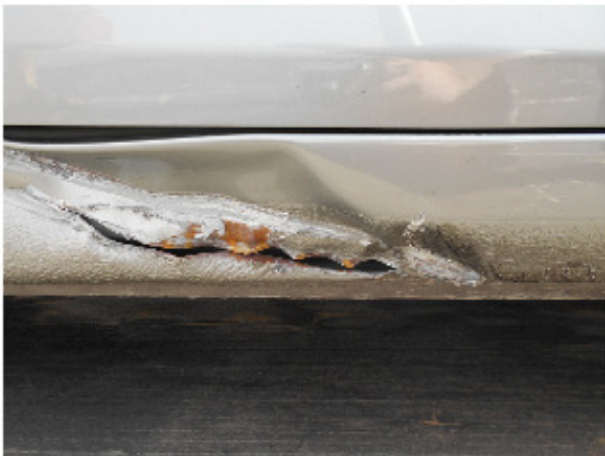
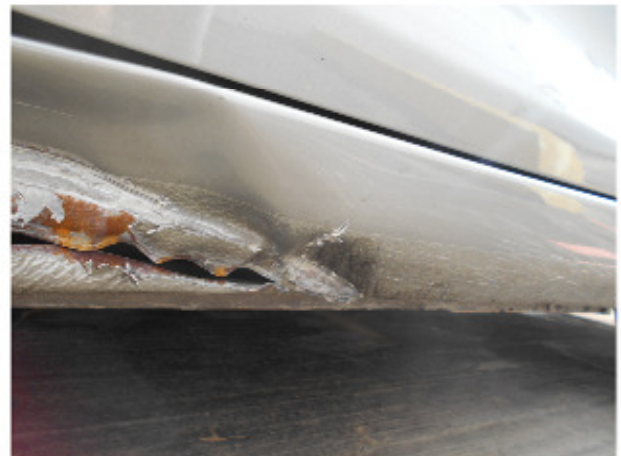
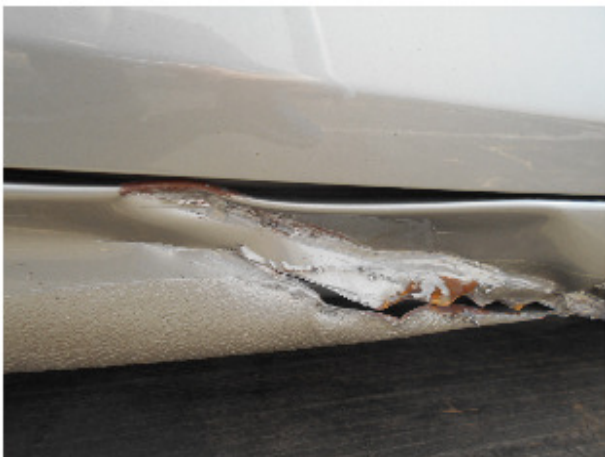
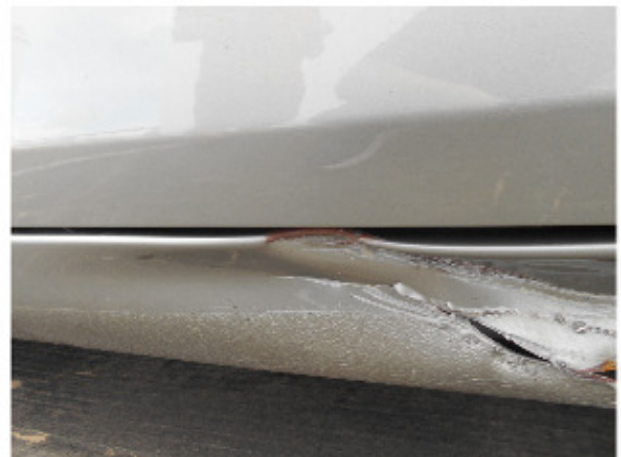
INSPECTION

THE VEHICLE SUSTAINED DAMAGES AT THE O/S BODY. DAMAGES SEE DETAILS.
--

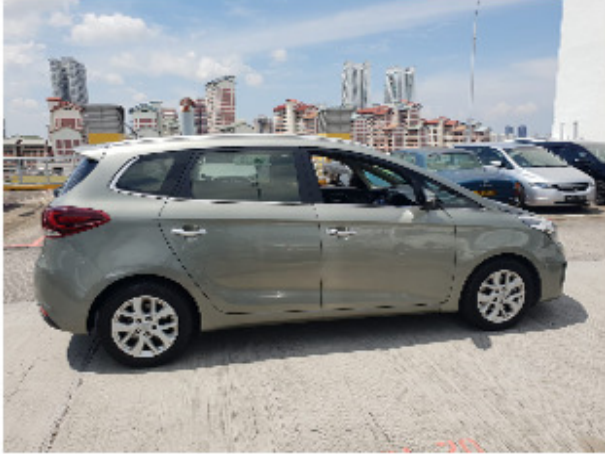
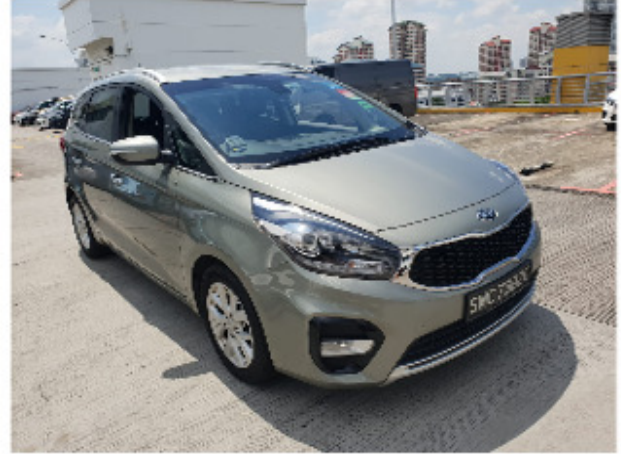
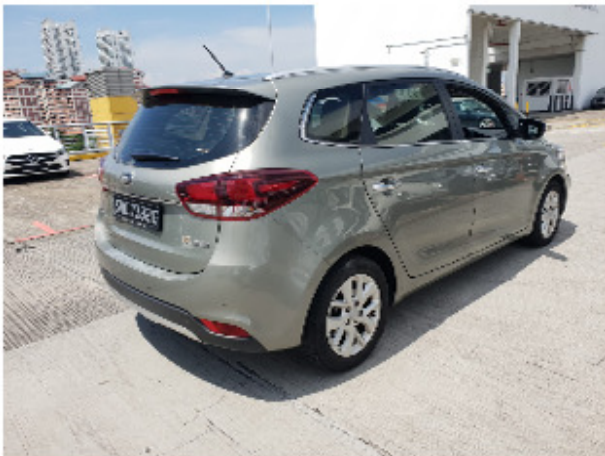
RE-INSPECTION

PHOTOGRAPHS FOR VEHICLE NO. SMC 7382G
