To Inspect Vehicle No: SHA 8925 Insured: SBV 707E

Type Of Accident CHAIN COLLISION
 Weather Conditions CLEAR
 Road Surface DRY

VEHICLE DAMAGE INSPECTION REPORT

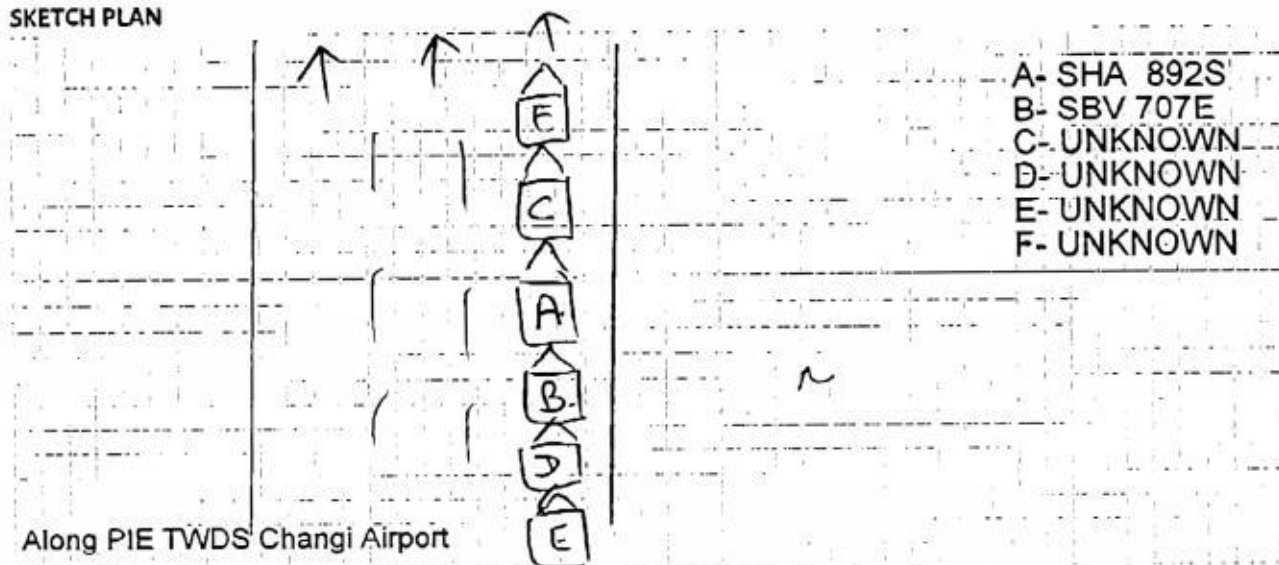
SKETCH PLAN

On 01.09.2019 @ 1930hrs I was travelling along PIE twds Changi Aiport with one female passenger onboard.

As veh(C) slowed down and I followed suddenly I felt an impact from my rear portion from veh(B) SBV 707E and caused my vehicle to surge forward.
