## LKK Auto Consultants Pte Ltd

### ADJUSTMENT ON REPAIR COST FOR VEHICLE NO. SJE 5611J

PHOTOGRAPHS FOR VEHICLE NO. SJE 5611J

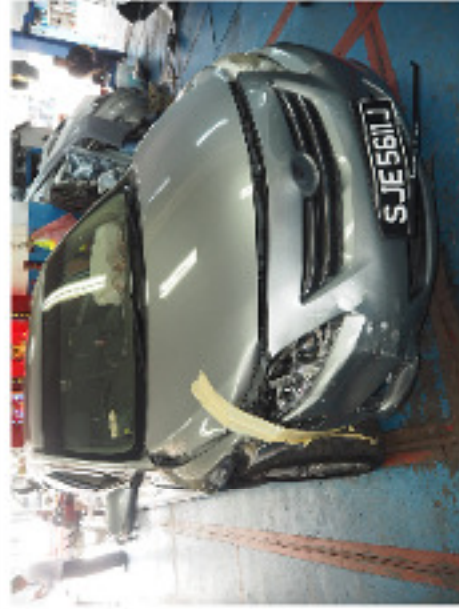
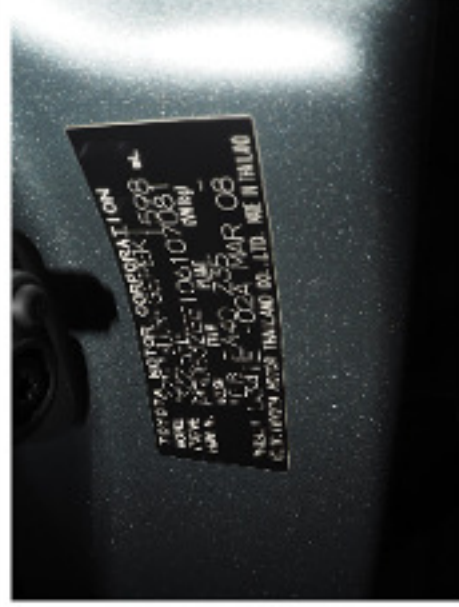
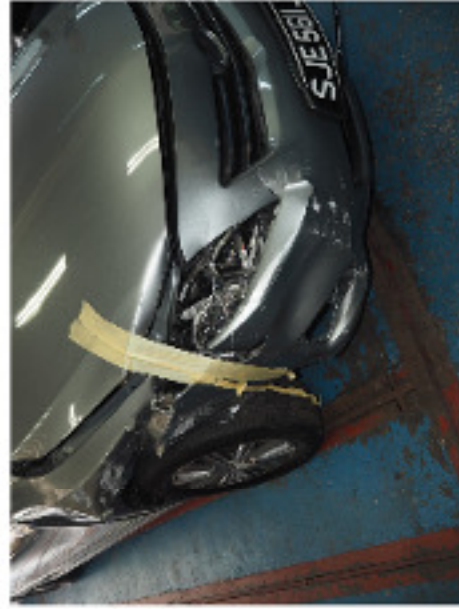
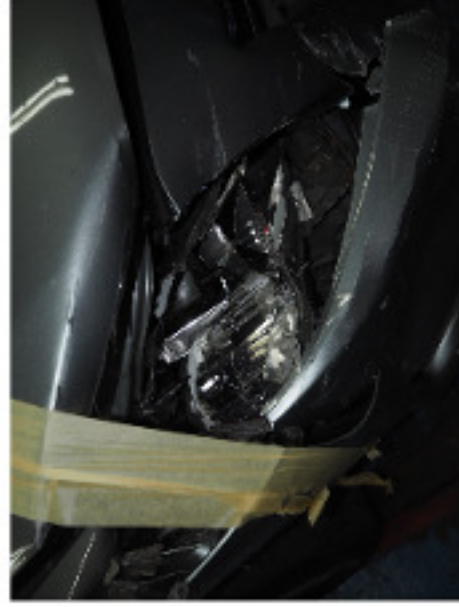
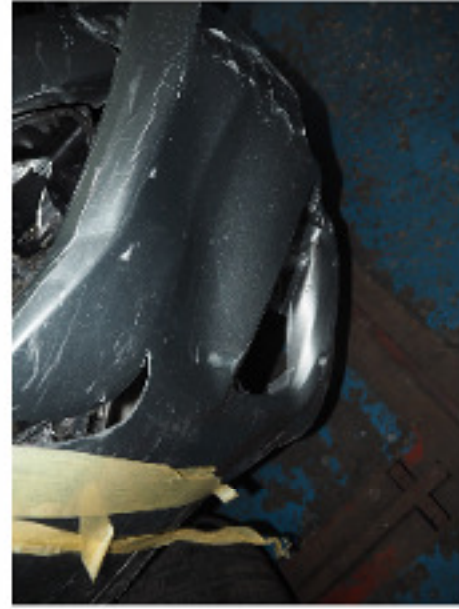
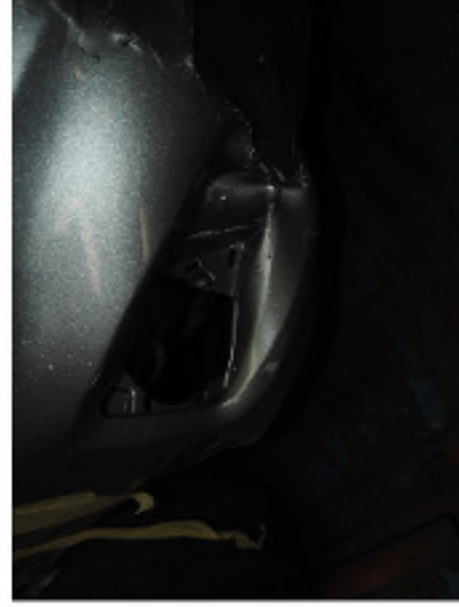
INSPECTION

| THE VEHICLE SUSTAINED DAMAGES AT THE FRONT PORTION.<br>DAMAGES SEE DETAILS. |
