LKK Auto Consultants Pte Ltd

TAX INVOICE

ADJUSTMENT ON REPAIR COST FOR VEHICLE NO. SKV 6203X

PHOTOGRAPHS FOR VEHICLE NO. SKV 6203X

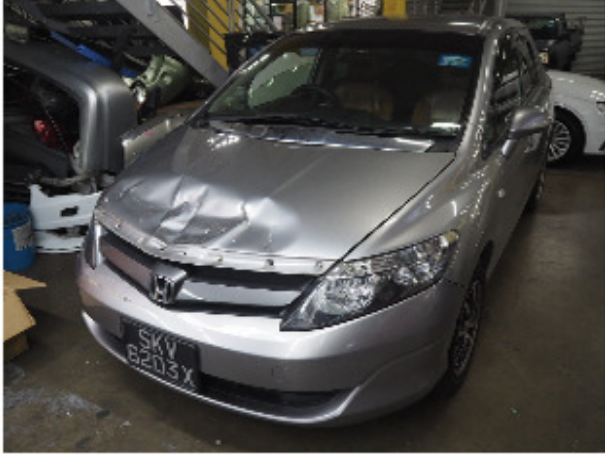
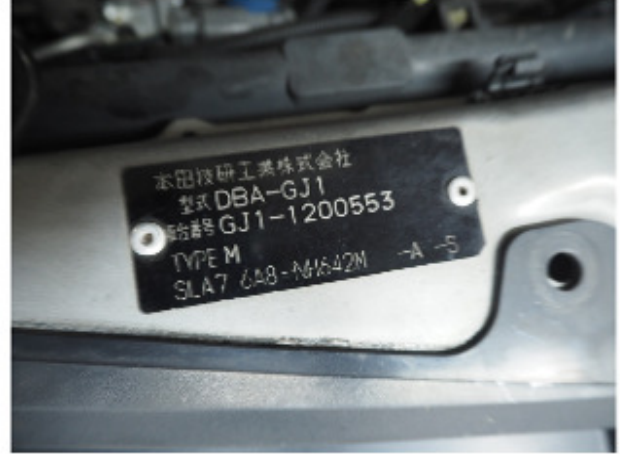
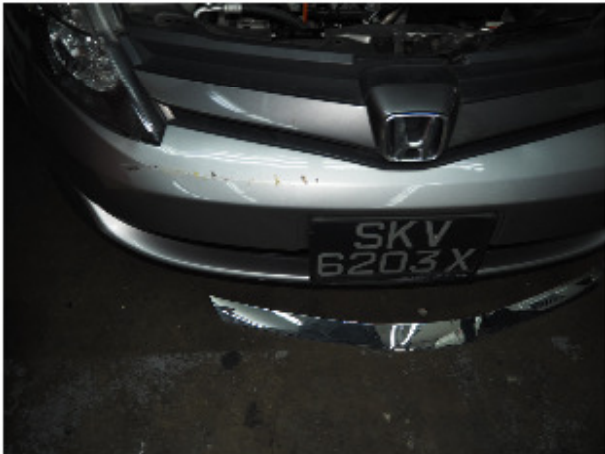
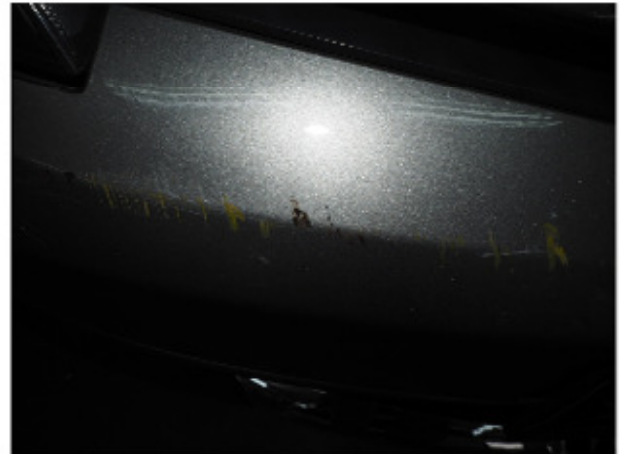
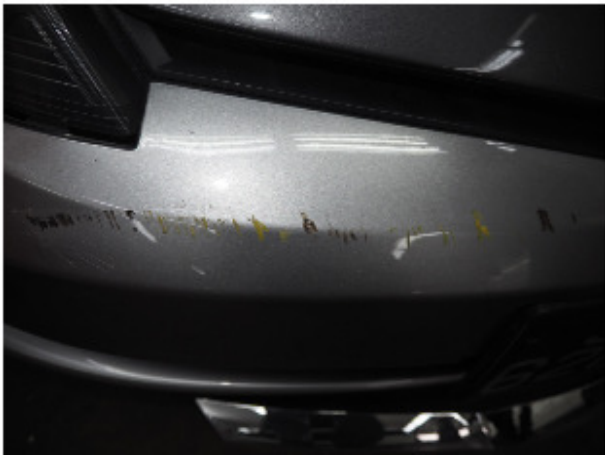
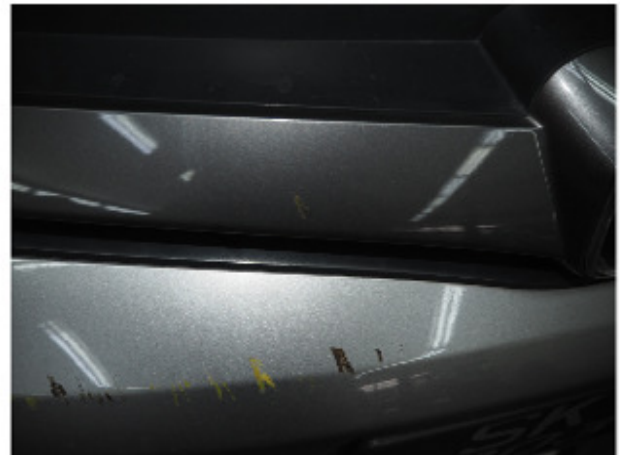
INSPECTION

THE VEHICLE SUSTAINED DAMAGES AT THE FRONT PORTION. DAMAGES SEE DETAILS.

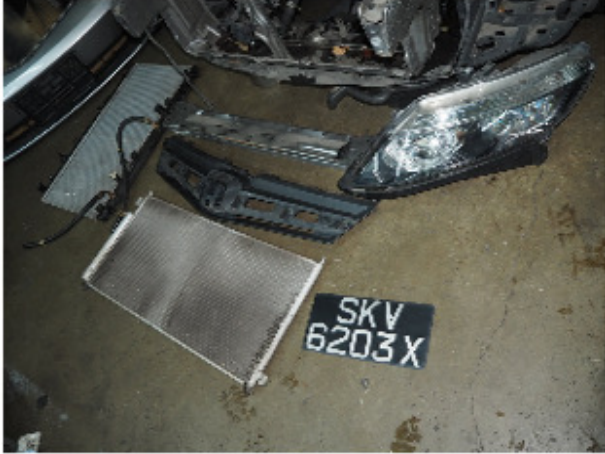
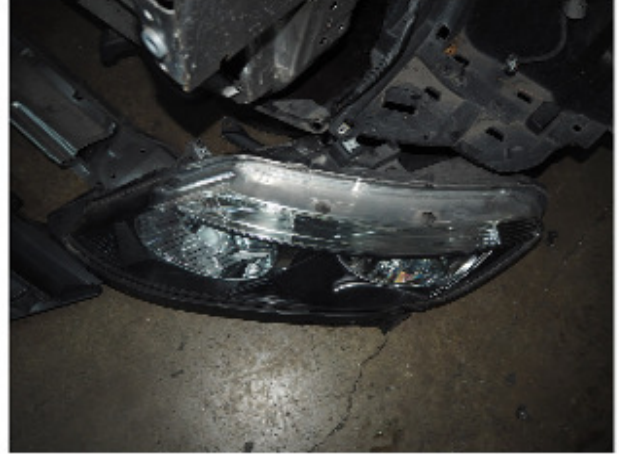
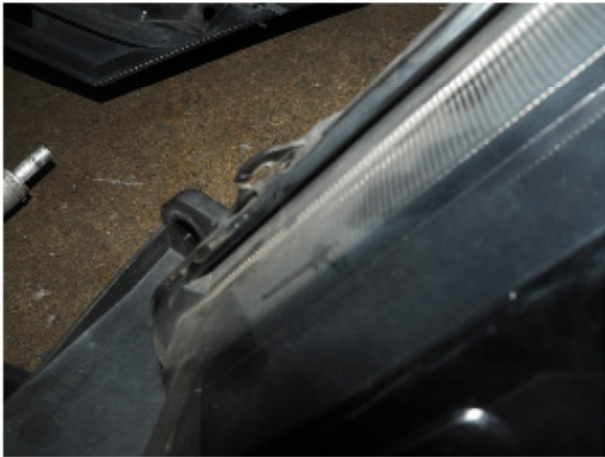
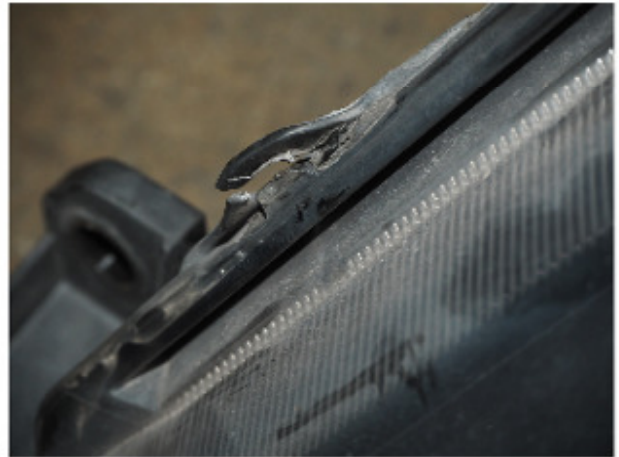
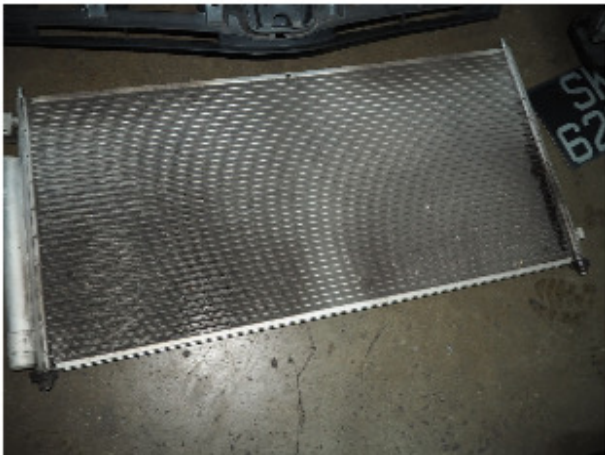
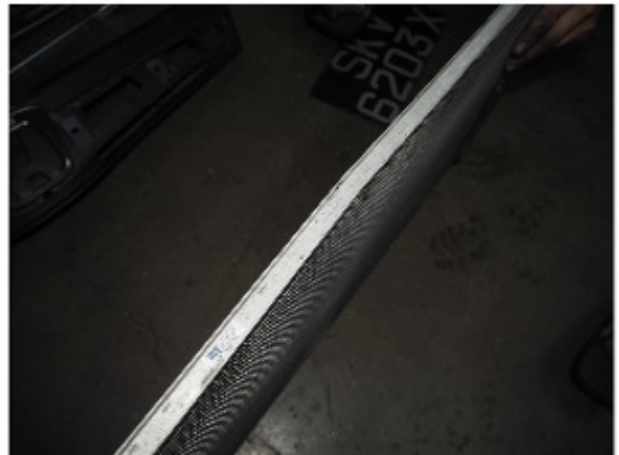
RE-INSPECTION

PHOTOGRAPHS FOR VEHICLE NO. SKV 6203X
