## LKK Auto Consultants Pte Ltd

## ADJUSTMENT ON REPAIR COST FOR VEHICLE NO. SJK 6106M

PHOTOGRAPHS FOR VEHICLE NO. SJK 6106M

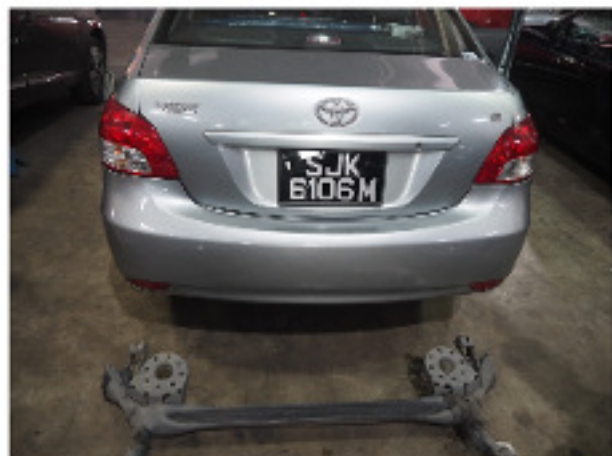
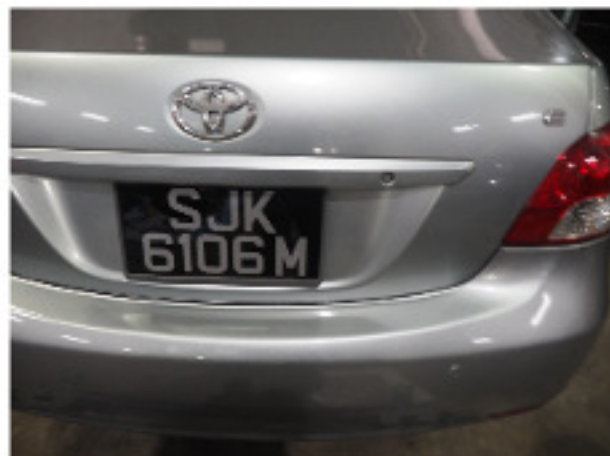
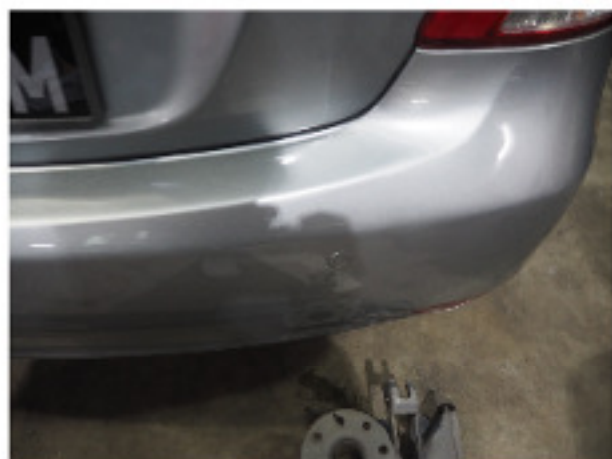
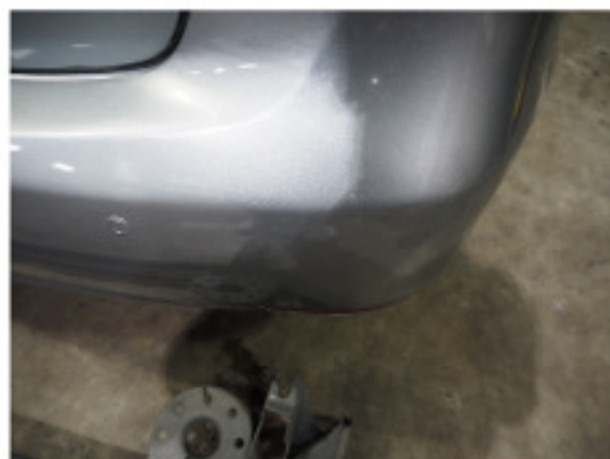
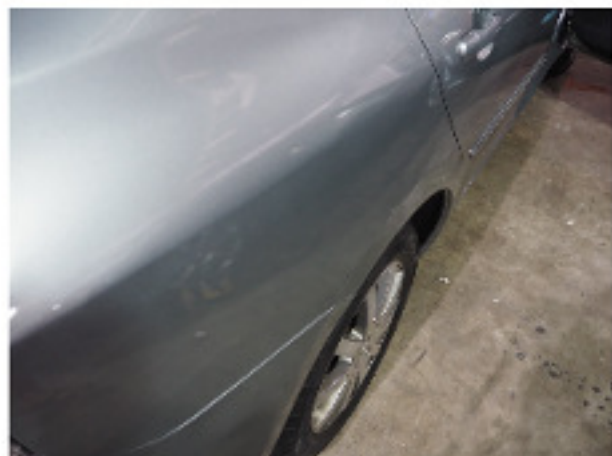
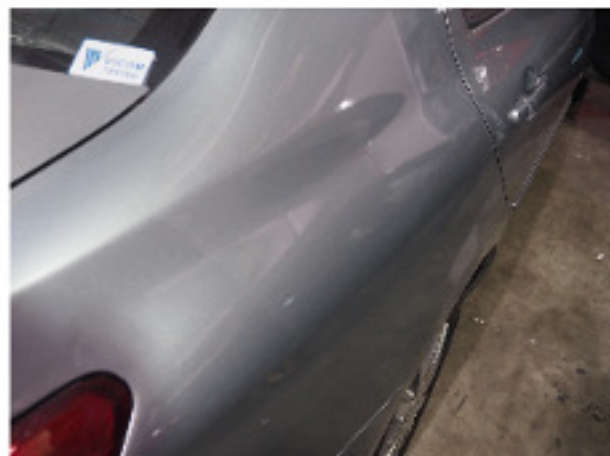
PHOTOGRAPHS FOR VEHICLE NO. SJK 6106M

RE-INSPECTION

THE VEHICLE SUSTAINED DAMAGES AT THE O/S BODY AND UNDERCARRIAGE.
