INSPECTION AND ASSESSMENT OF A DAMAGED VEHICLE FBK 3958 K ACCIDENT ON 14 NOV 2016

VEHICLE PARTICULAR

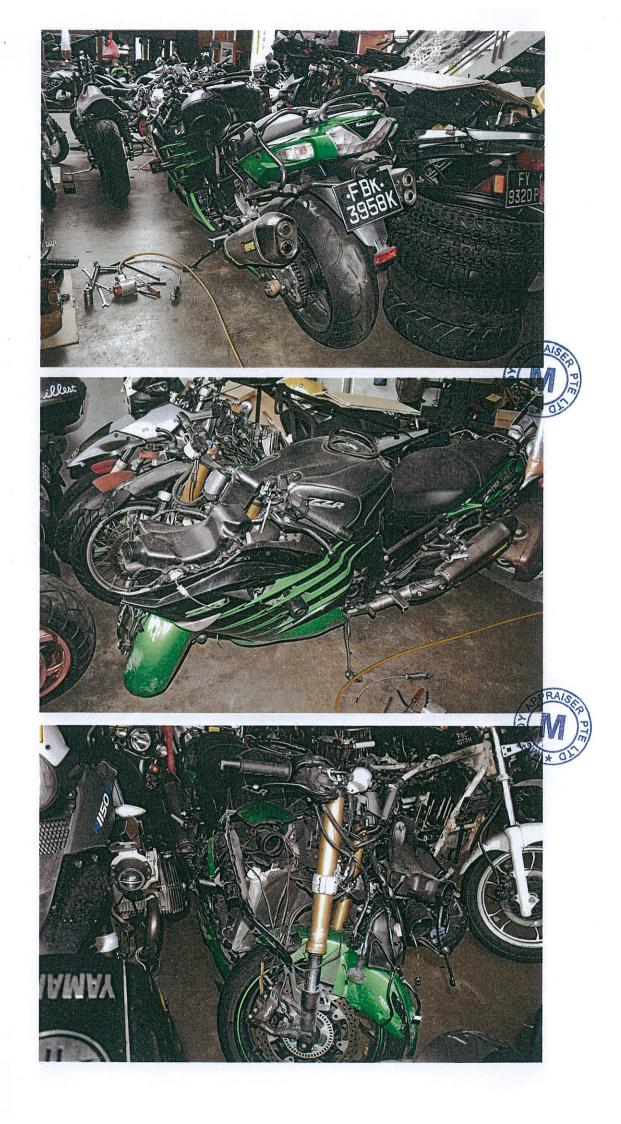
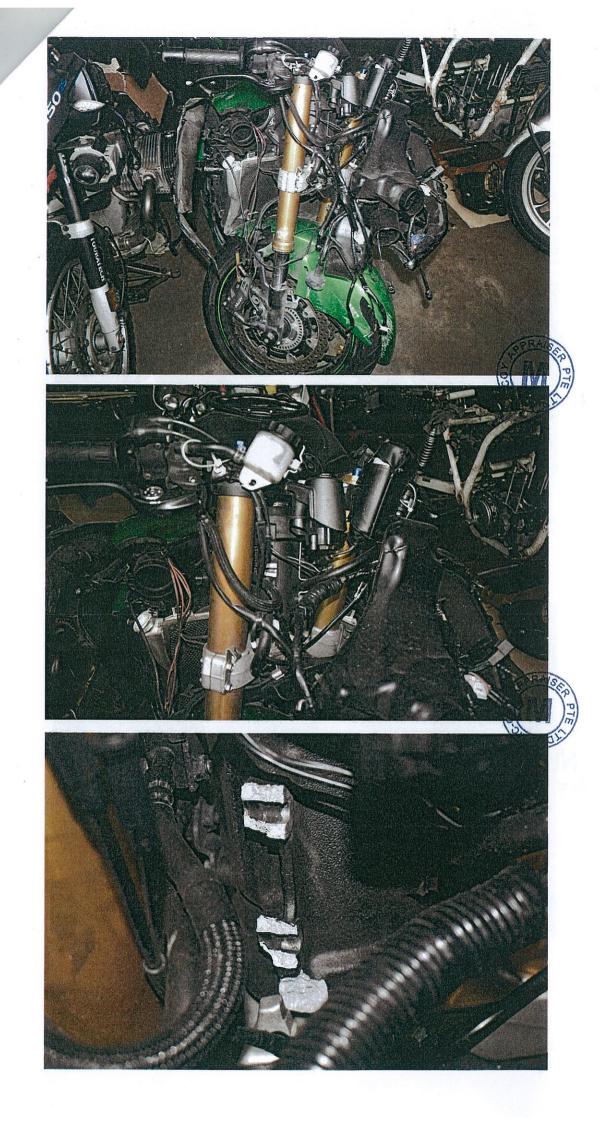
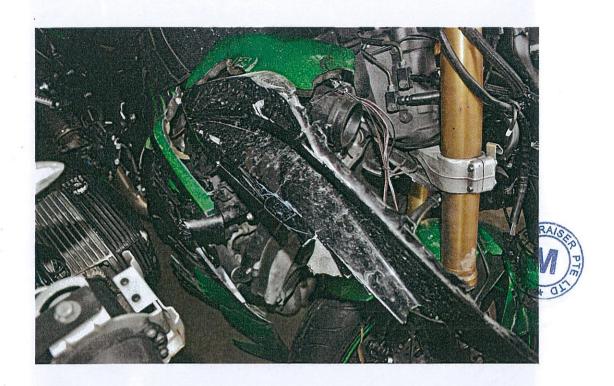
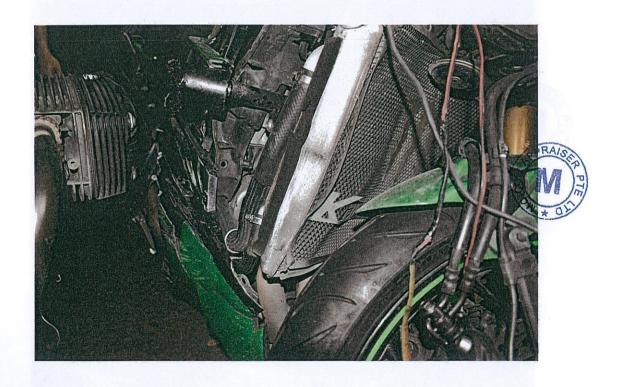
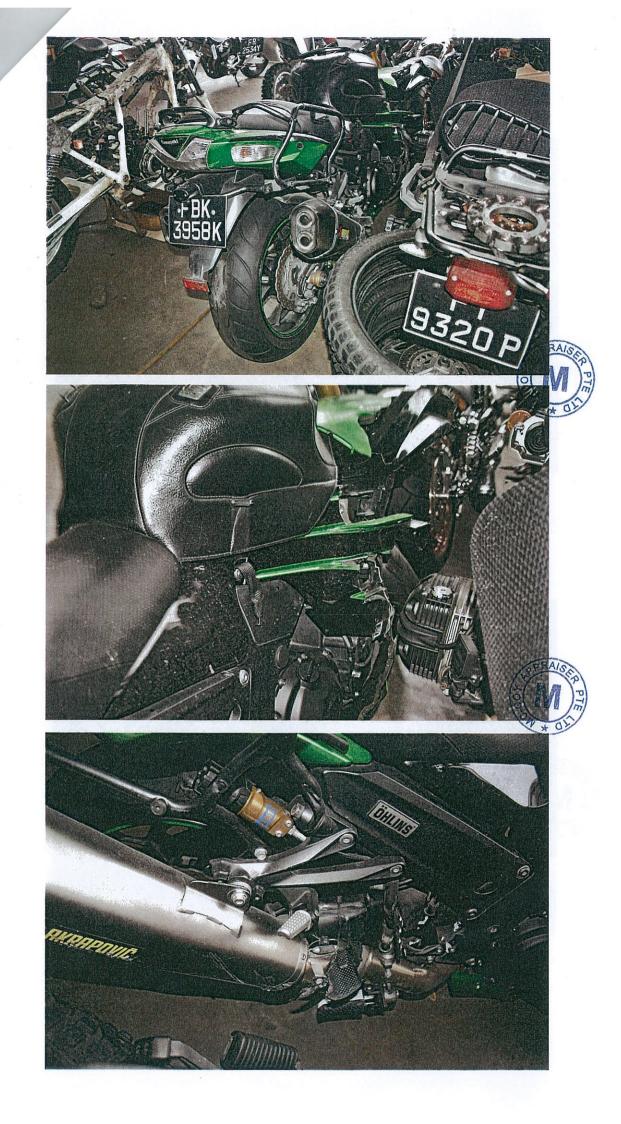
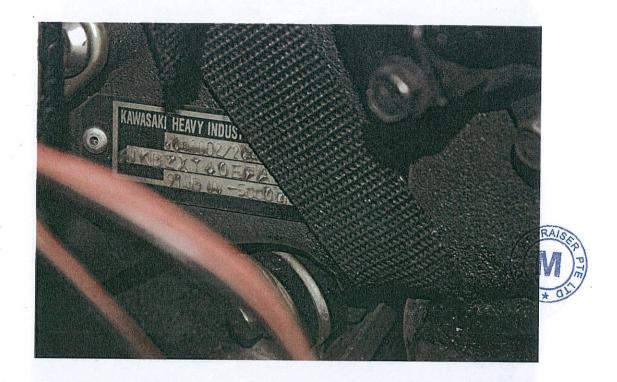
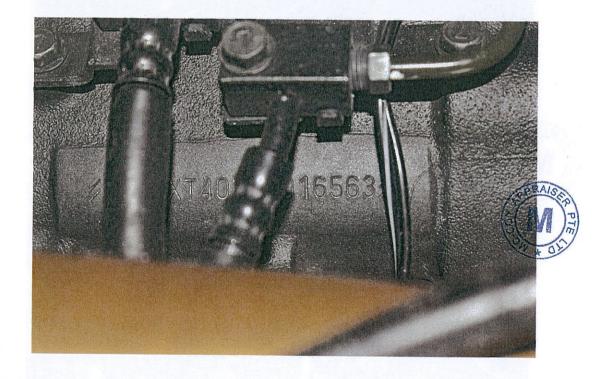
The vehicle sustained a severe impact damages on the rear and front portion, resulting front fork twisted, handle bar bent, lamps cracked, wheel, radiator bent, chassis frame badly twisted and cracked and etc.

For detail of the damages, kindly refer to the thirteen (13) copies of photographs attached herein.
