# LKK Auto Consultants Pte Ltd

### 1. Policy Particulars :- THIRD PARTY CLAIM

## ADJUSTMENT ON REPAIR COST FOR VEHICLE NO. SLZ 8561R

PHOTOGRAPHS FOR VEHICLE NO. SLZ 8561R

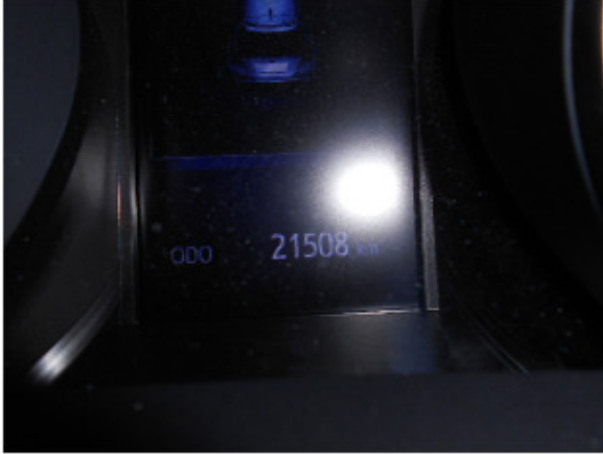
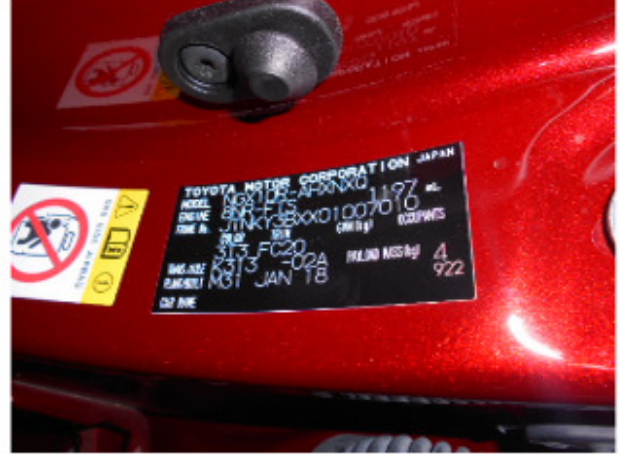
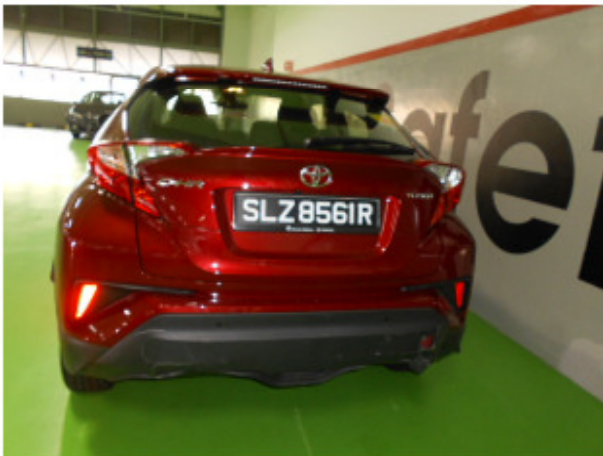
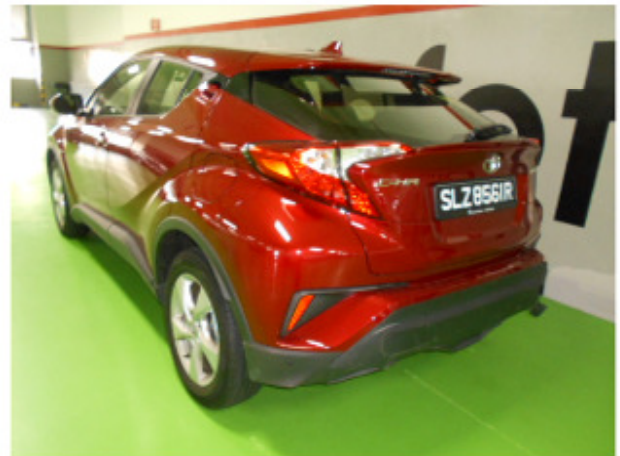
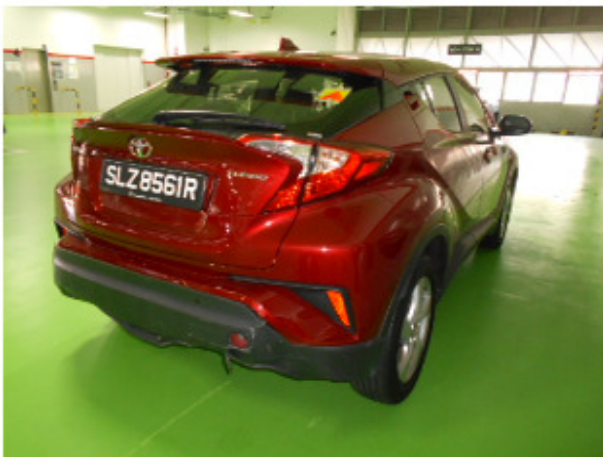
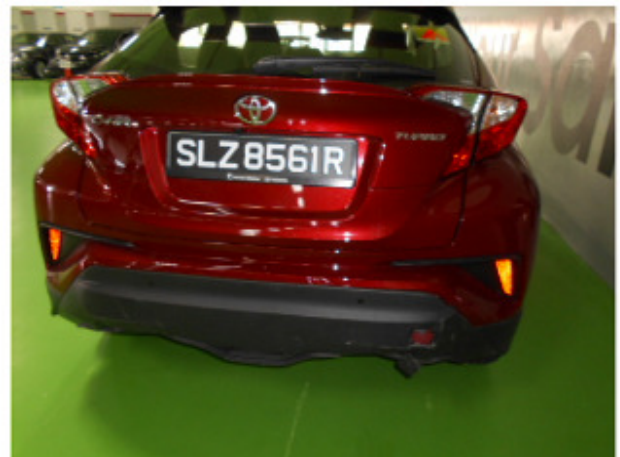
THE VEHICLE SUSTAINED DAMAGES AT THE REAR PORTION. DAMAGES SEE DETAILS.
--

INSPECTION

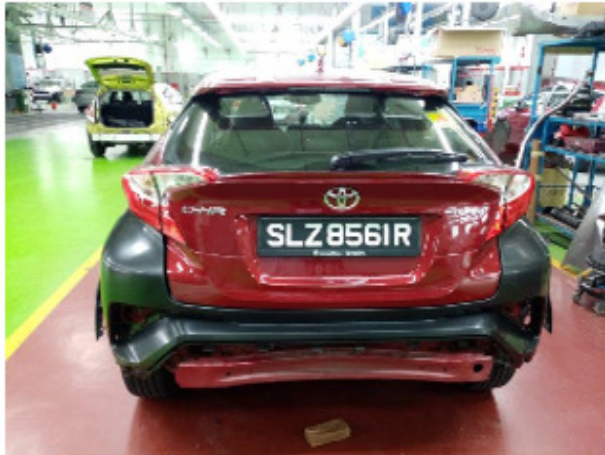
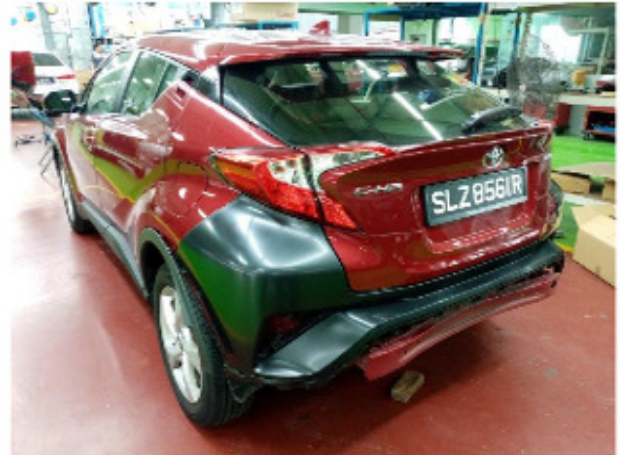
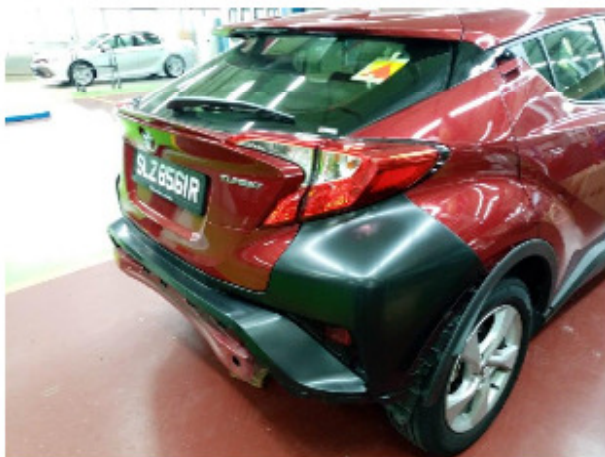
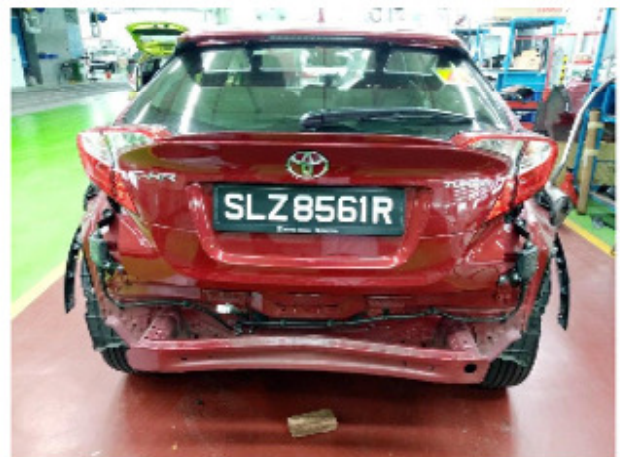
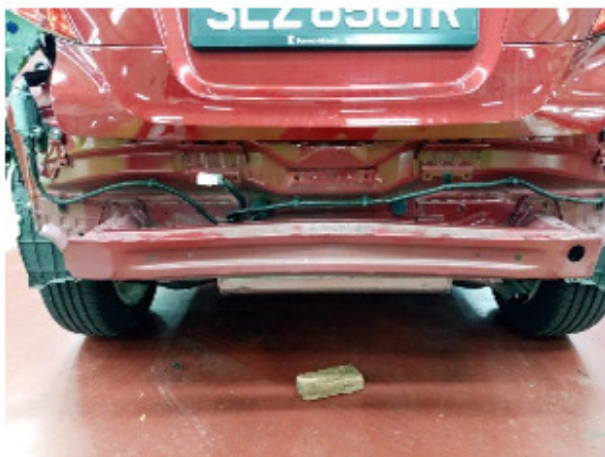
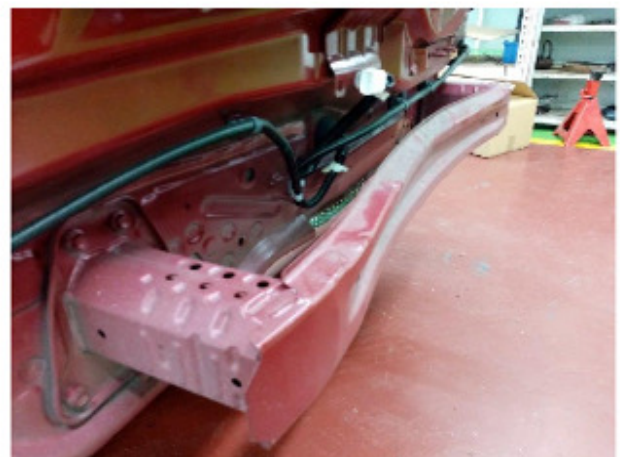
PHOTOGRAPHS FOR VEHICLE NO. SLZ 8561R

RE-INSPECTION
