LKK Auto Consultants Pte Ltd

ADJUSTMENT ON REPAIR COST FOR VEHICLE NO. GBA 863Y

PHOTOGRAPHS FOR VEHICLE NO. GBA 863Y

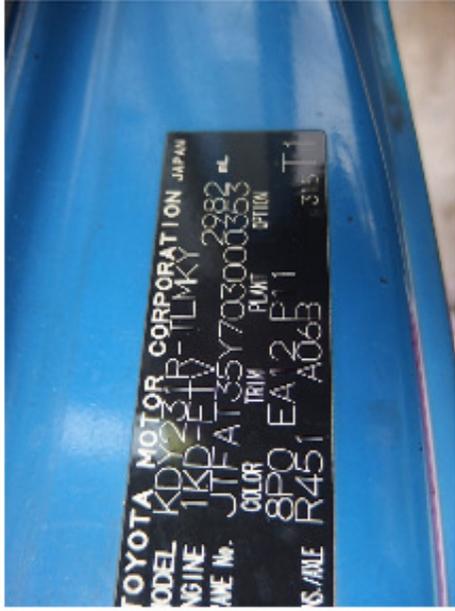
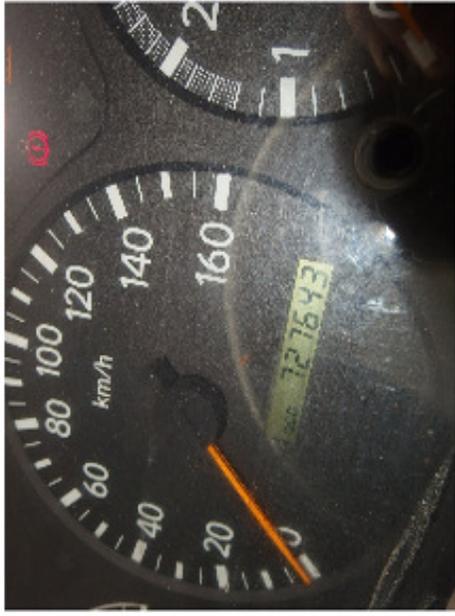
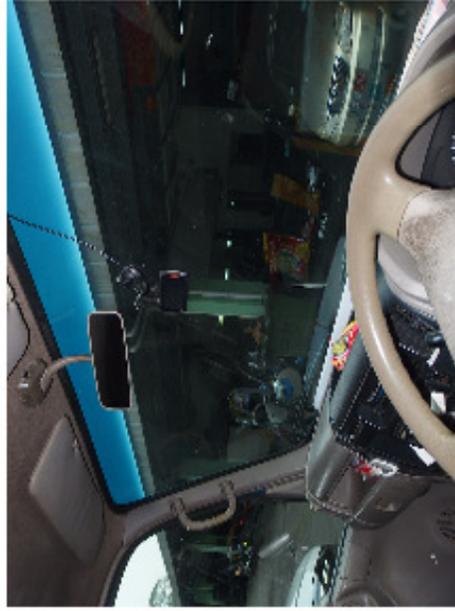
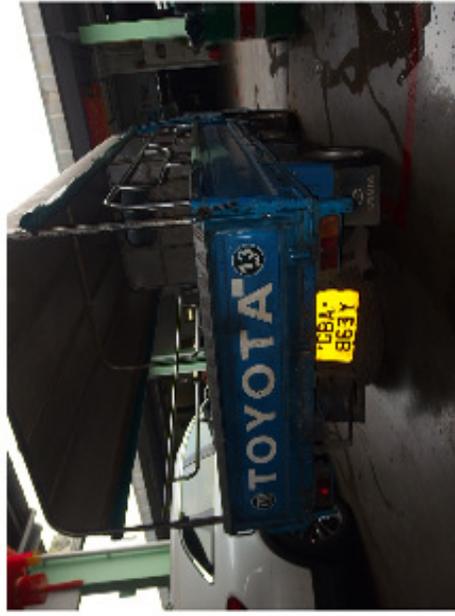
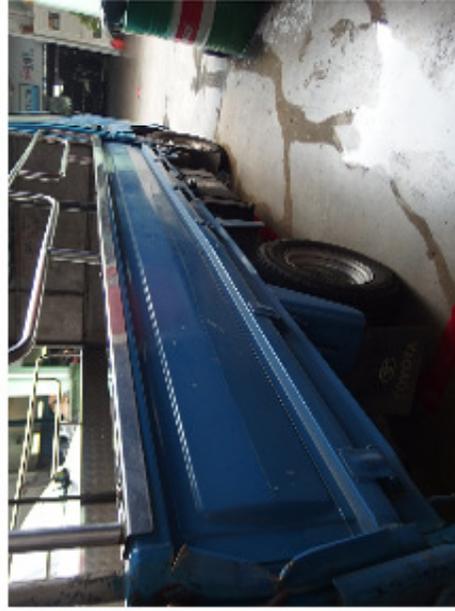
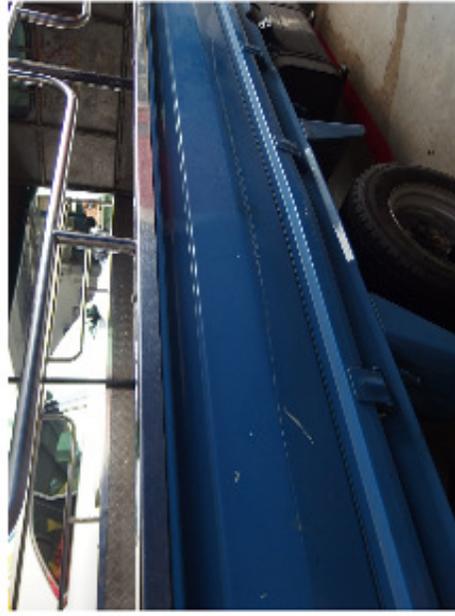
INSPECTION

THE VEHICLE SUSTAINED DAMAGES AT THE O/S REAR PORTION.
DAMAGES SEE DETAILS.

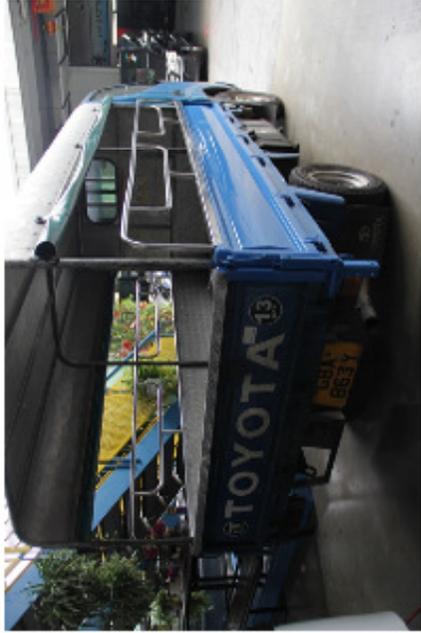
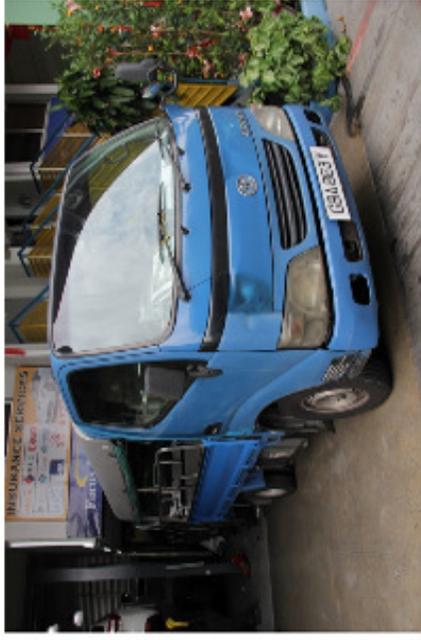
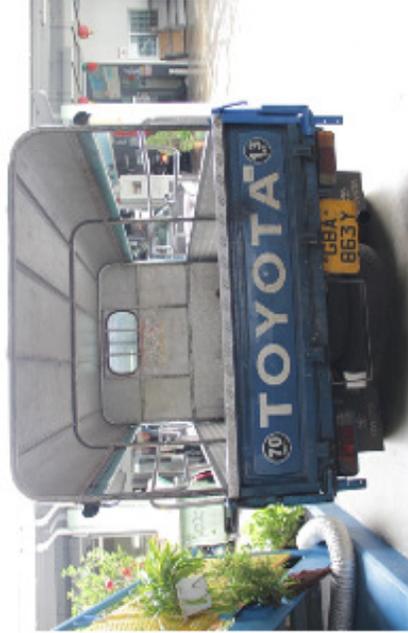
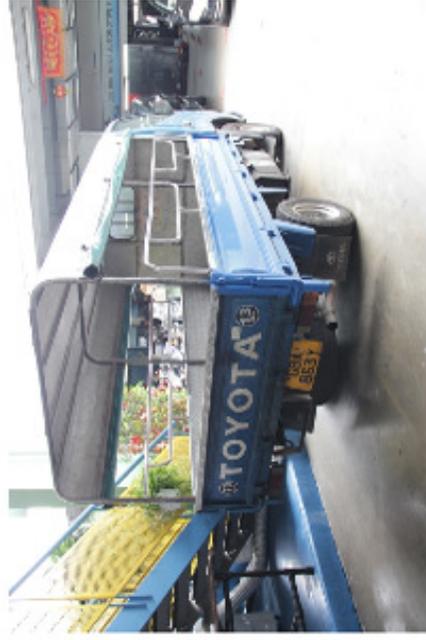
RE-INSPECTION

PHOTOGRAPHS FOR VEHICLE NO. GBA 863Y
